Process name:	Process [1]
Workpiece material:	6063
Billet temperature:	480 °C
Billet diameter:	130 mm
Billet length:	540 mm
Tool material:	H13 for extrusion
Friction conditions:	Extrusion
Die set temperature:	450 °C
Bolster and sub-bolster temperature:	150 °C
Ram temperature:	420 °C
Container temperature:	420 °C
Problem type:	Profile flow after die filling
Coupled deformation:	Yes
Ram velocity:	5 mm/s
Profile velocity:	9.72 m/min
Records count:	20
Solving time:	19 min 31 s
Extrusion ratio:	32.3899
Filling time:	14.4996 s
Extrusion load:	9.981 MN

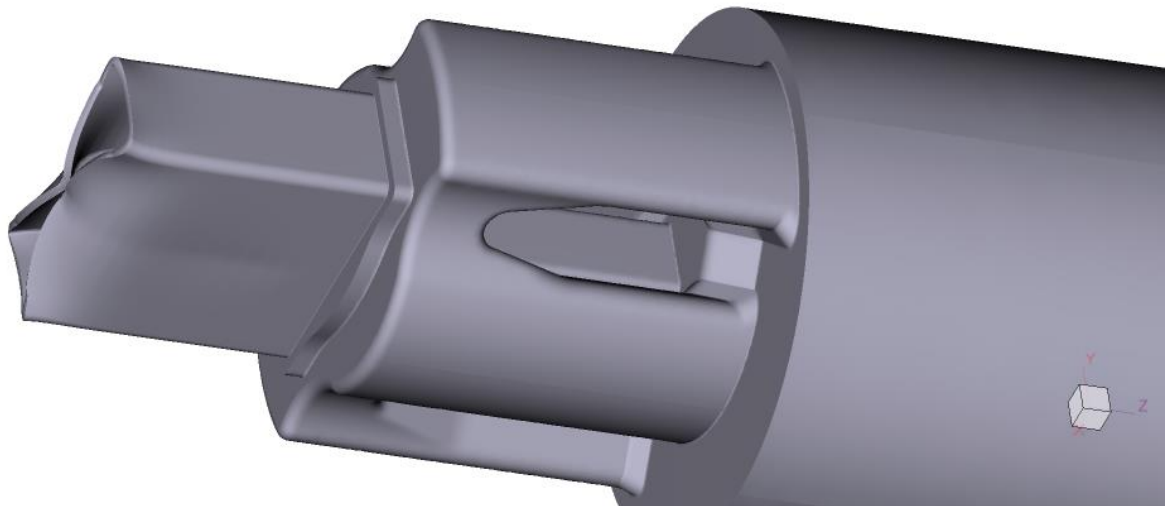
Profile front-end:

Comment: unbalance flow. Fold in the center.

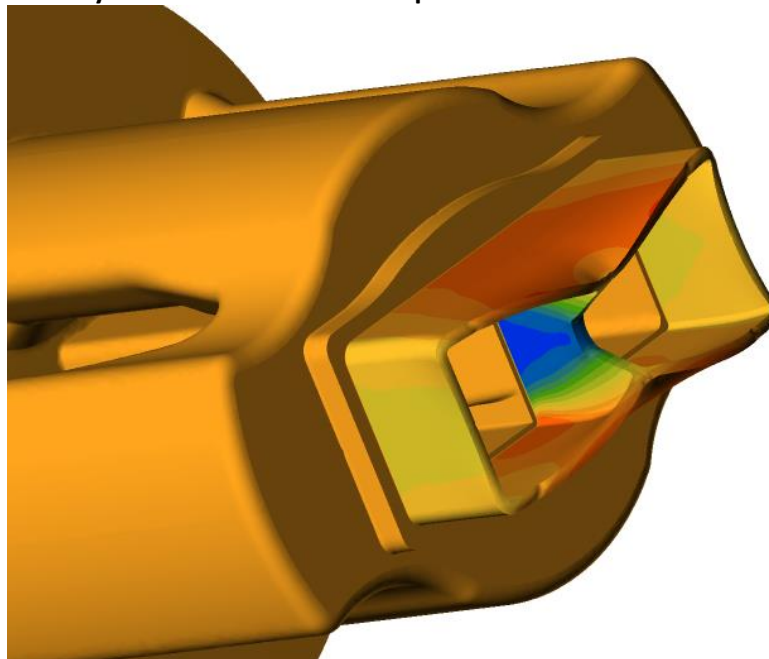
Velocity deviation distribution in profile:

Comment: Center is very slow.

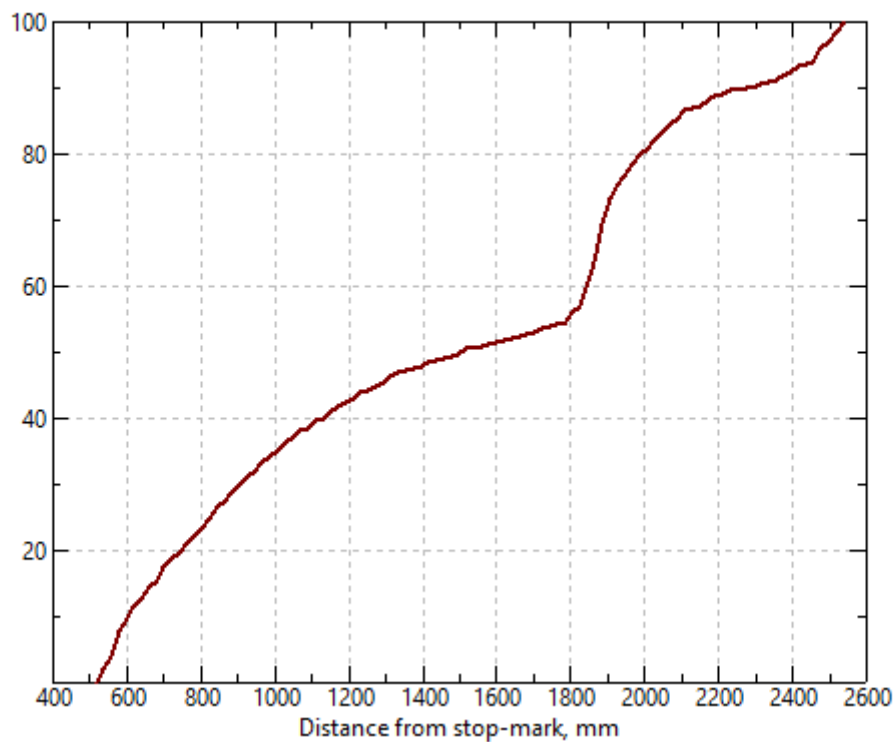
Charge weld:

Comment: Quite big scrap.

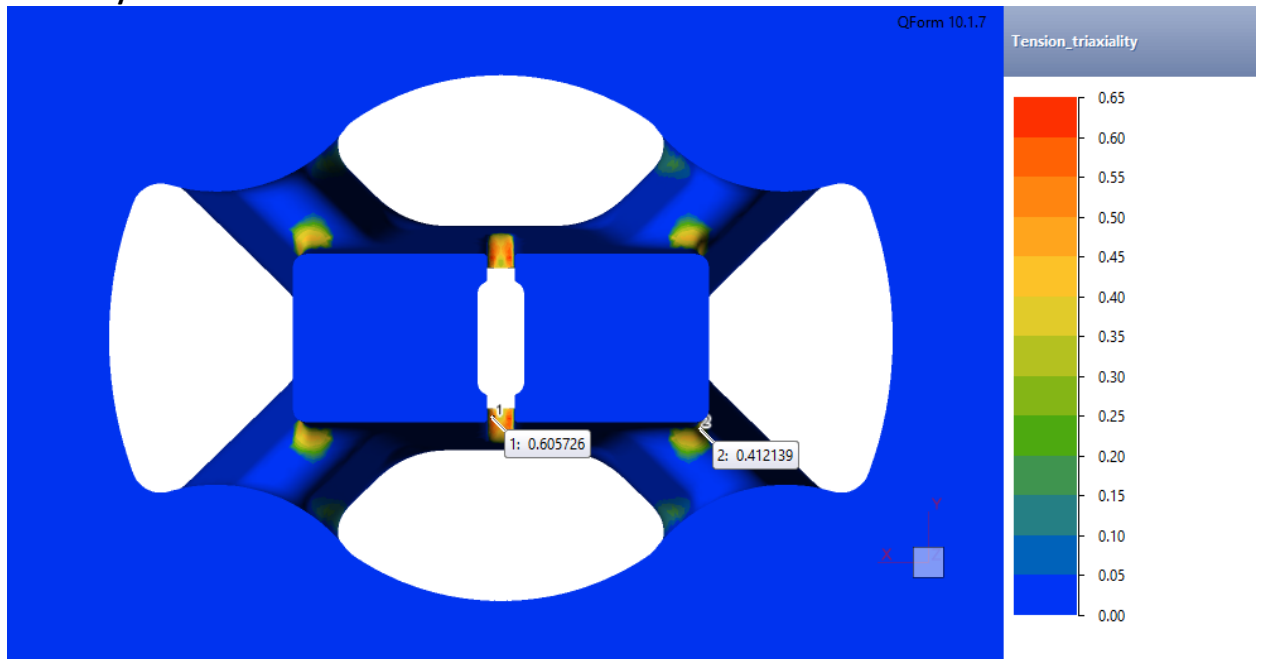
Triaxiality value:

Comment: Reference value is 0.55. Make sure that final design doesn't exceeds this value. Otherwise, acceptable tool life isn't guaranteed

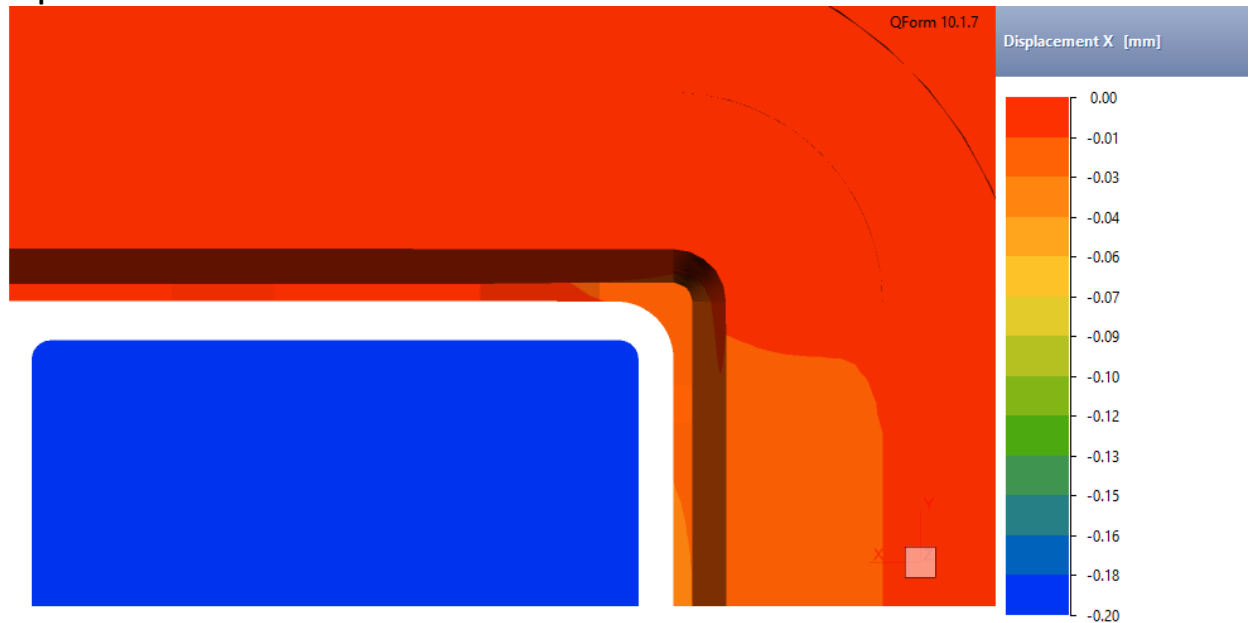
Displacement X in die set:

Comment: Out of tolerances.

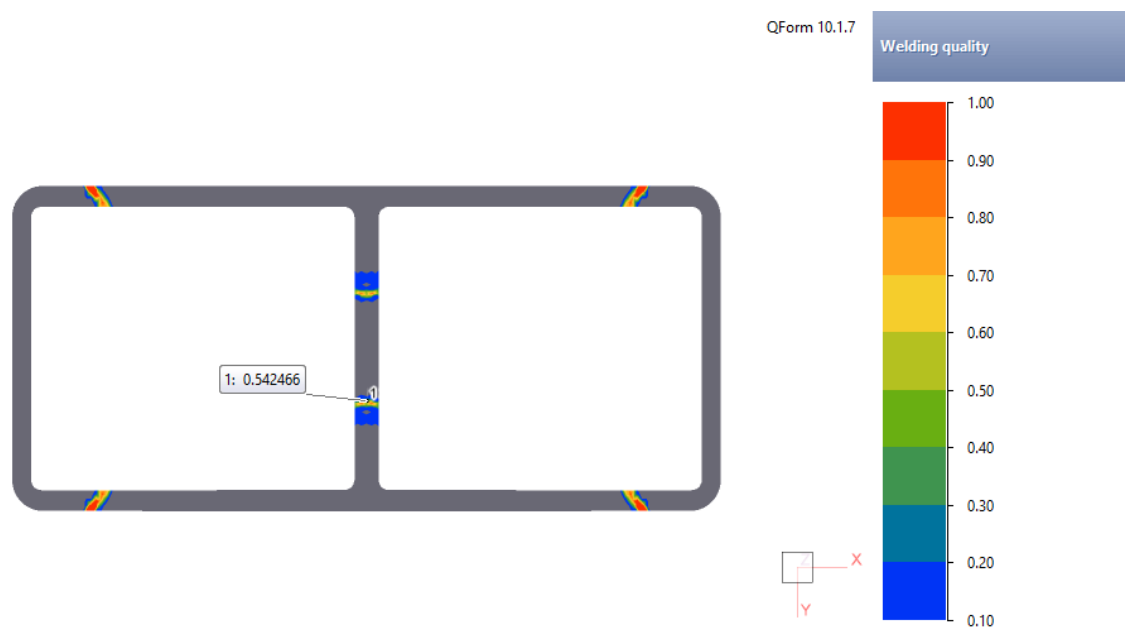
Welding quality:

Comment: Structural welding should be guaranteed.
