ASM HANDBOOK®

VOLUME
12

Fractography

Fractography, was published in 1987 as Volume 12 of the *ASM Handbook*. The Volume was prepared under the direction of the ASM Handbook Committee.

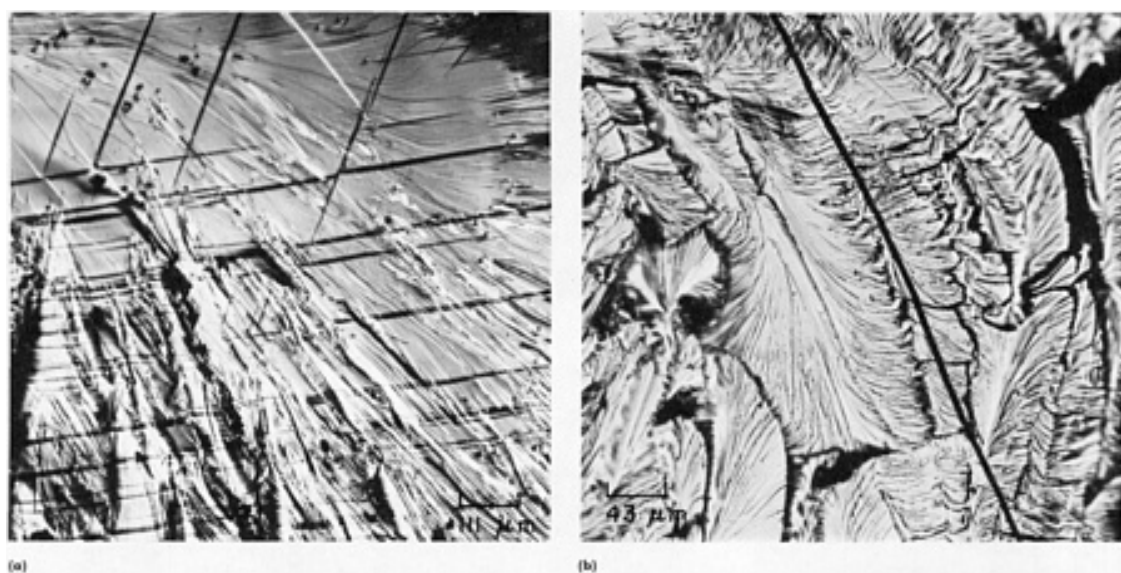
Fig. 5 Cleavage fractures in room-temperature impact specimens examined by C.A. Zapffe. (a) Cast polycrystalline antimony (99.83Sb-0.04S-0.035As-0.035Pb-0.015Fe-0.01Cu) (b) Vacuum-arc-cast high oxygen

Although bothered by the relatively small depth of focus of the light microscope, Zapffe and his co-workers were able to orient the facets of a fracture relative to the axis of the microscope so that examinations could be made at relatively high magnifications. (Zapffe routinely took fractographs with magnifications as high as 1500 to 2000 \times .) Most of Zapffe's work was done on brittle fractures in ingot iron and steels (notably welded ship plate, Ref 48), bismuth (Ref 35), zinc (Ref 37), antimony (Ref 42), molybdenum (Ref 44), and tungsten (Ref 45), from which he described in considerable detail the appearance and crystallography of cleavage facets. Figures 5(a) and 5(b) are examples of Zapffe's early work.

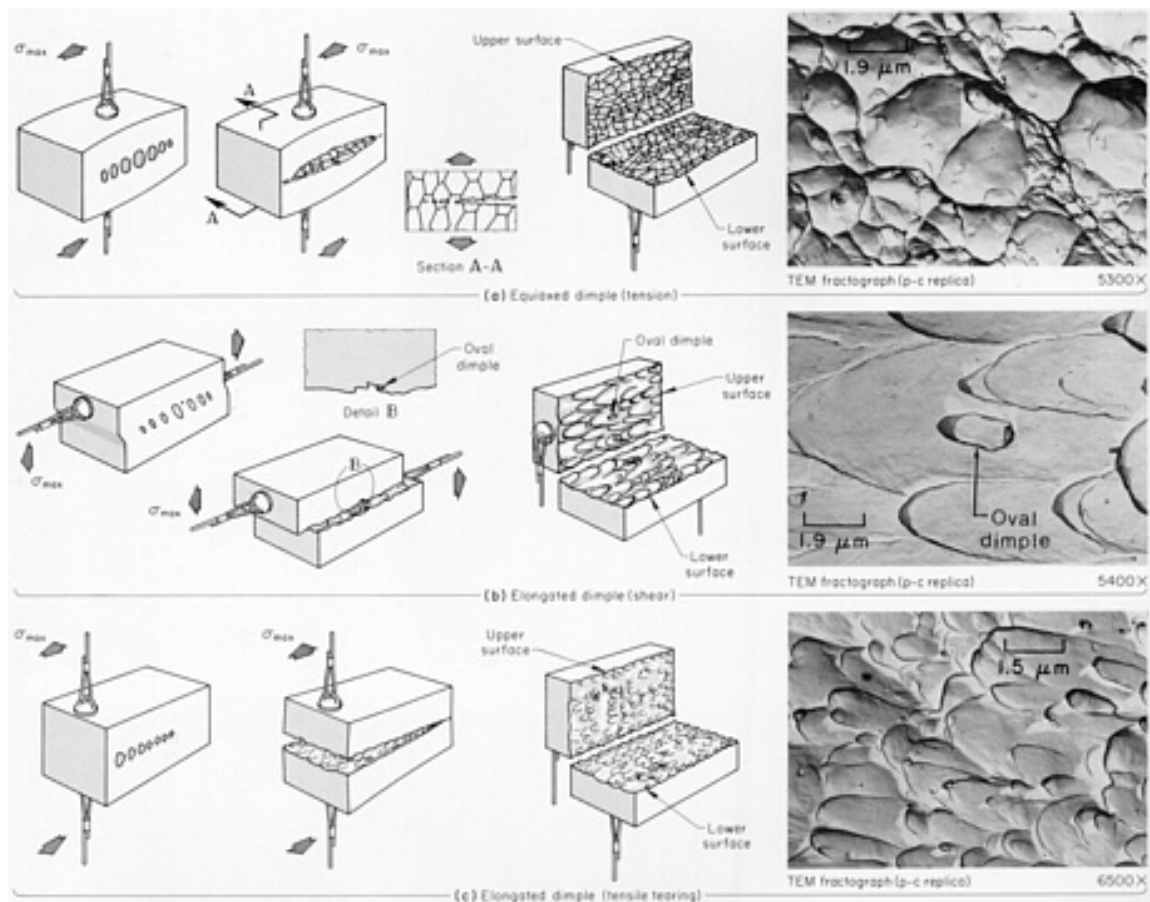
Fig. 1 Influence of direction of maximum stress (σ_{\max}) on the shapes of dimples formed by microvoid coalescence. (a) In tension, equiaxed dimples are formed on both fracture surfaces. (b) In shear, elongated dimples point in opposite directions on matching fracture surfaces. (c) In tensile tearing, elongated dimples point toward fracture origin on matching fracture surfaces

Dimple shape is governed by the state of stress within the material as the microvoids form and coalesce. Fracture under conditions of uniaxial tensile load (Fig. 1a) results in the formation of essentially equiaxed dimples bounded by a lip or rim (Fig. 3 and 4a). Depending on the microstructure and plasticity of the material, the dimples can exhibit a very deep, conical shape (Fig. 4a) or can be quite shallow (Fig. 4b). The formation of shallow dimples may involve the joining of microvoids by shear along slip bands (Ref 1).

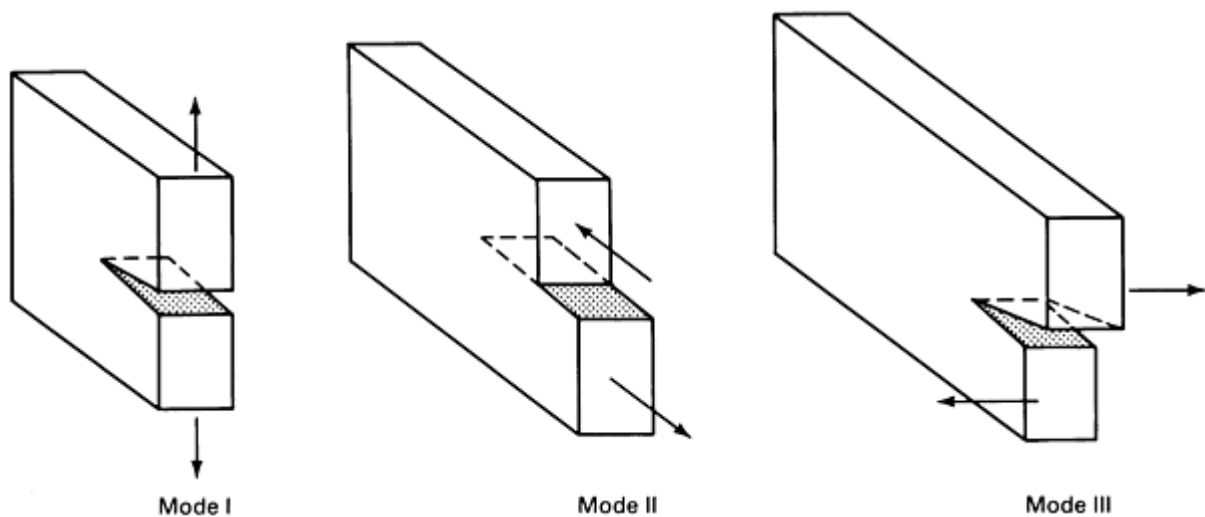
Fig. 5 Fracture loading modes. Arrows show loading direction and relative motion of mating fracture surfaces.

Fracture surfaces that result from tear (Mode I) or shear (Modes II and III) loading conditions (Fig. 5) exhibit elongated dimples (Ref 2, 3). The characteristics of an elongated dimple are that it is, as the name implies, elongated (one axis of the dimple is longer than the other) and that one end of the dimple is open; that is, the dimple is not completely surrounded by a rim. In the case of a tear fracture (Fig. 6a), the elongated dimples on both fracture faces are oriented in the same direction; and the closed ends point to the fracture origin. This characteristic of the tear dimples can be used to establish the fracture propagation direction (Ref 4) in thin sheet that ruptures by a full-slant fracture (by combined Modes I and III), which consists entirely of a shear lip and exhibits no macroscopic fracture direction indicators, such as chevron marks. A shear fracture, however, exhibits elongated dimples that point in opposite directions on mating fracture faces (Fig. 6b). Examples of typical elongated dimples are shown in Fig. 7.

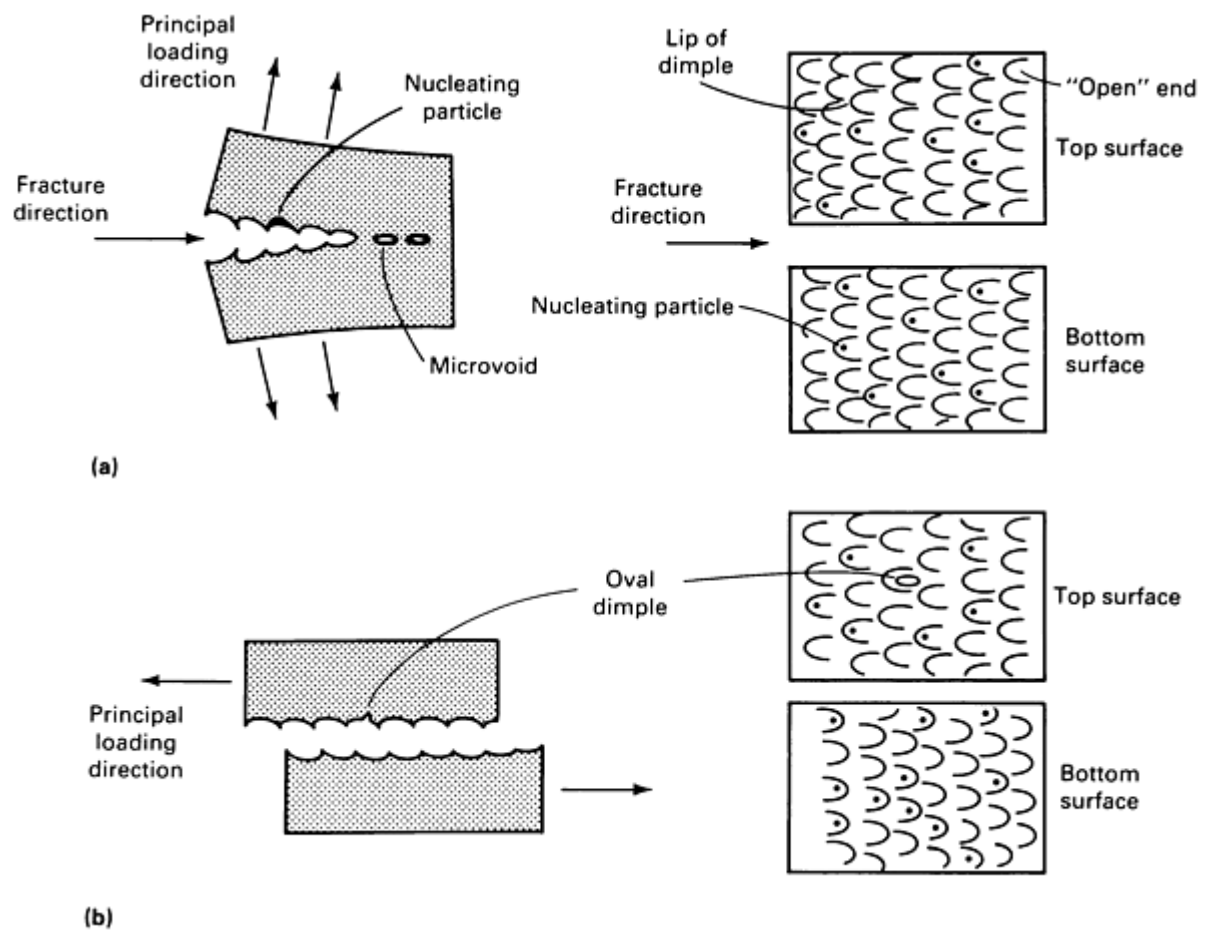
Fig. 6 Formation of elongated dimples under tear and shear loading conditions. (a) Tear fracture. (b) Shear fracture

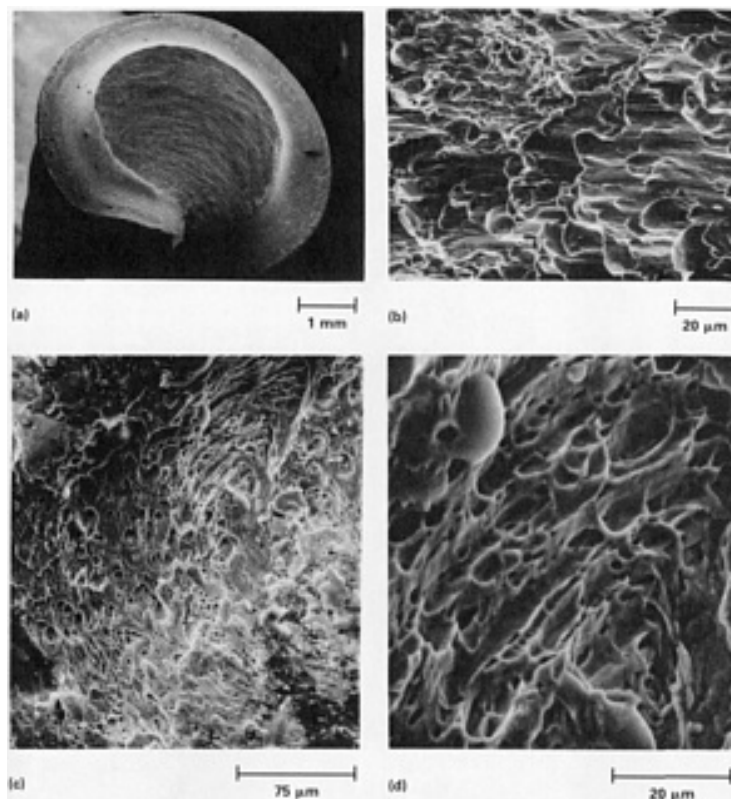
Fig. 7 Elongated dimples formed on shear and torsion specimen fracture surfaces. (a) Shear fracture of a commercially pure titanium screw. Macrofractograph shows spiral-textured surface of shear-of screw. Typical deformation lines are fanning out on the thread. (b) Higher-magnification view of (a) shows uniformly distributed elongated shear dimples. (O.E.M. Pohler, Institut Straumann AG). (c) Elongated dimples on the surface of a fractured single-strand copper wire that failed in torsion. (d) Higher-magnification view of the elongated dimples shown in (c). (R.D. Lujan, Sandia National Laboratories)

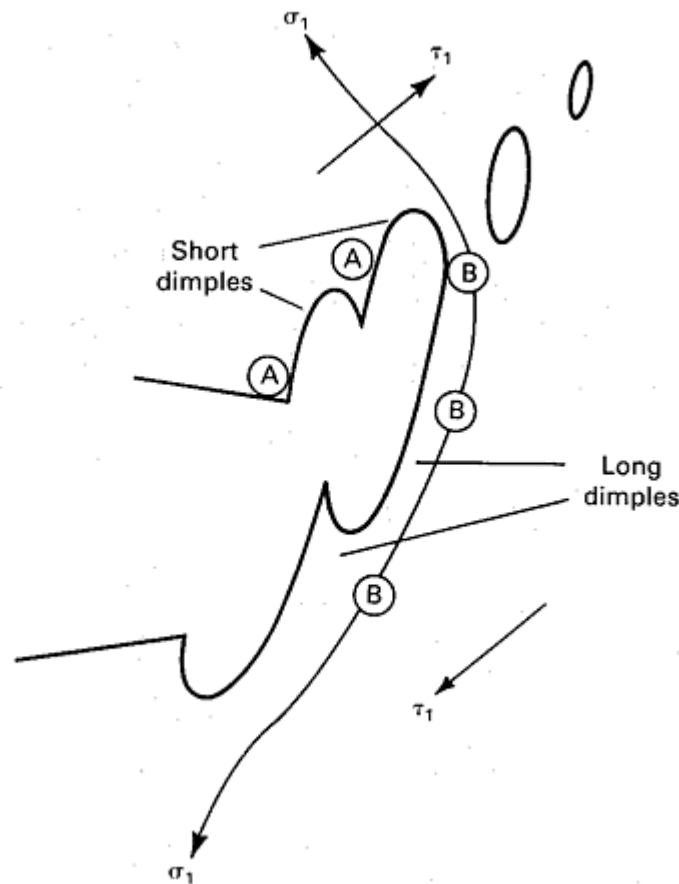
Fig. 8 Effect of asymmetry on dimple size

Figure 8 shows the effect of such asymmetry on dimple size. The surface (B) that is strained after fracture exhibits longer dimples than its mating half (A). When fracture occurs by a combination of Modes I and II, examination of the dimples on mating fracture surfaces can reveal the local fracture direction (Ref 5). As illustrated in Fig. 8, the fracture plane containing the longer dimples faces the region from which the crack propagated, while the mating fracture plane containing the shorter dimples faces away from the region. With the different combinations of Modes I, II, and III, there could be as many as 14 variations of dimple shapes and orientation on mating fracture surfaces (Ref 5.)

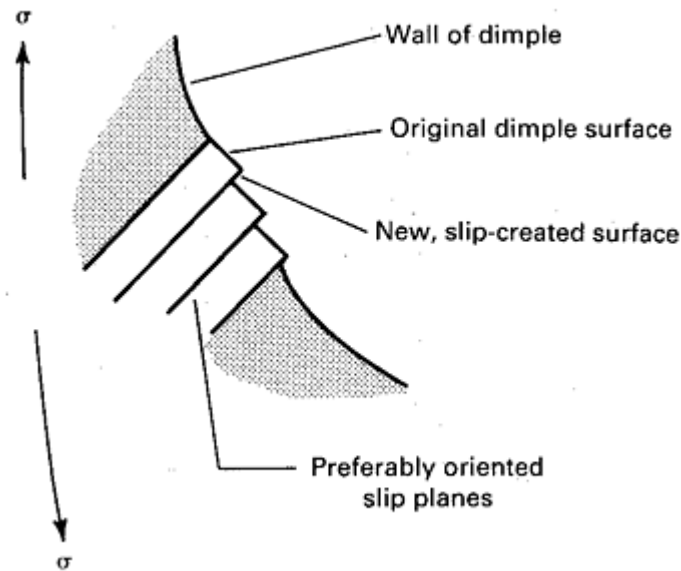
Fig. 9 Slip step formation resulting in serpentine glide and ripples on a dimple wall

Metals that undergo considerable plastic deformation and develop large dimples frequently contain deformation markings on the dimple walls. These markings occur when slip-planes at the surface of the dimples are favorably oriented to the major stress direction. The continual straining of the free surfaces of the dimples as the microvoids enlarge produces slip-plane displacement at the surface of the dimple (Ref 6), as shown in Fig. 9. When first formed, the slip traces are sharp, well defined, and form an interwoven pattern that is generally referred to as serpentine glide (Fig. 10). As the slip process proceeds, the initial sharp slip traces become smooth, resulting in a surface structure that is sometimes referred to as ripples.

(Ref 29) (for an analogy, see Fig. 9). Thus, one fracture surface may show well-developed striations, while its counterpart exhibits shallow, poorly formed striations.

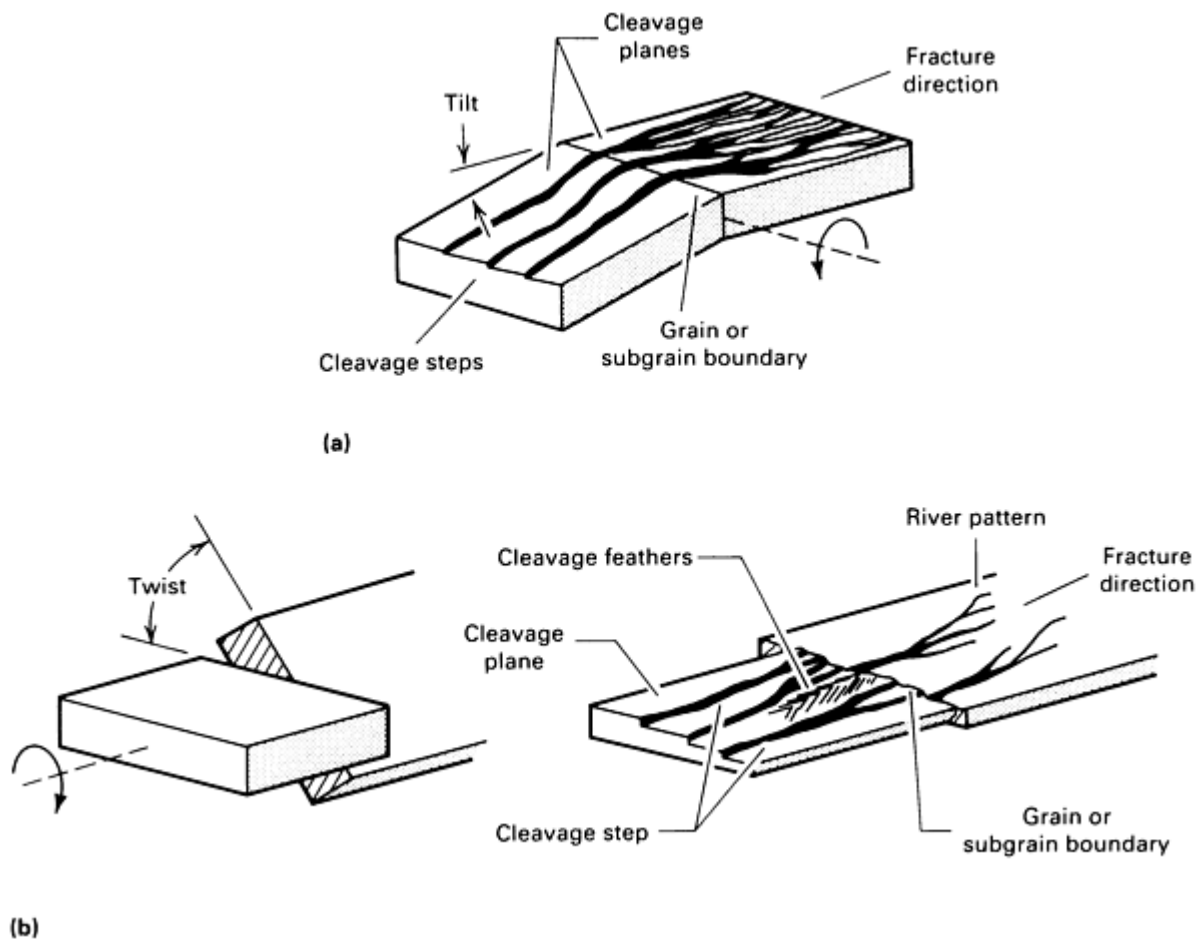
Fig. 11 Schematic of cleavage fracture formation showing the effect of subgrain boundaries. (a) Tilt boundary. (b) Twist boundary

As shown schematically in Fig. 11, cleavage fractures frequently initiate on many parallel cleavage planes. As the fracture advances, however, the number of active planes decreases by a joining process that forms progressively higher cleavage steps. This network of cleavage steps is known as a river pattern. Because the branches of the river pattern join in the direction of crack propagation, these markings can be used to establish the local fracture direction.

A tilt boundary exists when principal cleavage planes form a small angle with respect to one another as a result of a slight rotation about a common axis parallel to the intersection (Fig. 11a). In the case of a tilt boundary, the cleavage fracture path is virtually uninterrupted, and the cleavage planes and steps propagate across the boundary. However, when the principal cleavage planes are rotated about an axis perpendicular to the boundary, a twist boundary results (Fig. 11b). Because of the significant misalignment of cleavage planes at the boundary, the propagating fracture reinitiates at the boundary as a series of parallel cleavage fracture connected by small (low) cleavage steps. As the fracture propagates away from the boundary, the numerous cleavage planes join, resulting in fewer individual cleavage planes and higher steps. Thus, when viewing a cleavage fracture that propagates across a twist boundary, the cleavage steps do not cross but initiate new steps at the boundary (Fig. 11b). Most boundaries, rather than being simple tilt or twist, are a combination of both types and are referred to as tilt-twist boundaries. Cleavage fracture exhibiting twist and tilt boundaries are shown in Fig. 12(a) and 13, respectively.

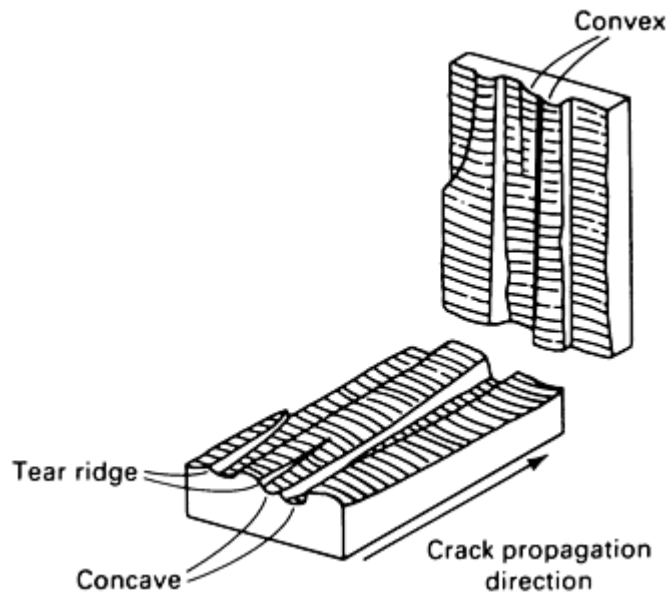
Fig. 26 Schematic illustrating fatigue striations on plateaus

Characteristics of Fractures With Fatigue Striations. During Stage II fatigue, the crack often propagates on multiple plateaus that are at different elevations with respect to one another (Fig. 26). A plateau that has a concave surface curvature exhibits a convex contour on the mating fracture face (Ref 29). The plateaus are joined either by tear ridges or walls that contain fatigue striations (Fig. 19 and 20a). Fatigue striations often bow out in the direction of crack propagation and generally tend to align perpendicular to the principal (macroscopic) crack propagation direction. However, variations in local stresses and microstructure can change the orientation of the plane of fracture and alter the direction of striation alignment (Fig. 27).

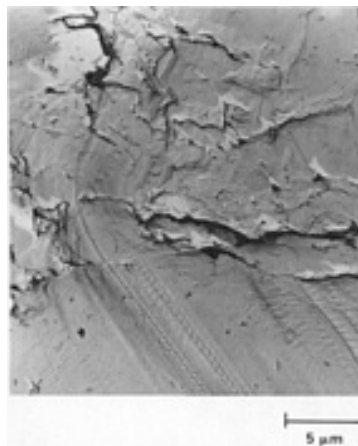
Fig. 28 Tire tracks on the fatigue fracture surface of a quenched-and-tempered AISI 4140 steel. TEM replica. (I. Le May, Metallurgical Consulting Services Ltd.)

The distinct, periodic markings sometimes observed on fatigue fracture surfaces are known as tire tracks, because they often resemble the tracks left by the tread pattern of a tire (Fig. 28). These rows of parallel markings are the result of a particle or a protrusion on one fatigue fracture surface being successively impressed into the surface of the mating half of the fracture during the closing portion of the fatigue cycle (Ref 23, 29, 34). Tire tracks are more common for the tension-compression than the tension-tension type of fatigue loading (Ref 23). The direction of the tire tracks and the change in spacing of the indentations within the track can indicate the type of displacement that occurred during the fracturing process, such as lateral movement from shear or torsional loading. The presence of tire tracks on a fracture surface that exhibits no fatigue striations may indicate that the fracture occurred by low-cycle (high-stress) fatigue (Ref 35).

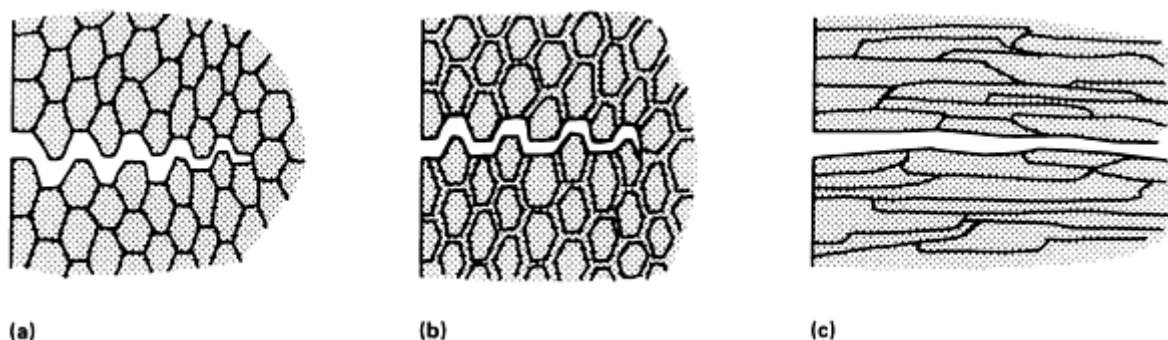
Fig. 29 Schematic illustrating decohesive rupture along grain boundaries. (a) Decoherence along grain boundaries of equiaxed grains. (b) Decoherence through a weak grain-boundary phase. (c) Decoherence along grain boundaries of elongated grains

A fracture is referred to as decohesive rupture when it exhibits little or no bulk plastic deformation and does not occur by dimple rupture, cleavage, or fatigue. This type of fracture is generally the result of a reactive environment or a unique microstructure and is associated almost exclusively with rupture along grain boundaries. Grain boundaries contain the lowest melting point constituents of an alloy system. They are also easy paths for diffusion and sites for the segregation of such elements as hydrogen, sulfur, phosphorus, antimony, arsenic, and carbon; the halide ions, such as chlorides; as well as the routes of penetration by the low melting point metals, such as gallium, mercury, cadmium and tin. The presence of these constituents at the boundaries can significantly reduce the cohesive strength of the material at the boundaries and promote decohesive rupture (Fig. 29).

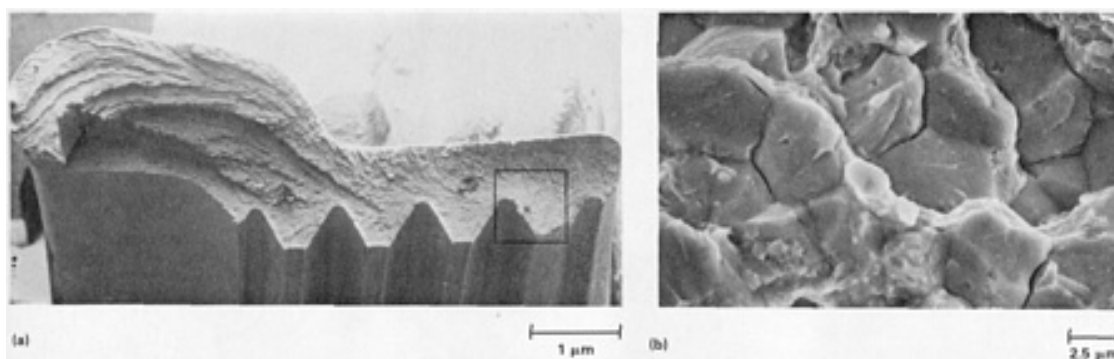
Fig. 30 Decohesive rupture in an AISI 8740 steel nut due to hydrogen embrittlement. Failure was due to inadequate baking following cadmium plating; thus, hydrogen, which was picked up during the plating process, was not released. (a) Macrograph of fracture surface. (b) Higher-magnification view of the boxed area in (a) showing typical intergranular fracture. (W.L. Jensen, Lockheed Georgia Company)

The source of hydrogen may be a processing operation, such as plating (Fig. 30) or acid cleaning, or the hydrogen may be acquired from the environment in which the part operates. If hydrogen absorption is suspected, prompt heating at an elevated temperature (usually about 200 °C, or 400 °F) will often restore the original properties of the material.

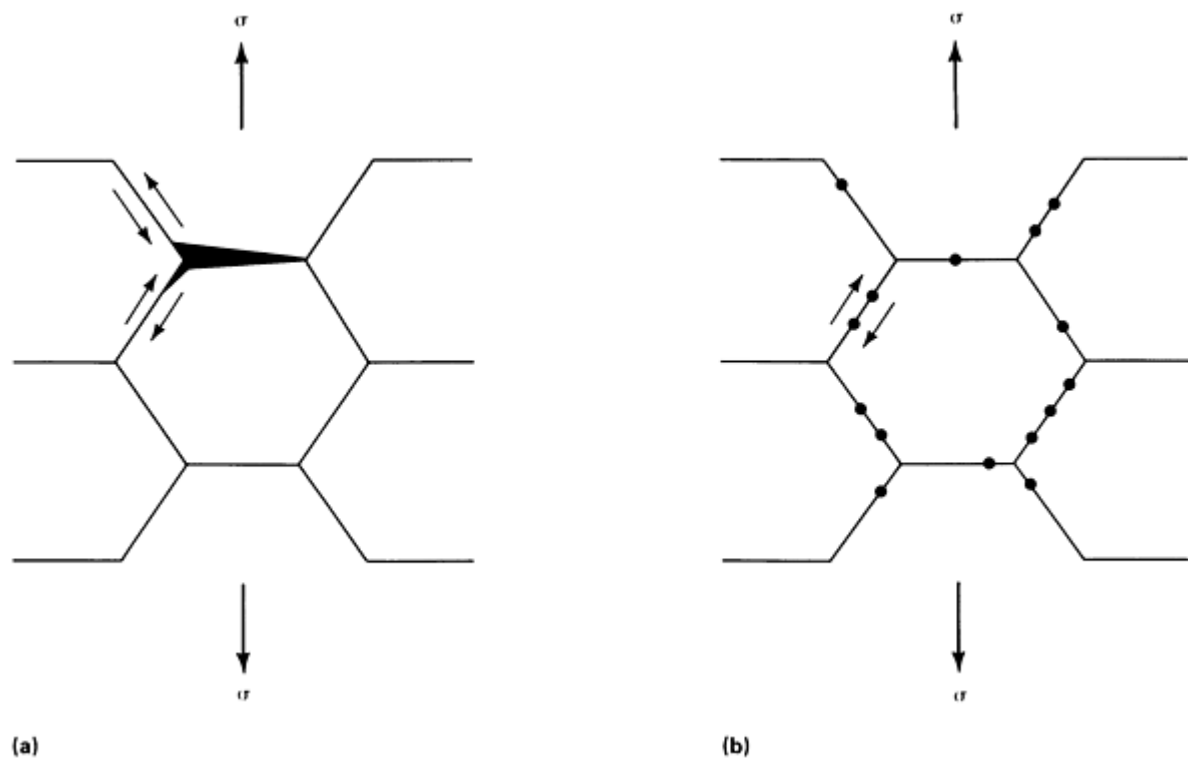
Fig. 34 Triple-point cracking (a) and cavitation (b) in intergranular creep rupture. Small arrows indicate grain-boundary sliding.

As shown schematically in Fig. 34, intergranular creep ruptures occur by either of two fracture processes: triple-point cracking or grain-boundary cavitation (Ref 50, 51, 52, 53, 54, 55, 56, 57, 58, 59, 60, 61, 62, 63). The strain rate and temperature determine which fracture process dominates. Relatively high strain rates and intermediate temperatures promote the formation of wedge cracks (Fig. 34a). Grain-boundary sliding as a result of an applied tensile stress can produce sufficient stress concentration at grain-boundary triple points to initiate and propagate wedge cracks (Ref 50, 51, 52, 55, 56, 58, 59, 60, 61). Cracks can also nucleate in the grain boundary at locations other than the triple point by the interaction of primary and secondary slip steps with a sliding grain boundary (Ref 61). Any environment that lowers grain-boundary cohesion also promotes cracking (Ref 59). As sliding proceeds, grain-boundary cracks propagate and join to form intergranular decohesive fracture (Fig. 35a and b).

At high temperatures and low strain rates, grain-boundary sliding favors cavity formation (Fig. 34b). The grain-boundary cavities resulting from creep should not be confused with microvoids formed in dimple rupture. The two are fundamentally different; the cavities are principally the result of a diffusion-controlled process, while microvoids are the result of complex slip. Even at low strain rates, a sliding grain boundary can nucleate cavities at irregularities, such as second-phase inclusion particles (Ref 54, 57, 63, 64). The nucleation is believed to be a strain-controlled process (Ref 63, 64), while the growth of the cavities can be described by a diffusion growth model (Ref 65, 66, 67) and by a power-law growth relationship (Ref 68, 69). Irrespective of the growth model, as deformation continues, the cavities join to form an intergranular fracture. Even though the fracture resulting from cavitation creep exhibits less sharply defined intergranular facets (Fig. 35c), it would be considered a decohesive rupture.

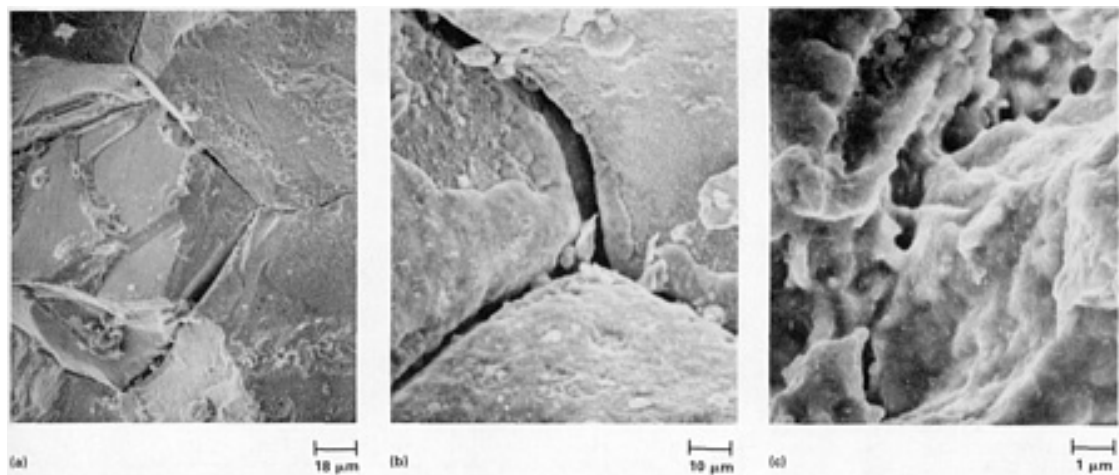
Fig. 35 Examples of intergranular creep fractures. (a) Wedge cracking in Inconel 625. (b) Wedge cracking in Incolay 800. (c) Intergranular creep fracture resulting from grain-boundary cavitation in PE-16. Source: Ref 59

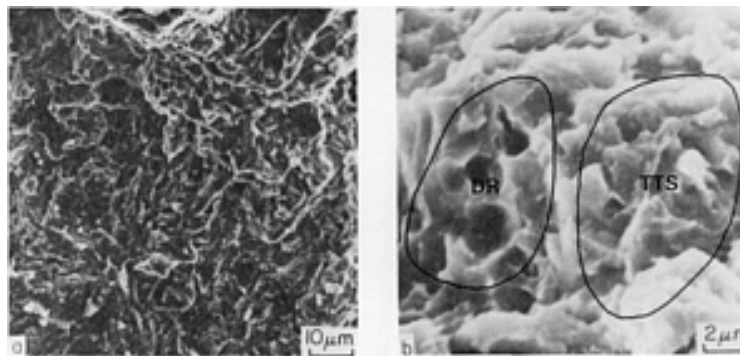
Fig. 41 Appearance of TTS fracture. (a) An essentially 100% pearlitic eutectoid steel (similar to AISI 1080) where fractures propagate across pearlite colonies. (b) Fractographs showing dimple rupture (DR) and TTS fracture in a quenched-and-tempered (martensitic) HY-130 steel. Source: Ref 91, 93

A tentative fracture mode called tearing topography surface (TTS) has been identified and described (Ref 91). The TTS fracture occurs in a variety of alloy systems, including steels, aluminum, titanium, and nickel alloys, and under a variety of fracture conditions, such as overload, hydrogen embrittlement (Ref 92), and fatigue. Examples of TTS fractures are shown in Fig. 40, 41, and 42.

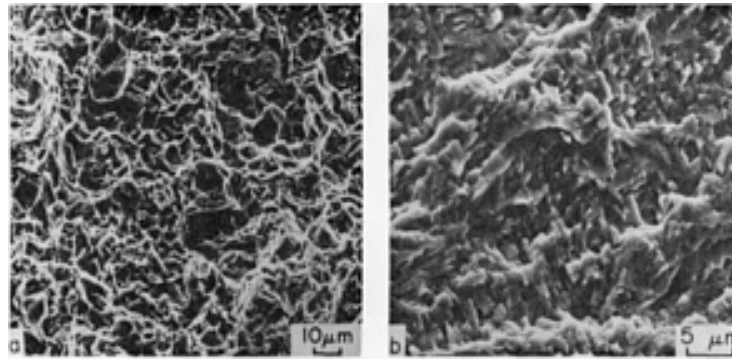
Fig. 42 Examples of TTS fracture in Ti-6Al-4V α - β alloys. (a) Solution treated and aged microstructure consisting of about 10- μ m diam primary α particles in a matrix of about 70 vol% of fine Widmanstätten α and β . The microstructural constituents are not evident on the fracture surface as verified by the plateau-etching technique (Ref 91, 94). (b) Fractograph of a β -quenched Ti-6Al-4V alloy consisting of a fine Widmanstätten martensitic microstructure. The tearing portions of the fracture surface exhibit TTS.

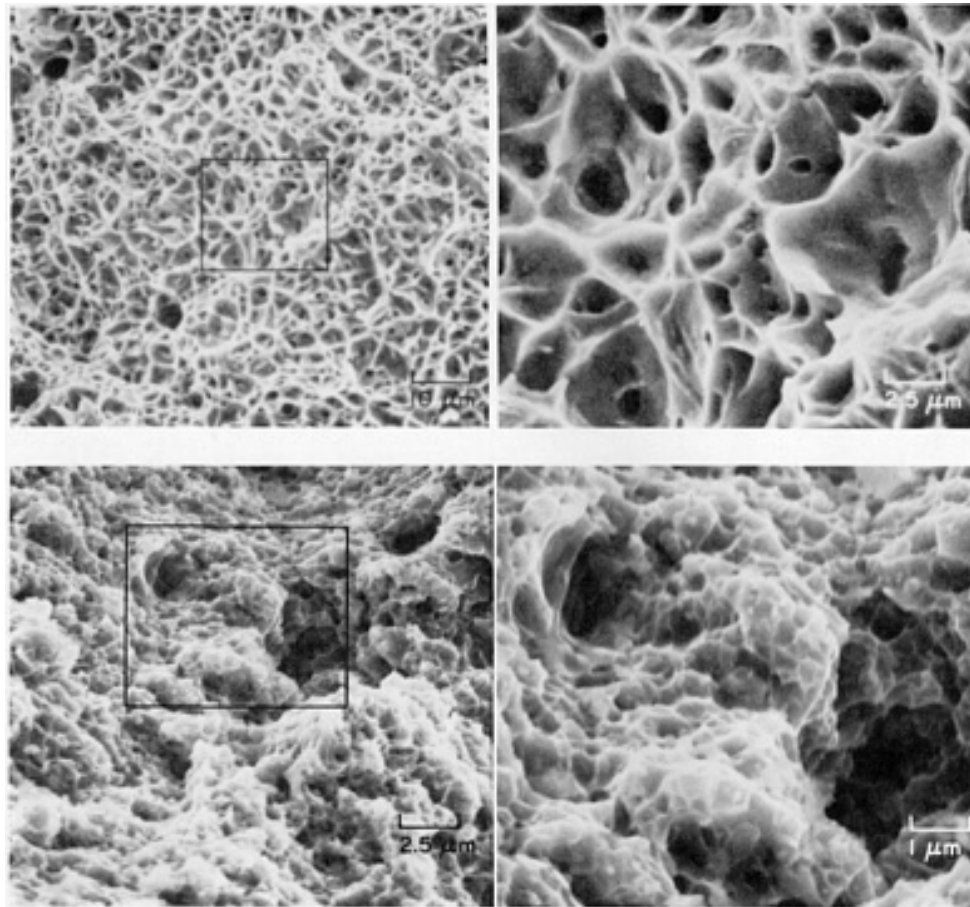
Fig. 43 Effect of hydrogen on fracture appearance in 13-8 PH stainless steel with a tensile strength of MPa (237 ksi). Top row: SEM fractographs of a specimen not embrittled by hydrogen. Bottom row: SEM fractographs of a specimen charged with hydrogen by plating without subsequent baking.

If the effect of hydrogen is subtle, such as when there is a slight decrease in the reduction of area at fracture as a result of a tensile test, there is no perceivable change in the dimple rupture fracture appearance. However, the dimples become more numerous but are more shallow at a greater loss in ductility (Fig. 43).

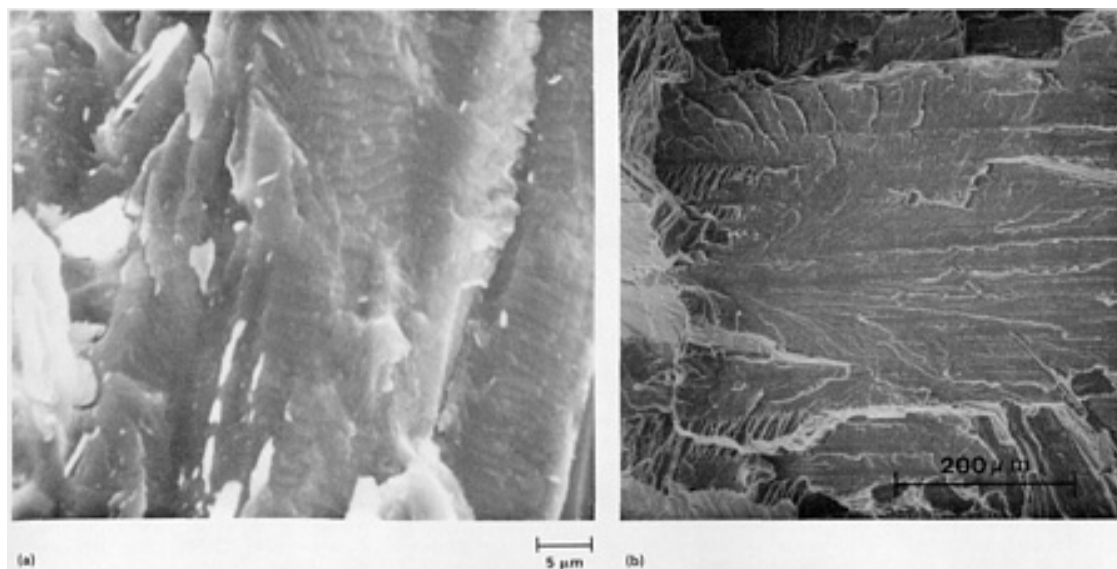
Fig. 46 Examples of hydrogen-embrittled titanium alloys. (a) Hydrogen embrittlement fracture in a Ti-8Al-1Mo-1V alloy in gaseous hydrogen. Note crack-arrest marks. Source: Ref 137. (b) Cleavage fracture in hydrogen-embrittled Ti-5Al-2.5Sn alloy containing 90 ppm H. Source: Ref 141

Hydrogen Embrittlement of Titanium. Although titanium and its alloys have a far greater tolerance for hydrogen than high-strength steels, titanium alloys are embrittled by hydrogen. The degree and the nature of the embrittlement is strongly influenced by the alloy, the microstructure, and whether the hydrogen is present in the lattice before testing or is introduced during the test. For example, a Ti-8Al-1Mo-1V alloy that was annealed at 1050 °C (1920 °F), cooled to 850 °C (1560 °F), and water quenched to produce a coarse Widmanstätten structure exhibited cracking along the α - β interfaces when tested in 1-atm hydrogen gas at room temperature (Ref 137). The fracture surface, which exhibited crack-

arrest markings, is shown in Fig. 46(a). The arrest markings are believed to be due to the discontinuous crack propagation as a result of the repeated rupture of titanium hydride phase at the crack tip (Ref 137). Also, Fig. 46(b) shows a hydrogen embrittlement fracture in a Ti-5Al-2.5Sn alloy containing 90 ppm H that was β processed at 1065 °C (1950 °F) and aged for 8 h at 950 °C (1740 °F). The fracture occurred by cleavage.

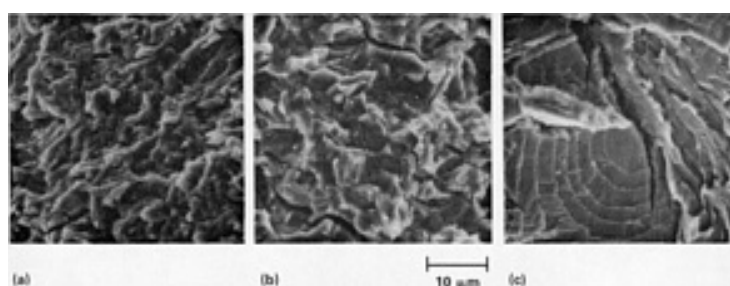
Fig. 47 Influence of heat treatment and resulting microstructure on the fracture appearance of a hydrogen-embrittled Ti-6Al-4V alloy. Specimens tested in gaseous hydrogen at a pressure of 1 atm. (a) Transgranular fracture in a specimen heat treated at 705 °C (1300 °F) for 2 h, then air cooled. (b) Intergranular decohesion along α - β boundaries in a specimen heat treated at 955 °C (1750 °F) for 40 min, then stabilized. (c) Coarse acicular structure resulting from heating specimen at 1040 °C (1900 °F) for 40 min, followed by stabilizing. The relatively flat areas of the terraced structure are the prior- β grain boundaries. See text for a discussion of the microstructures of these specimens. Source: Ref 142.

Cleavage was also the mode of fracture for a Ti-6Al-4V alloy having a microstructure consisting of a continuous, equiaxed α phase with a fine, dispersed β phase at the α grain boundaries embrittled by exposure to hydrogen gas at a pressure of 1 atm (Fig. 47a). However, when the same Ti-6Al-4V alloy having a microstructure consisting of a medium, equiaxed α phase with a continuous β network was embrittled by 1-atm hydrogen gas, the fracture occurred by intergranular decohesion along the α - β boundaries (Fig. 47b and c).

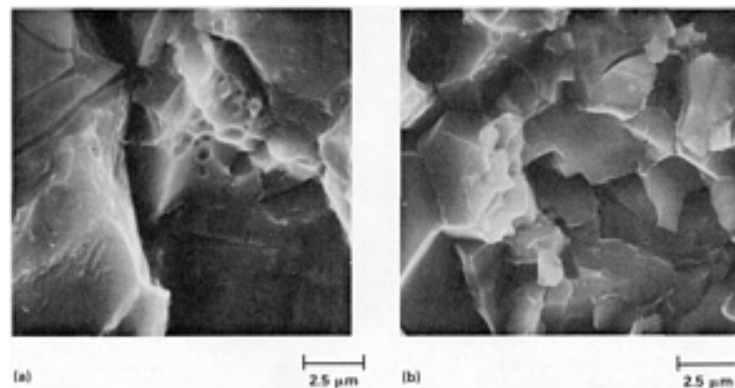
Fig. 53 Stress-corrosion fractures from two different areas in a 7075-T6 aluminum alloy specimen exposed to water at ambient temperature. The fracture exhibits intergranular decohesion, although some dimple rupture is present near center of fracture in (a).

SCC Aluminum. Aluminum alloys, especially the 2000 and 7000 series, that have been aged to the high-strength T6 temper or are in an underaged condition are susceptible to SCC in such environments as moist air, water, and solutions containing chlorides. The sensitivity to SCC depends strongly on the grain orientation with respect to the principal stress, the short-transverse direction being the most susceptible to cracking. Figure 53 shows examples of stress-corrosion fractures in a 7075-T6 (maximum tensile strength: 586, MPa, or 85 ksi) aluminum alloy that was tested in water. The fracture occurred primarily by intergranular decohesion.

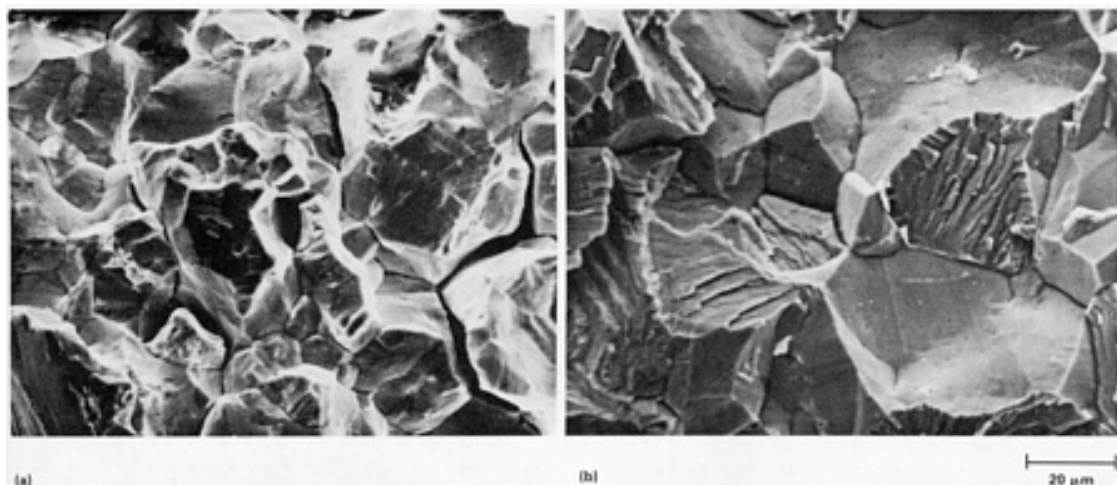
Fig. 54 Stress-corrosion fractures in a Cu-30Zn brass tested in distilled water at a potential of $E = 0 V_{SCE}$ (SCE,

saturated calomel electrode). Brass containing 0.002% As fails by predominantly intergranular decohesion (a), and one with 0.032% As fails by a combination of cleavage and intergranular decohesion (b). Source: Ref 176

SCC of brass in the presence of ammonia and moist has long been recognized. The term season cracking was used to describe the SCC of brass that appeared to coincide with the moist weather in the spring and fall. Environments containing nitrates, sulfates, chlorides, ammonia gas and solutions, and alkaline solutions are known to stress corrode brass. Even distilled water and water containing as little as $5 \times 10^{-3}\%$ sulfur dioxide have been shown to attack brass (Ref 176, 178). Depending on the arsenic content of the Cu-30Zn brass, SCC in distilled water occurs either by intergranular decohesion by a combination of cleavage and intergranular decohesion (Fig. 54). When brass containing 0.032% As in stress corrode in water containing minute amounts of sulfur dioxide, it exhibits a unique transgranular fracture containing relatively uniformly spaced; parallel markings (Fig. 55). These distinct periodic marks apparently represent the stepwise propagation of the stress-corrosion fracture.

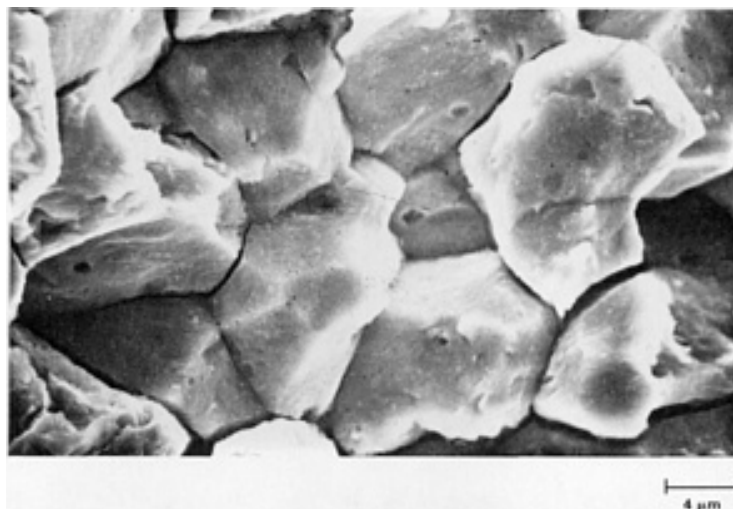
Fig. 61 Intergranular fracture surface of an AISI 4140 low-alloy steel nut that failed because of embrittlement by liquid cadmium

Examples of low-melting metal embrittlement fractures are shown in Fig. 32, 59, 60, and 61. Figure 59 shows fractures in AISI 4140 steel resulting from testing in argon and in liquid lead. Figure 60 shows the embrittlement of a 7075-T6 aluminum alloy by mercury and Fig. 61 shows the embrittlement of AISI 4140 steel by liquid cadmium. The articles "Liquid-Metal Embrittlement" and "Embrittlement by Solid-Metal Environments" in Volume 11 of *ASM Handbook*, formerly 9th edition of *Metals Handbook* provide additional information on the effect of exposure to low melting point metals.

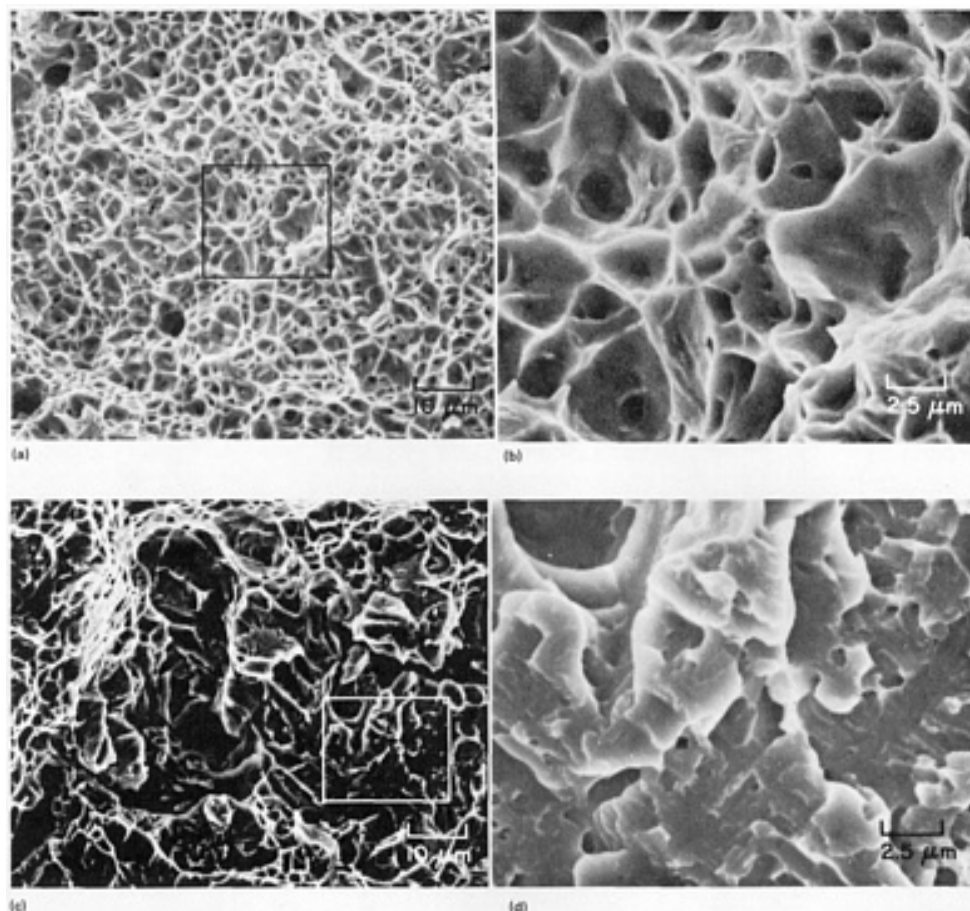
Fig. 63 Effect of a triaxial state of stress on the fracture mode in 13-8 pH stainless steel heat treated to an ultimate tensile strength of 1634 MPa (237 ksi). (a) and (b) Equiaxed dimples on the fracture surface of an unnotched specimen. (c) and (d) The quasi-cleavage fracture appearance if a notched specimen

Figure 62 shows the effect of a biaxial state of stress on dimples in a basal-textured Ti-6Al-4V alloy. Under a biaxial state of stress, the size and the depth of the dimples decreased. For a pearlitic AISI 4130 steel (Ref 198) and a PH 13-8 precipitation-hardenable stainless steel, a triaxial state of stress resulting from the presence of a notch with a stress concentration factor of at least $K_t = 2.5$ can change the fracture mode from dimple rupture to quasi-cleavage (Fig. 63). When a high-strength AISI 4340 steel is subjected to a triaxial stress, the mode of fracture can change from dimple rupture to intergranular decohesion.

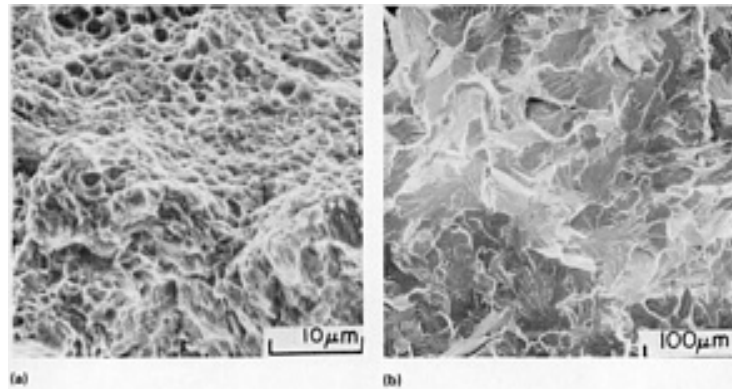
Fig. 69 Effect of test temperature on a fully pearlitic AISI 1080 carbon steel. Smooth cylindrical specimens tensile tested at a strain rate of $3.3 \times 10^{-4} \text{ s}^{-1}$. Specimens tested at 125 °C (225 °F) show fractures consisting entirely of dimple rupture (a), while at -125 °C (-195 °F), the fractures exhibit 99% cleavage (b). The size of the cleavage approximates the prior-austenite grain size. Source: Ref 210

Effect of Low Temperature. Similar to the effect of the state of stress, low temperatures affect the bcc metals far more than the fcc or hcp metal systems (see the section "Effect of the State of Stress" in this article). Although lower temperatures can result in a decrease in the size and depth of dimples in fcc and hcp metals, bcc metals often exhibit a change in the fracture mode, which generally occurs as a change from dimple rupture or intergranular fracture to cleavage. For example, a fully pearlitic AISI 1080 carbon steel tested at 125 °C (255 °F) showed a fracture that consisted entirely of dimple rupture; at room temperature, only 30% of the fracture was dimple rupture, with 70% exhibiting cleavage. At -125 °C (-195 °F), the amount of cleavage fracture increased to 99% (Ref 210). This transition in fracture mode is illustrated in Fig. 69.

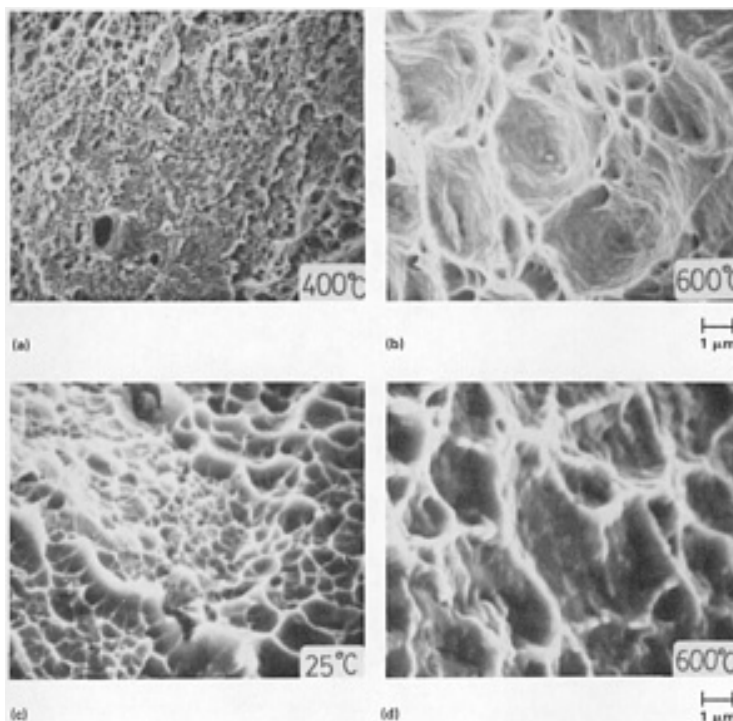
Fig. 72 Effect of temperature on dimple size in a 0.3C-1Cr-1.25Mo-0.25V-0.7Mn-0.04P steel that was heat treated to an ultimate strength level of 880 MPa (128 ksi). (a) and (b) Dimples on transgranular facets. (c) and (d) Dimples on intergranular facets. Note that dimple size increased with temperature. Source: Ref 213

The effects of high temperature on fracture are more complex because solid-state reactions, such as phase changes and precipitation, are more likely to occur, and these changes affect bcc as well as fcc and hcp alloys. As shown in Fig. 72, the size of the dimples generally increases with temperature (Ref 209, 212, 213). The dimples on transgranular fractures and those on intergranular facets in a 0.3C-1Cr-1.25Mo-0.25V-0.7Mn-0.04P steel that was heat treated to an ultimate strength of 880 MPa (128 ksi) show an increase in size when tested at temperatures ranging from room temperature to 600 °C (1110 °F) (Ref 213).

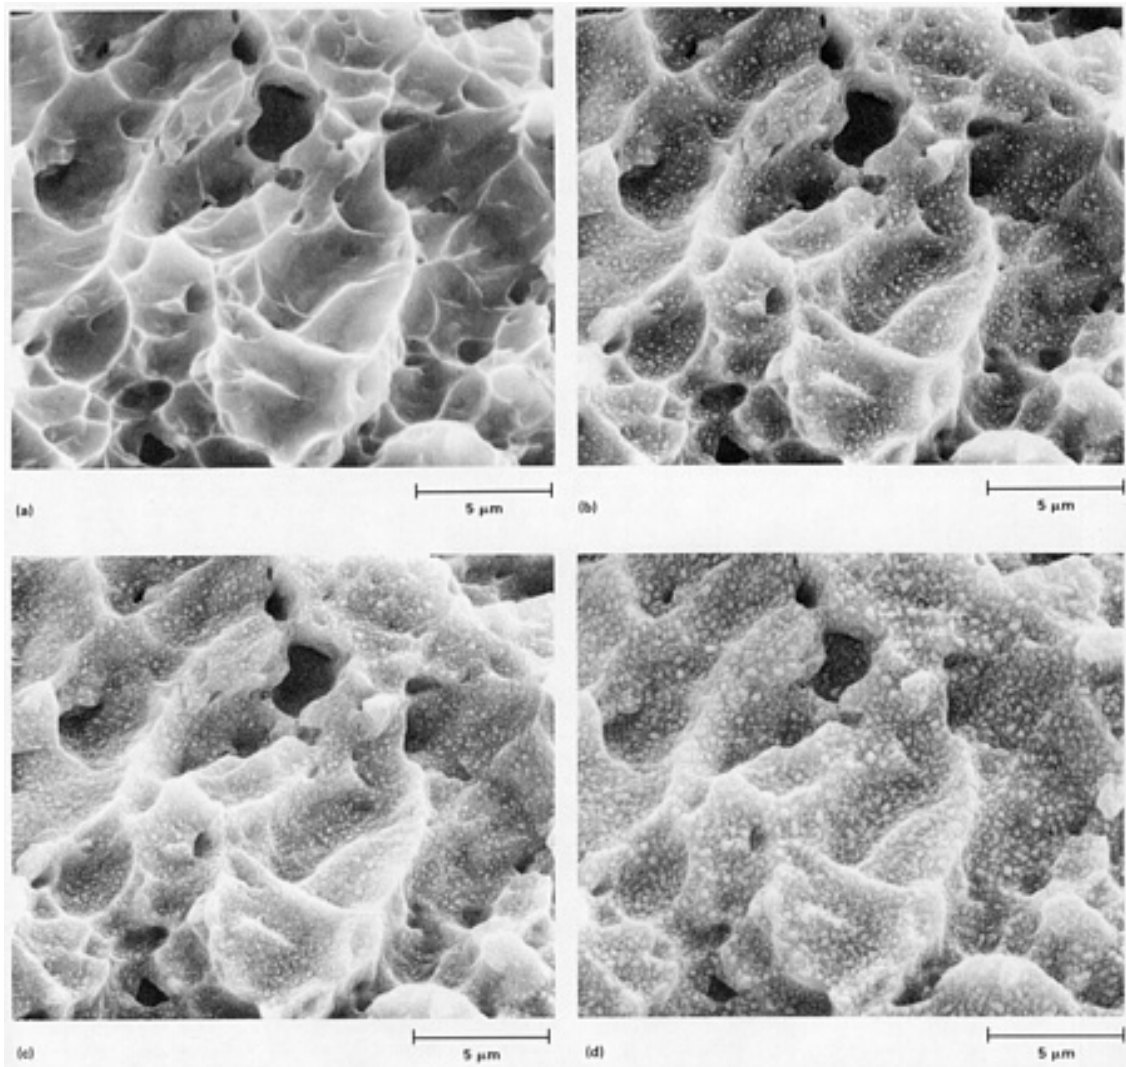
Fig. 77 Effect of a 700- °C (1290- °F) air exposure on an annealed Ti-6Al-2Sn-4Zr-6Mo alloy dimple rupture overload fracture. (a) As fractured. (b) The identical area as in (a) except exposed for 3 min (c) 10 min. (d) 30 min. As time at temperature increases, the fracture surface becomes progressively more obscured by the oxide. (V. Kerlins, McDonnell Douglas Astronautics Company)

Figures 77, 78, and 79 show the effects of high-temperature air exposure on the overload fracture surfaces of two titanium alloys and a steel. The progressive deterioration of the fracture surface of an annealed Ti-6Al-2Sn-4Zr-6Mo alloy exposed for various times at 700 °C (1290 °F) in air is illustrated in Fig. 77. As seen in Fig. 77(b), the oxide formed after only a 3-min exposure already obscured the fine ridges of the smaller dimples. An example of an extremely severe oxidation attack is shown in Fig. 78. The oxide cover is so complete that it is not possible to identify the fracture mode. A similar result was observed for a 300M high-strength steel fracture exposed for only 5 min at 700 °C (1290 °F) (Fig. 79). The relatively short exposure formed an oxide film that completely covered the fracture surface and rendered even the most prominent features unrecognizable.
