ASM HANDBOOK®

VOLUME
12

Fractography

Fractography, was published in 1987 as Volume 12 of the *ASM Handbook*. The Volume was prepared under the direction of the ASM Handbook Committee.

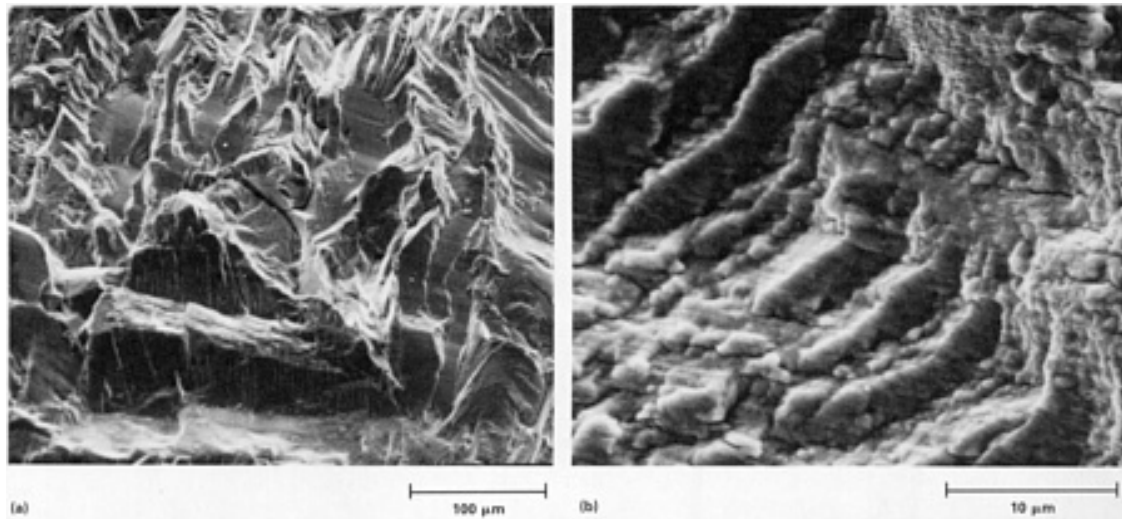
Fig. 90 Fatigue fractures in Inconel X-750 tested at a stress intensity of $\Delta K = 20 \text{ MPa}\sqrt{m}$ ($18 \text{ ksi}\sqrt{in}$) in air and vacuum at 650°C (1200°F). The crack propagation direction is from bottom to top. The fracture in air (a) exhibited a faceted, crystallographic appearance; the vacuum fracture (b) was less faceted and contained distinct, periodic crack front markings. Source: Ref 245

The largest decrease in the fatigue crack growth rate in vacuum at 650 °C (1200 °F) occurred at the lower ΔK testing levels. Figure 90 shows the air and vacuum fatigue fractures produced at a stress intensity range of $\Delta K = 20 \text{ MPa}\sqrt{m}$ ($18 \text{ ksi}\sqrt{in}$). The fractures in both environments were predominantly transgranular. The air fatigue fractures exhibited a more crystallographic, faceted appearance than those in vacuum. The vacuum fractures contained periodic marking that were believed to be due to slip offsets resulting from stress gradients produced by crack front jumps (Ref 245, 246). The large decrease in the fatigue crack growth rate in vacuum at 650 °C (1200 °F) was attributed to the absence of oxygen, which can diffuse along slip bands to embrittle the material ahead of the crack tip and increase the rate at which a fatigue crack propagates. No reason was given for the identical fatigue propagation rates in air and vacuum at 25 °C (75 °F), although the high oxidation and corrosion resistance of this alloy at ambient temperatures rendered it immune to any adverse effects of air.

Fig. 92 Fatigue fracture appearance of Inconel X-750 tested in air at 650 °C (1200 °F) at $\Delta K = 35 \text{ MPa}\sqrt{m}$ (32 ksi \sqrt{in}). The fracture path is transgranular with ductile fatigue striations. The crack propagation direction is indicated by arrow. Compare with the fracture appearance of the same alloy shown in Fig. 90(a), which was tested at $\Delta K = 20 \text{ MPa}\sqrt{m}$ (18 ksi \sqrt{in}). Source: Ref 245

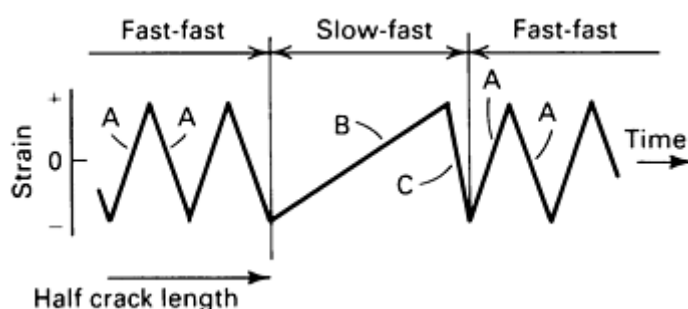
Fig. 96 Fatigue test strain wave form. A, strain, rate = $50 \times 10^{-5} \text{ s}^{-1}$ (fast-fast cycles); B, strain rate = $1.4 \times 10^{-5} \text{ s}^{-1}$ (the slow-rising strain cycle ramp of the slow-fast cycle); C, strain rate = $28 \times 10^{-5} \text{ s}^{-1}$ (the fast-declining strain ramp of the slow-fast cycle). Source: Ref 255

Example 26. An annealed SUS 304 stainless steel (SUS 304 is the Japanese equivalent of AISI type 304 stainless steel) with ultimate tensile strengths of 648 MPa (94 ksi) and 356 MPa (52 ksi) at room temperature and 600 °C (1110 °F), respectively, was tested to determine the effect of the type of cyclic load on the fatigue crack growth rate (Ref 255). Through-thickness cracks in thin-wall cylindrical test specimens were grown to half crack lengths ranging from 0.55 to 1.23 mm (0.02 to 0.048 in.) using fast-fast strain cycling. At the predetermined half length, one slow-fast cycle was introduced, and the fast-fast strain cycling was resumed. The fatigue test wave form is illustrated in Fig. 96. The wave form was triangular, fully reversed, with a total strain range of 0.8 to 1.5%. The fast-fast cycles were applied at a strain rate of $\pm 50 \times 10^{-5} \text{ s}^{-1}$, and the slow-fast cycle consisted of a $1.4 \times 10^{-5} \text{ s}^{-1}$ rising strain ramp and $28 \times 10^{-1} \text{ s}^{-1}$ declining strain ramp. All test were conducted in air at a temperature of 600 °C (1110 °F).

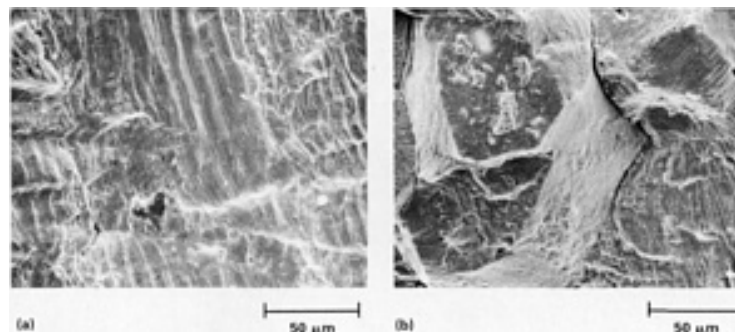
Fig. 97 Effect of one slow-fast cycle on the fracture appearance of an SUS 304 stainless steel that was fatigue tested in air at 600 °C (1110 °F). (a) Increase in fatigue striation spacing after the introduction of the slow-fast cycle at a half crack length = 0.97 mm (0.038 in.) (b) Intergranular fracture after the application of one slow-fast cycle at a half crack length of 1.0 mm (0.039 in.). Crack growth direction in both figures is right to left. Source: Ref 255

The introduction of one slow-fast cycle always increased the fatigue crack growth rate, sometimes by up to a factor of two. When the fast-fast cycling was resumed after the slow-fast cycle, the crack propagated by a fatigue striation forming mechanism, in which case there was a local increase in the striation spacing, or by intergranular fracture (Fig. 97). Where the crack propagated by a striation-forming mechanism or by intergranular fracture was determined by the ratio $\Delta J_c / \Delta J_f$, where ΔJ_c = range of the creep J -integral and ΔJ_f = range of the cycle J -integral. The values of ΔJ_c and ΔJ_f can be determined from plots of load versus crack-opening displacement at half crack length for the slow-fast cycle, ΔJ_c , and the fast-fast cycle, ΔJ_f (Ref 255). When the value of $\Delta J_c / \Delta J_f$ is less than 0.1, the crack propagates by a striation-forming mechanism; if the value exceeds 0.1, the crack propagates by intergranular fracture when fast-fast cycling is resumed. In

general, fatigue striations were formed when half crack lengths were less than about 0.85 mm (0.033 in.) and the total strain range was less than 1%. Intergranular fractures occurred at the longer half crack lengths and the higher total strain ranges.

From a material standpoint, the factors that determined whether the cracking occurred by striation fatigue or intergranular fracture were the degree of creep damage and the size of the damaged zone produced during the slow-fast cycle. If the creep-damaged zone ahead of the crack tip was smaller than the stain-deformed region resulting from the fast-fast cycling before the slow-fast cycle, the crack propagated by striation-forming fatigue. However, if the creep-damaged zone was larger than that of the fast-fast cycling and if wedge cracks were produced at the grain boundaries adjacent to the crack tip, intergranular fracture resulted. Regardless of the cracking mechanism, the fatigue crack growth rate is accelerated until the fatigue crack escapes the creep-damaged zone (Ref 255).

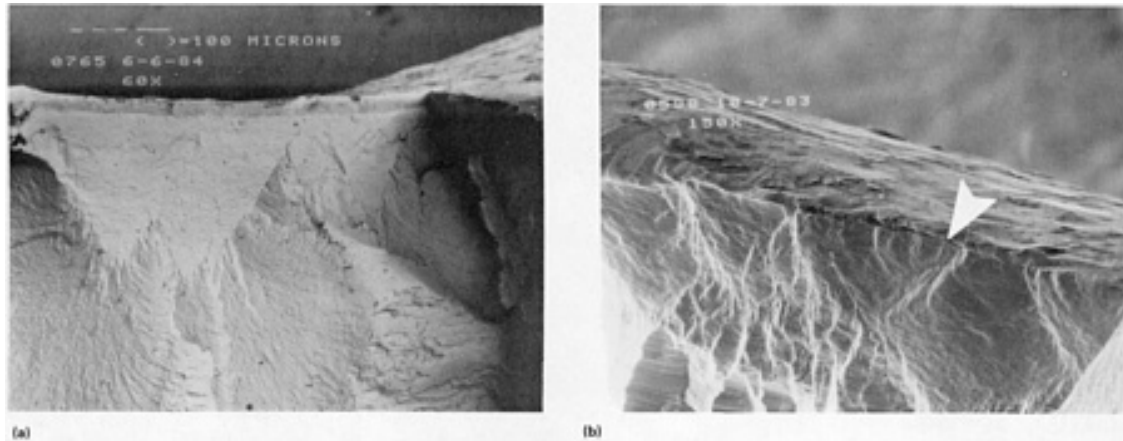
Fig. 99 Fractures in AISI 5160 wire springs that originated at seams. (a) Longitudinal fracture originating at a seam. (b) Fracture origin at a very shallow seam, the arrow indicates the base of the seam. (J.H. Maker, Associated Spring)

Failures in valve springs that originated at a seam are shown in Fig. 99. The failure shown in Fig. 99(a) began at the seam that extended more than 0.05 mm (0.002 in.) below the spring wire surface. The fatigue fracture front progressed downward from several origins. Each one of these fronts produces a crack that is triangular in outline and is without fine detail due to sliding of the opposing surfaces during the later stages of fracture. This occurs when the fracture plane changes to an angle with the wire axis in response to the torsional strain. These surfaces are visible in the lower part of Fig. 99(a).

The failure shown in Fig. 99(b) has many of the characteristics of that shown in Fig. 99(a), except that the seam is scarcely deeper than the folding of the surface that results from shot peening. Observation of it requires close examination of the central portion of the fractograph. This spring operated at a very high net stress and failed at less than 10^6 cycles.

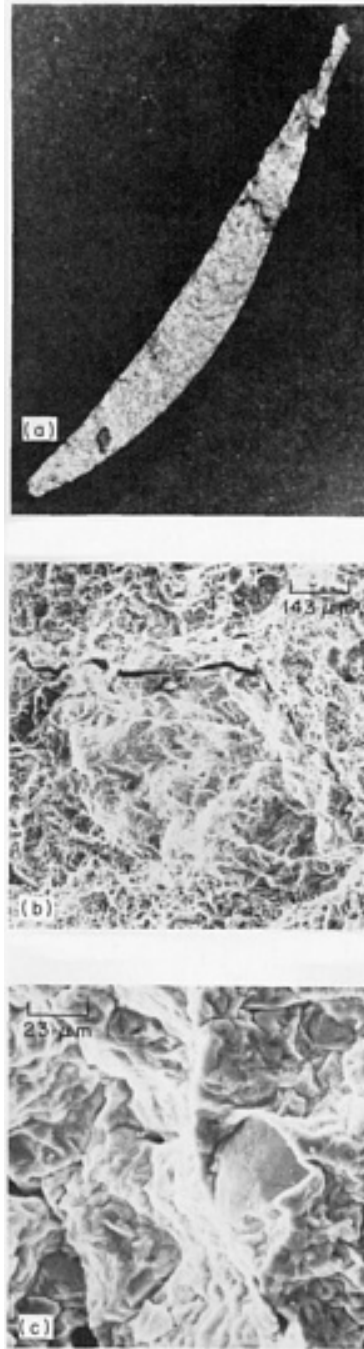
Fig. 105 Fracture surface of a cast aluminum alloy A357-T6 air-turbine blade. (a) Overall view of the fracture surface showing a large inclusion (dark) near the tip of the blade. Approximately 0.4×. (b) and (c) Decohesion at the interfaces between the inclusion and the aluminum matrix

Figure 105 shows a large inclusion in a fracture surface of a cast aluminum alloy A357-T6 blade of a small, high-speed air turbine and two views of the fracture-surface features around this inclusion.

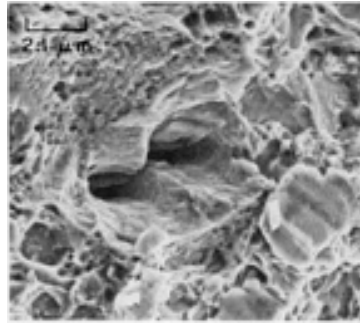
Fig. 106 Fracture surface of an AISI 4340 steel that was heat treated to a tensile strength of 1790 to 1930 MPa (260 to 280 ksi) showing deep dimples containing the inclusions that initiated them. (J. Kilpatrick, Delta Air Lines)

Figure 106 shows the fracture features associated with inclusions in AISI 4340 steel with a tensile strength of 1790 to 1930 MPa (260 to 280 ksi). Entrapped flux in a brazed joint can effectively reduce the strength of the brazement and also can create a long-term corrosion problem. A 6061 aluminum alloy attachment bracket was dip brazed to an actuator of the same alloy in a flux consisting of a mixture of sodium, potassium and lithium halides, then heat treated to the T6 temper after brazing. The flux inclusion, shown in Fig. 107, reduced the cross section of the joint, and a overload fracture occurred in the Al-12Si brazing alloy.

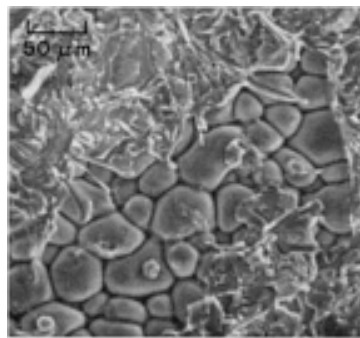
Fig. 107 Halide-flux inclusion (rounded granules) in the joint between an actuator and an attachment bracket of aluminum alloy 6061 that were joined by dip brazing using an Al-12Si brazing alloy

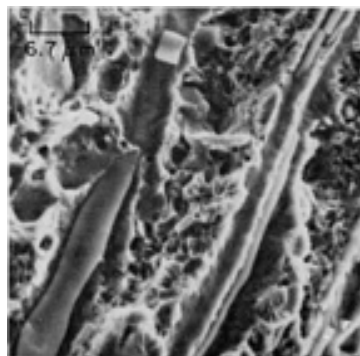
Fig. 108 Stringers on the surface of a fracture that occurred during straightening of an AISI 4340 steel forging that had been heat treated to a tensile strength of 1380 to 1520 MPa (200 to 220 ksi). Stringers are visible as parallel features inclined about 30° to right of vertical. They were not identified as to composition, but may be accidentally entrapped slag that was elongated in the major direction of flow during forging.

Stringers are elongated nonmetallic inclusions, or metallic or nonmetallic constituents, oriented in the direction of working. Nonmetallic stringers usually form from deoxidation products or slag, but may also result from the intentional addition of elements such as sulfur to enhance machinability. Figure 108 shows unidentified stringers on the fracture surface of an AISI 4340 steel forging. Overload cracking occurred during straightening after the forging had been heat treated to a tensile strength of 1380 to 1520 MPa (200 to 220 ksi).

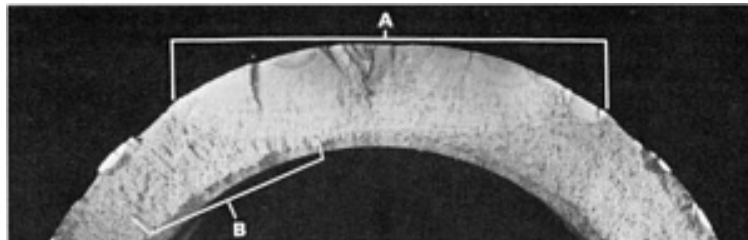
Fig. 112 Fatigue fracture through a region of unfavorable grain flow and large inclusions in an aircraft landing-gear axle forged from AISI 4340 steel. Several fatigue crack origins were found in region A. Numerous small discontinuous marks nearly perpendicular to the direction of crack propagation were determined by metallographic examination to be related to forging flow lines and large, elongated sulfide inclusions. Woody appearance outside fatigue zones, region B, also suggests unfavorable grain flow. Light fractograph. 1.8×

Unfavorable Grain Flow. Grain flow in an unfavorable direction may be indicated by a woody fracture in some materials and by a flat, delaminated appearance in others. An area of woody fracture is indicated in region B in Fig. 112, which shows a fatigue fracture in a forged AISI 4340 steel aircraft landing-gear axle. The fatigue fracture occurred in an area where the resistance of the material to fatigue cracking was low because the fluctuating loads were applied nearly perpendicular to the direction of grain flow. In high-strength aluminum alloys extrusions and hot-rolled products, tension loads are occasionally applied perpendicular to the flow direction, which may cause splitting along flow lines. This somewhat resembles the pulling apart of laminated material. Splitting may also appear as secondary cracks perpendicular to the primary fracture when these materials are broken by bending loads.

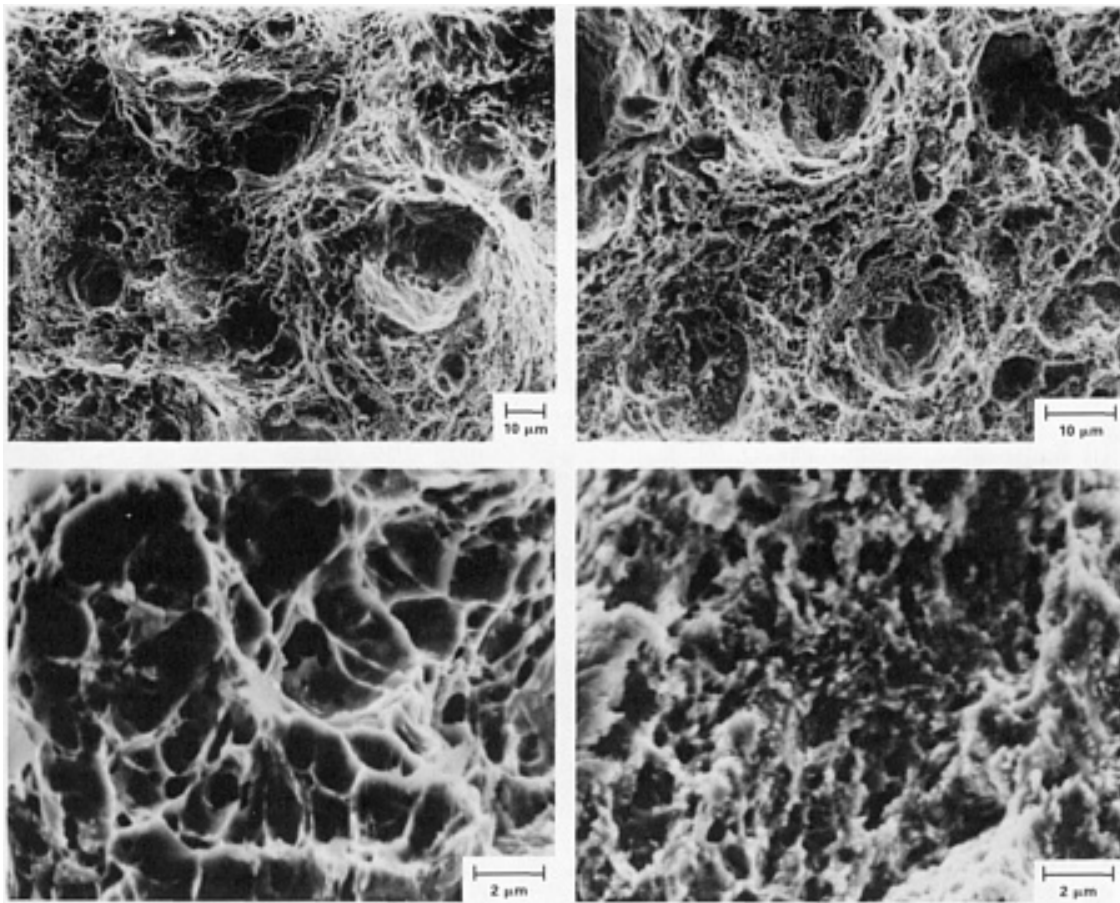
Fig. 6 Comparison of stable ductile crack growth areas from quenched-and-tempered 1085 carbon steel at increasing magnifications. The fractographs on the left show the as-fractured surface; those on the right show the fracture surface after corrosion exposure and cathodic cleaning.

Figure 6 shows a comparison of an asfractured surface with a corroded and cathodically stable ductile cracking region in a quenched-and-tempered 1085 carbon steel. The relatively low magnification (1000 ×) shows that the dimpled topography characteristic of ductile tearing was unchanged as a result of the corrosion and cathodic cleaning. High magnification (5000 ×) shows that the perimeters of the small interconnecting dimples were corroded away.

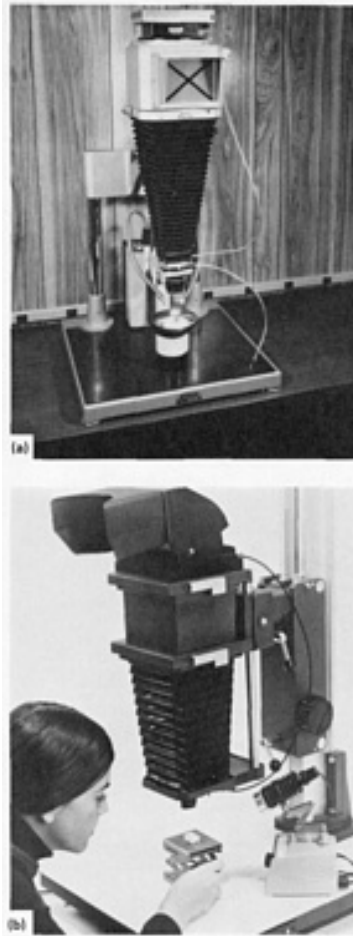
Fig. 1 Specialized view camera systems for photomacrography. (a) System with a bifurcated fiber optic source. Courtesy of Nikon, Inc. (b) View camera system. Courtesy of Polaroid Corporation

For laboratories doing frequent analyses of fractures, a camera with a 4- × 5-in. (100- × 125-mm) Polaroid back is almost a necessity, because it provides immediate availability of prints with suitable sizes for most applications. Inadequacies in illumination or exposure can be quickly detected and corrected. Specialized view camera systems for photomacrography are commonly used for fractography (Fig. 1). These cameras are mounted on very rigid stands needed for higher-magnification photomacrography. These photomacrography systems lack the tilts and swings of conventional view cameras. The tilts are generally not needed for fractography, because a viewing direction perpendicular to the fracture is normally used for fractographs. The conventional view camera can be mounted on a rigid stand for high-magnification fractography and on a tripod for oblique photography of parts. The tilts and swings can be useful in the latter application.

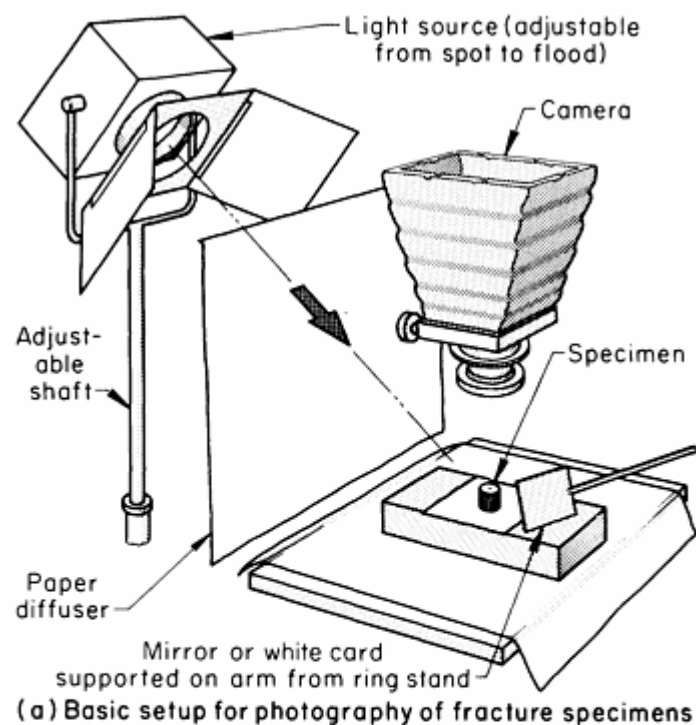
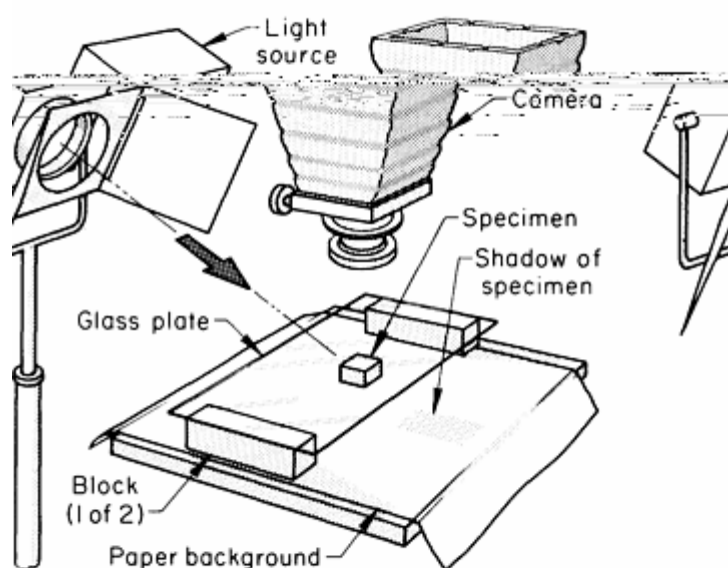
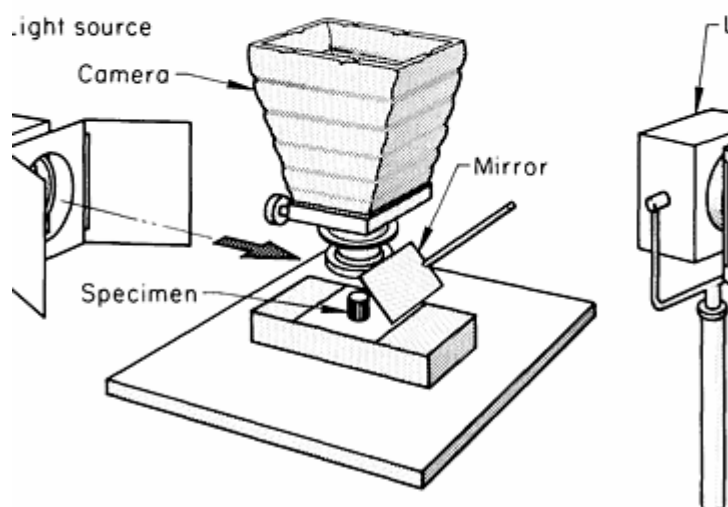
(a) Basic setup for photography of fracture specimens

Shadowless background for photography of fracture specimens

Horizontal illumination for close-up photography of fracture specimens

Fig. 6 Basic setups and lighting used to photograph fracture specimens and small parts. (a) General arrangement of camera, light source with diffuser, and specimen. Size and angle of the beam of light should be adjusted to give the best display of texture. A reflecting mirror or white card can be used to fill in shadows. (b) Placing the specimen on a raised glass plate will throw the shadow beyond the view range of the camera and provide a shadowless background. (c) If the magnification desired requires the close approach of the camera to the specimen, a horizontal light beam reflected by a small mirror positioned near the camera lens will provide the proper angle of illumination.

Basic lighting for photographing fracture surfaces and small parts is shown in Fig. 6. Three other illumination setups are shown in Fig. 7, 8, and 9. Shadowless lighting of a surface can be obtained with a white background by supporting the specimen on a piece of glass above the white background paper. For basic lighting, one spotlight is suggested. A piece of tracing paper placed between the light and the specimen will diffuse the light. The light is then raised or lowered and the beam adjusted from flood to spot to obtain the exact quality of lighting desired. Fracture texture is best illuminated when the light is placed at a relatively low angle. A spotlight beam without a diffuser or a bare bulb with a small filament will give

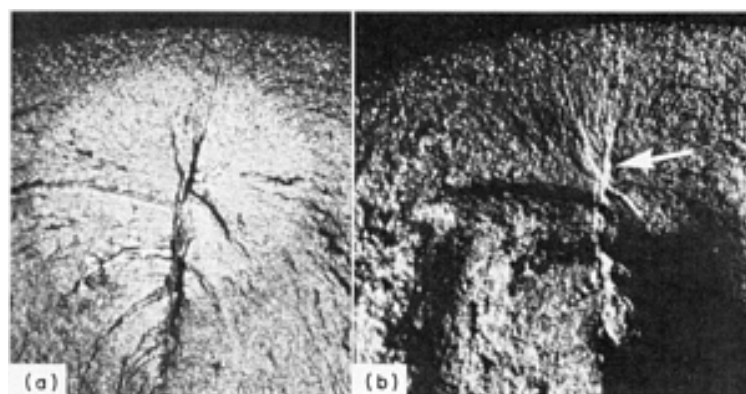
Fig. 13 Effect of illumination technique on appearance of a fracture surface of a laboratory fatigue test specimen of carburized-and-hardened 8620 steel. (a) Floodlight plus glass plate to give vertical illumination. Fatigue zone is well defined. (b) Oblique spotlight with crossed polarization. Fatigue zone is not shown, but a large silicate inclusion (arrow) is highlighted at the crack origin. Light fractographs. Both 1.5×

Figure 13 shows a further illustration of the effects of different lighting. In Fig. 13(a), for which vertical illumination was used, the fatigue zone below the carburized case is clearly shown. In Fig. 13(b), for which oblique spotlighting with crossed polarization was used, the fatigue zone is not shown at all, but a large silicate inclusion at the fatigue crack origin is highlighted.

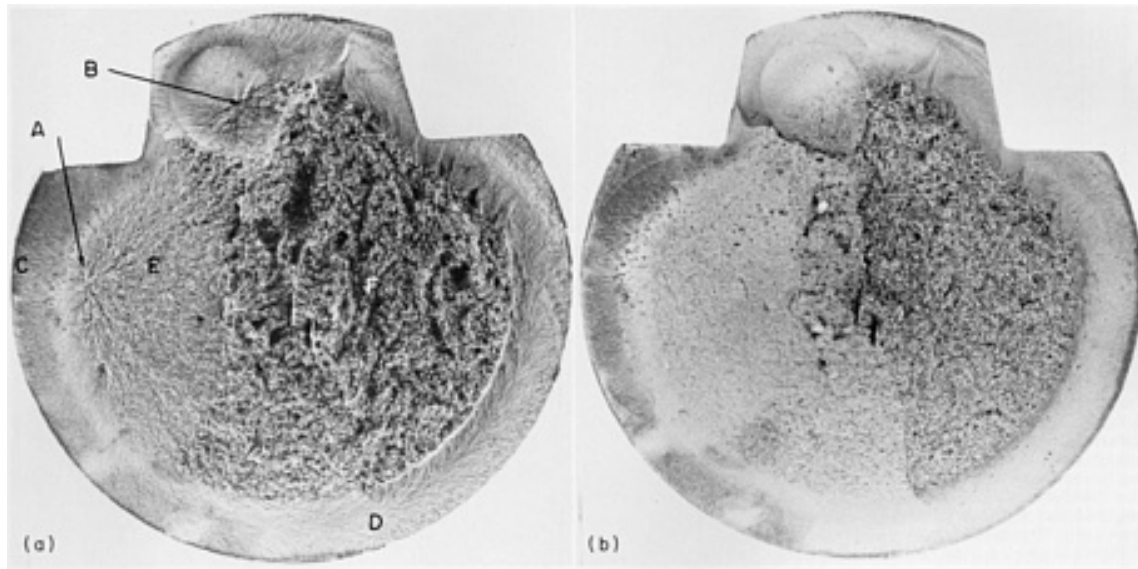
Fig. 14 Change in fracture detail that resulted from a shift in the position of the light source. Illumination was by a circular fluorescent-light tube. The details in the surface are well revealed in (a) but are missing in (b), for which the light was moved up 25 mm (1 in.). These fractographs are of the surface of a fatigue fracture in a 1541 steel axle that was induction hardened to 50 HRC and tested in rotating bending. The better-detailed fractograph at left shows that two fatigue cracks (one at A and the other at B) originated at the interface between the hardened zone and the soft core. The crack that began at A progressed around the hardened zone by fatigue in area C and by fast fracture in area D, before meeting the crack that began at B. The fatigue crack from A also penetrated the soft core, at area E. Final fast fracture occurred in the soft core, at area F. Light fractographs. Both 1.15×

Figure 14 shows the importance of the position of the light source. The fracture was illuminated by a circular fluorescent-light tube for both photographs. For Fig. 14(a), the incident light had proper obliquity to reveal all details of the

fracture surface. For Fig. 14(b), the light was moved up 25 mm (1 in.), which changed the degree of obliquity, with consequent loss of detail.

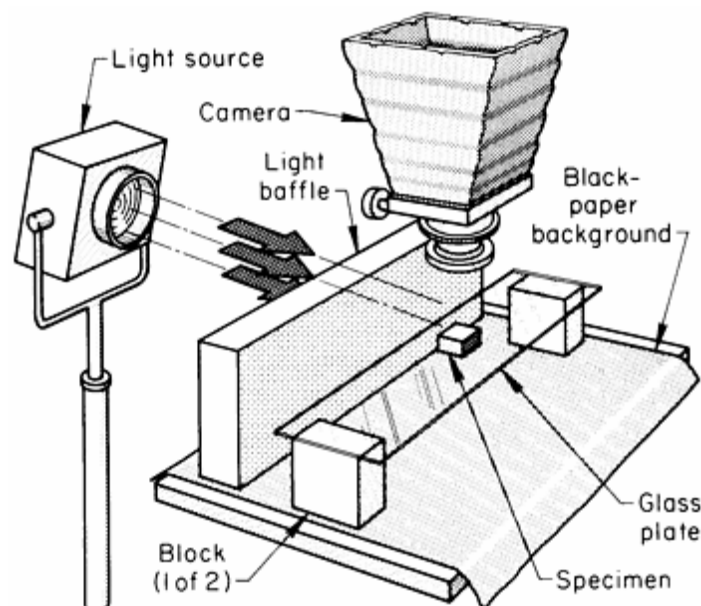
Fig. 19 Lighting for deeply etched specimens to show grain flow and inclusions

Lighting of Deeply Etched Specimens to Show Grain Flow. Deeply etched specimens are photographed with a vertical setup and a single spotlight at a low angle (Fig. 19). The specimen can be supported on a glass plate over a piece of black paper to provide a black background. The light should be shielded such that it does not illuminate the background paper. The direction of incident light must be across the grain flow to show texture properly (Fig. 20). Greater contrast is obtained if all room lights are off.

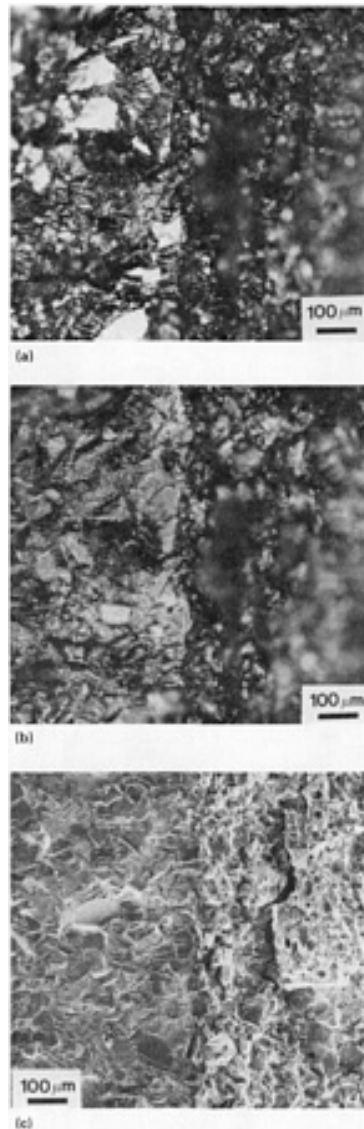
Fig. 10 Comparison of light microscope (a and b) and SEM (c) images of the interface between the fatigue-precrack area (left) and the test fracture region (right) of an alloy X-750 rising-load test specimen broken in air. The test fracture is ductile. (a) Bright-field image. (b) Dark-field image. (c) Secondary electron image. All 68×

For comparison, Fig. 10 shows a similar X-750 rising-load specimen tested in air in which the test fracture is ductile. Figure 10 shows bright-field and dark-field light fractographs of the interface between the fatigue precrack and the ductile fracture.

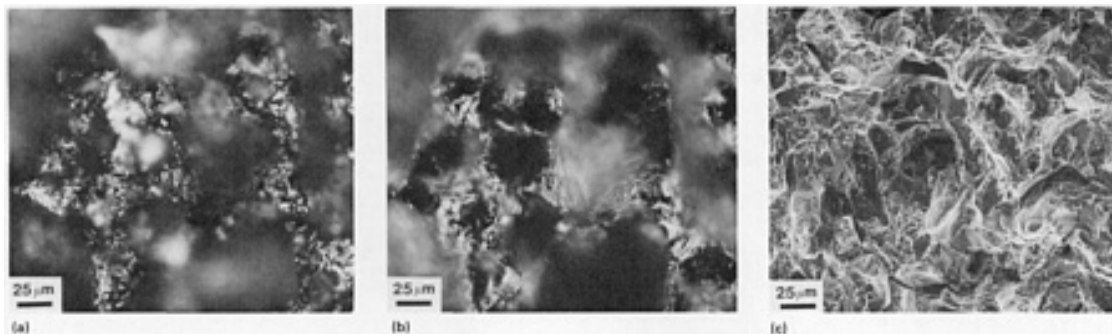
Fig. 11 Comparison of light microscope (a and b) and SEM (c) images of a ductile fracture in an alloy X-750

rising-load test specimen broken in air. (a) Bright-field image. (b) Dark-field image. (c) Secondary electron image. All 240×

A secondary electron fractograph is also included for comparison. Figure 11 shows high-magnification bright-field and dark-field light fractographs and a secondary electron fractograph of the ductile region of the test fracture at the same magnification. Microvoid coalescence (dimples) can be observed in all the fractographs, but the limited depth of field of the light fractographs is obvious.

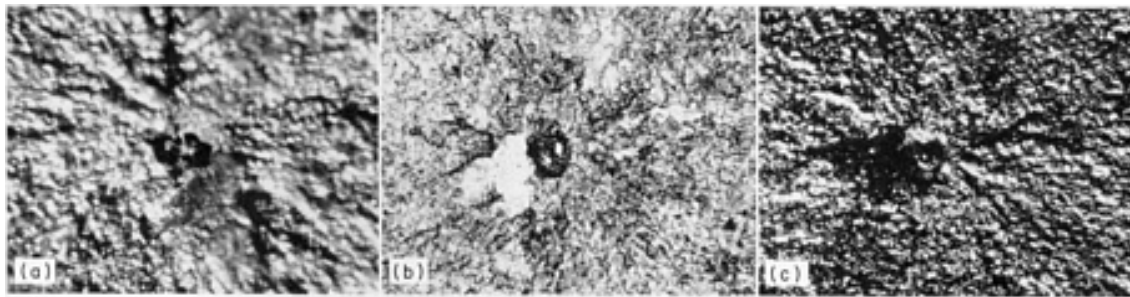
Fig. 14 Comparison of replica fractographs of a fatigue fracture in an induction-hardened 15B28 steel shaft. Fracture was initiated at the large inclusion in the center of the views during rotating bending. (a) Oblique illumination from a point source lamp. (b) Same area as (a), photographed using transmitted light. (c) Replica shadowed with a vapor-deposited coating and photographed using oblique illumination from a point source lamp. All 30×

Additional contrast can be obtained by shadowing the replica with either carbon or a heavy metal, such as chromium, molybdenum, gold, or gold-palladium, as is normally done in TEM fractography. Some fractographers also coat the back side of the replica with a reflective metal, such as aluminum, for reflected-light examination, or they tape the replica to a mirror surface. With an inverted microscope, some fractographers place the replica over the stage plate and then place a polished, unetched specimen against the tape to hold it flat and to reflect the light. Others prefer to examine the tape with transmitted light, but not all metallographers have access to a microscope with transmitted-light capability. Figure 14 illustrates low-power examination procedures for examination of replicas by light microscopy. Figure 14(a) shows the replica photographed with oblique illumination from a point source lamp, and Fig. 14(b) shows the same area using transmitted light. Carbon was then vapor deposited onto the replica, and it was photographed again using oblique light from a point source (Fig. 14c). Figure 14(c) exhibits the best overall contrast and sharpest detail. Figure 12(d) illustrates examination of a fracture replica by light microscopy using high magnification. This replica was shadowed with gold-palladium.

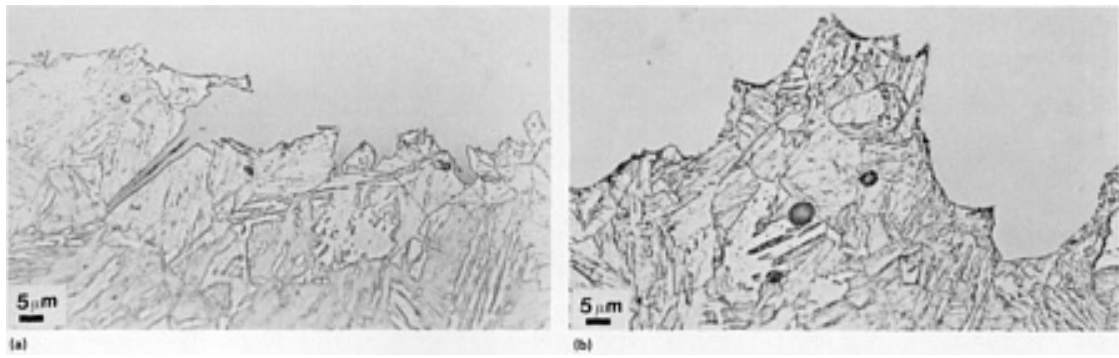
Fig. 21 Brittle (a) and ductile (b) crack paths in a fractured quenched-and-tempered low-alloy steel. Both etched with 2% nital. 800×

Although light microscopy has rather limited value for the examination of ductile dimples (as shown in Fig. 10 and 11), dimples can be easily observed by using metallographic cross sections. Figure 21 compares the appearance of ductile and brittle fractures of a quenched-and-tempered low-alloy steel using nickel-plated cross sections. The ductile fracture consists of a series of connected curved surfaces, and it is easy to envision how this surface would appear if viewed directly. Also, near the fracture surface, small spherical voids, particularly at inclusions, are often seen that have opened during the fracture process. These should not be interpreted as pre-existing voids. The brittle fracture, by comparison, is much more angular, and crack intrusions into the matrix on cleavage planes can be observed (Fig. 21). The problems associated with the measurement of dimples are discussed in the article "Quantitative Fractography" in this Volume.

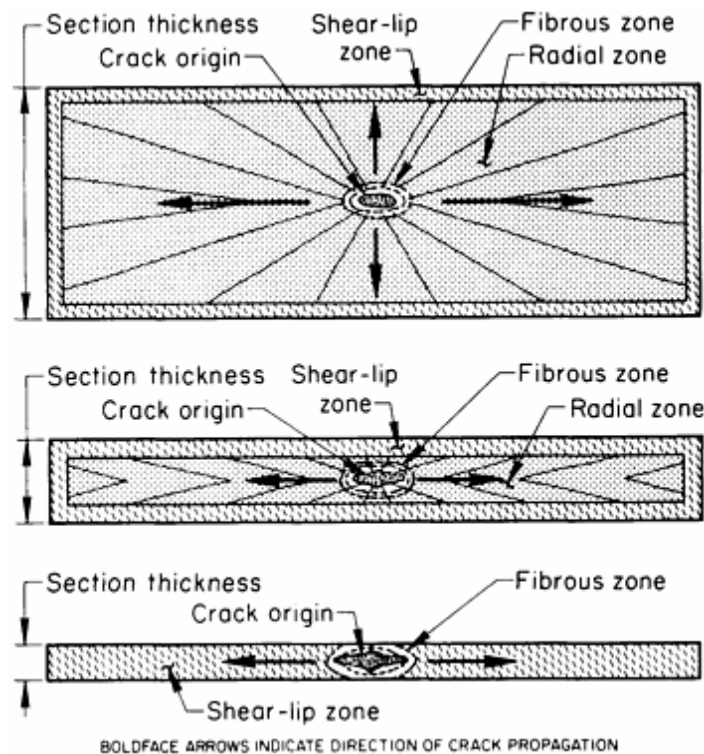
Fig. 30 Effect of section thickness on the fracture surface markings of rectangular tensile specimens. Schematics show the change in size of the radial zone of specimens of progressively decreasing section thickness. The thinnest of the three examples has a small fibrous zone surrounding the origin and a shear-lip zone, but no radial zone. Source: Ref 63

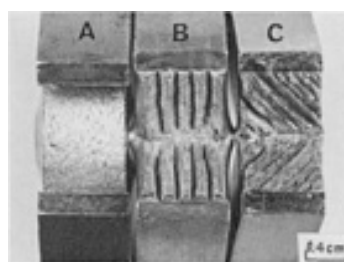
Fig. 35 Macrograph illustrating the influence of specimen orientation (with respect to the hot-working direction) on splitting observed in Charpy V-notch impact specimens. A, notch parallel to the plate surface; B, notch perpendicular to the plate surface; C, notch 45° to the plate surface. Source: Ref 83

Splitting has been observed in Charpy V-notch specimens, as well as on tensile specimens, as discussed previously. One investigation (Ref 83) has shown that the orientation of the splits is always parallel to the rolling plane of plate in the longitudinal direction (Fig. 35). Therefore, splitting is always associated with planes of weakness in the rolling direction.

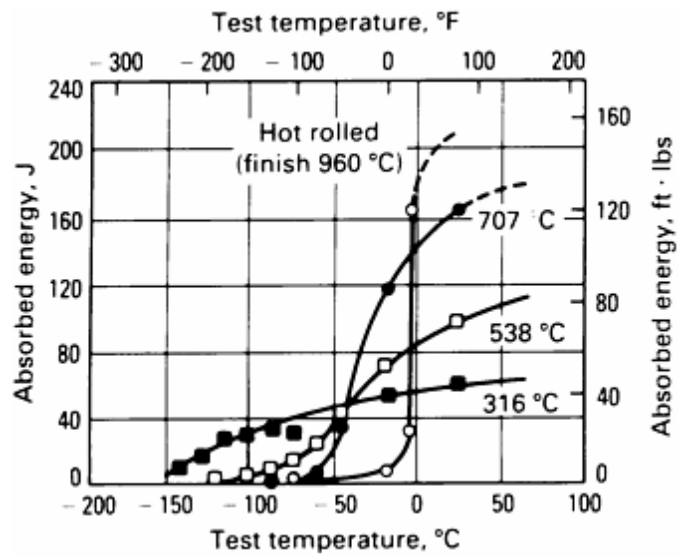
Fig. 36 Plot of absorbed-energy Charpy V-notch test data for Fe-1Mn steels finished at different temperatures (indicated on graph). Source: Ref 83

Figure 36 shows Charpy V-notch absorbed-energy curves for Fe-1Mn steel that was finish rolled at temperatures for 960 to 316 °C (1760 to 600 °F) from the study discussed in Ref 83. As the finishing temperature decreased, the absorbed-energy transition temperature (temperature for a certain level of absorbed energy, for example, 20 or 34 J, or 15 or 25 ft · lb) decreased, but the upper shelf energy also decreased. Figure 37 shows the fracture appearance of Charpy V-notch specimens used to produce the curves in Fig. 36. This demonstrates that the occurrence of splitting increased as the finishing temperature decreased. In general, lowering the test temperature for a given finishing temperature increased the number of splits unless the test temperature was low enough to produce a completely brittle cleavage fracture, for example, the -73- °C (-100- °F) samples of the plates finish rolled at 707 and 538 °C (1305 and 1000 °F).

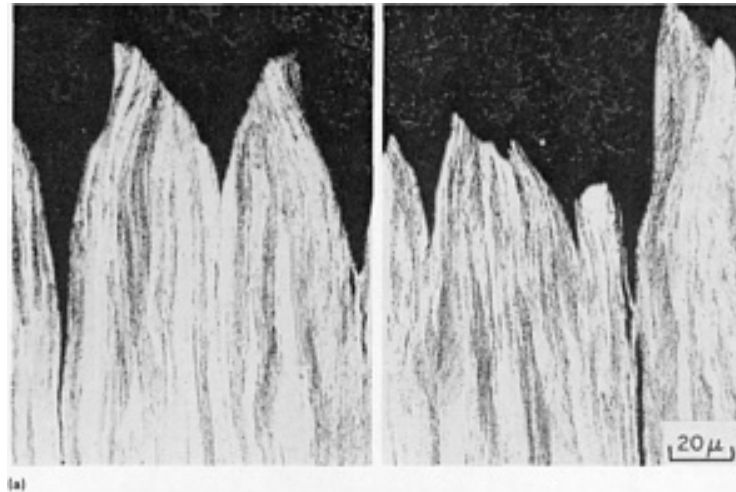
Fig. 38 The microstructure of Fe-1Mn steel finish rolled at 315 °C (600 °F) and impact tested at two temperatures. A, tested at -18 °C (0 °F); B, tested at -135 °C (-210 °F). Source: Ref 83

Figure 38 shows the microstructural appearances of the splitting in two Charpy V-notch specimens in plate that was finish rolled at 315 °C (600 °F). The regions between the splits resemble a cup-and-cone tensile fracture.

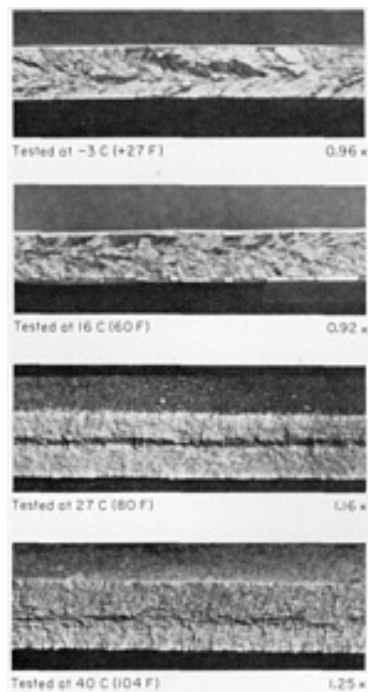
Fig. 42 Transition of fracture appearance with change in test temperature. Light fractographs show four specimens cut from a single length of low-carbon steel pipe that were burst by hydraulic pressure at the temperatures indicated. Note the increasing size of the shear-lip zone as test temperature increases.

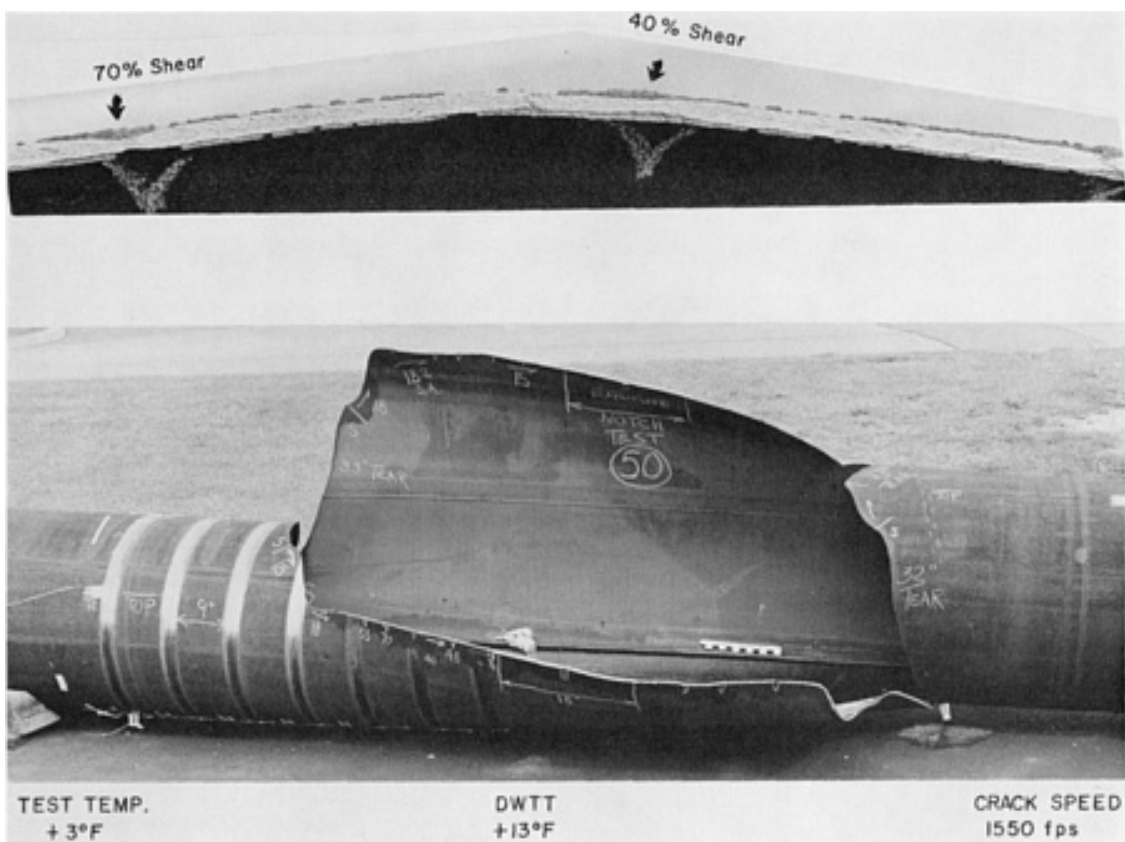
Fig. 45 Fracture of API grade X-60 line pipe tested 6 °C (10 °F) below the 50% shear area drop-weight tear test transition temperature. See also Fig. 43, 44, and 46.

Figure 45 shows the result of testing a line pipe at 6 °C (10 °F) below the 50% shear area DWTT transition temperature; the resultant crack speed was 470 m/s (1550 ft/s). From the notch, the fracture propagated by cleavage with a 15 to 18% shear area, with some small patches having shear areas as high as 70% (see macrograph of fracture. Fig. 45). The crack propagated straight along the top of the pipe for 685 mm (27 in.) and then developed a wave pattern. Only a half wave was completed before the crack changed to 100% shear and then tore circumferentially for 840 mm (33 in.) before stopping. Although the actual crack speed was 470 m/s (1550 ft/s), the straight line crack speed was 380 m/s (1250 ft/s).

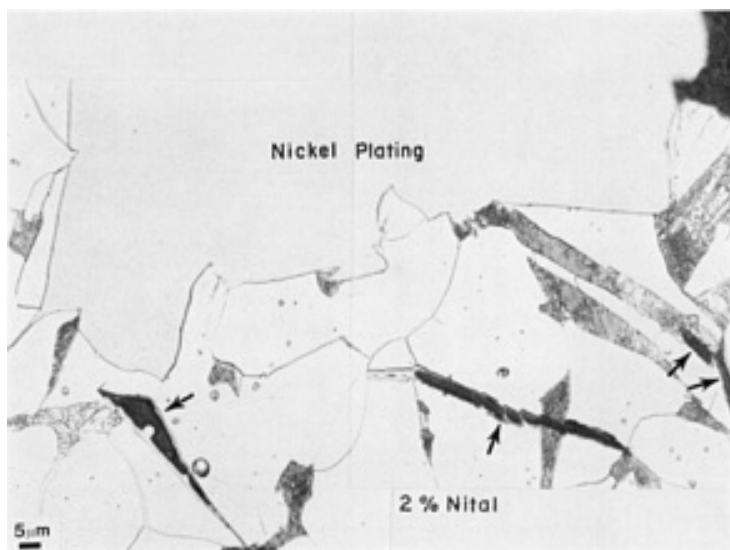
Fig. 47 Cleavage crack path in a ferritic-pearlitic low-carbon steel. Note the subsurface cracks (arrows). One crack has been partially filled by nickel plating. Etched with 2% nital. 1000×

Engineering alloys are polycrystalline with randomly oriented grains (or some form of preferred texture). Because cleavage occurs along well-defined crystallographic planes within each grain, a cleavage fracture will change directions when it crosses grain or subgrain boundaries. Engineering materials contain second-phase constituents; therefore, true featureless cleavage is difficult to obtain, even within a single grain. Examples of cleavage fractures, as examined with the light microscope and SEM, are shown in Fig. 1, 2, 3, 4, 5, 12, and 18, while light microscope views on cross section are shown in Fig. 12 and 21(a). Figure 47 shows an additional example of a cleavage fracture in a low-carbon steel with a ferrite-pearlite microstructure using a light microscope cross section. The orientation of the cleavage planes can be seen to vary in the different ferrite grains.

Figure 71(a) shows the same fatigue crack in an aluminum alloy as shown in Fig. 16, but after etching. The roughness of the crack pattern and the interaction with the intermetallic particles are evident. Figure 71(b) shows a similar fatigue crack in the same aluminum alloy after etching; but in this case, the specimen was completely broken, and only one side of the fracture can be observed. Comparison of Fig. 71(a) and 71(b) clearly shows that the nature of the crack pattern is much easier to observe in a partially broken specimen where both sides of the fracture can be observed. Figure 72 shows a fatigue crack in a ferrite-pearlite carbon steel after etching in which both sides of the crack can be observed. The irregular path of the crack through the ferrite phase is evident in Fig. 72 as compared to the nature of cleavage cracks in ferrite shown in Fig. 47.

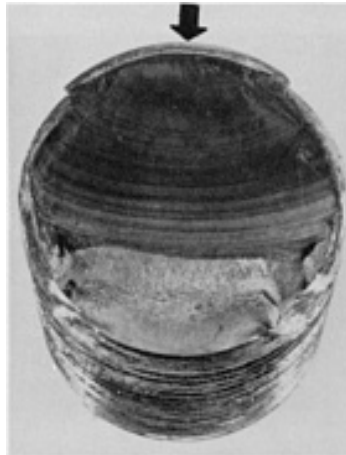
Fig. 50 Fatigue failure of a bolt due to unidirectional cycling bending loads. The failure started at the thread root (arrow) and progressed across most of the cross section before final fast fracture. Actual size.

Figure 50 shows a bolt that failed by fatigue. The arrow indicates the origin, which was the root of the first thread, the location of greatest stress concentration. The overload portion of the fracture (side opposite the arrow) is rather small compared to the overall cross section; this indicates that the loads were rather low. Comparison of Fig. 50 to the schematics in Fig. 48 suggests that loading was tension-tension or tension-compression with a mild stress concentration at low nominal

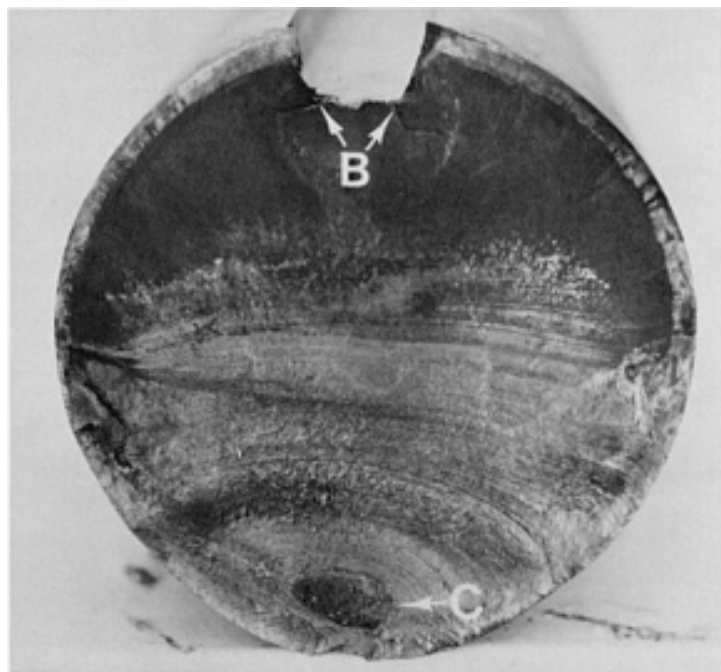
Fig. 51 Macrograph of the fracture face of an AISI 4320 drive shaft that failed by fatigue. The failure began at the end of a keyway that was machined without fillets (B) and progressed to final rupture at (C). The final rupture zone is small, indicating that loads were low.

Figure 51 shows the fracture of a drive shaft that failed by fatigue. The fracture started at the end of the keyway (B), which was not filletted; that is, the corners were sharp. Final rupture occurred at C, a very small zone. The slight curvature of the beach marks becomes substantial near the final rupture zone. Comparison of Fig. 51 to the schematics shown in Fig. 48 indicates that the failure occurred by rotating-bending stresses, which would be expected in a drive shaft, with the direction of rotation clock-wise looking at the fracture and with a mild stress concentration and low nominal stresses.

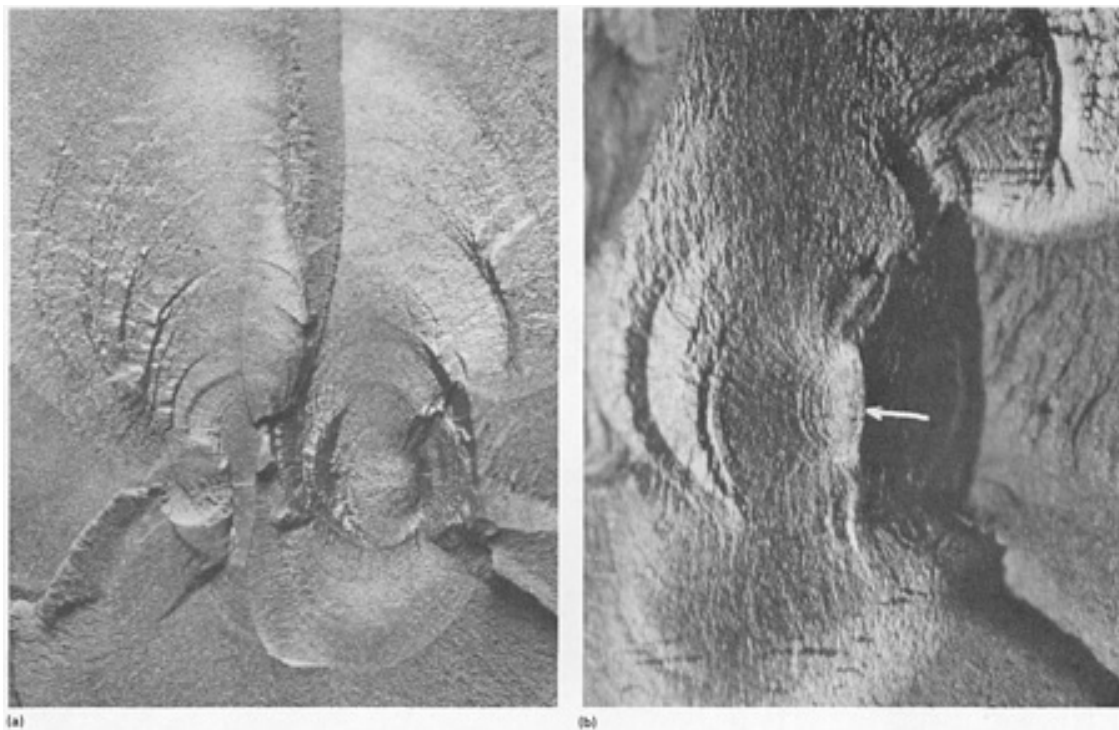
Fig. 59 Close-ups of the primary initiation site of the spall shown in Fig. 58. (a) Area A. 4x. (b) Area B. 8x. See also Fig. 60.

Figure 58 shows a circular spall from a forged hardened steel roll with well-defined fatigue origins (areas A and B) and other regions, such as areas C and D, away from the origin that exhibit beach marks. Enlargements of areas A to D are shown in Fig. 59 and 60. It is clear that the spall originated from the multiple fatigue origins in the light-colored area (A and B) near the center. However, it appears that other fatigue origins, such as at areas C and D, were also growing when the overload fracture occurred.

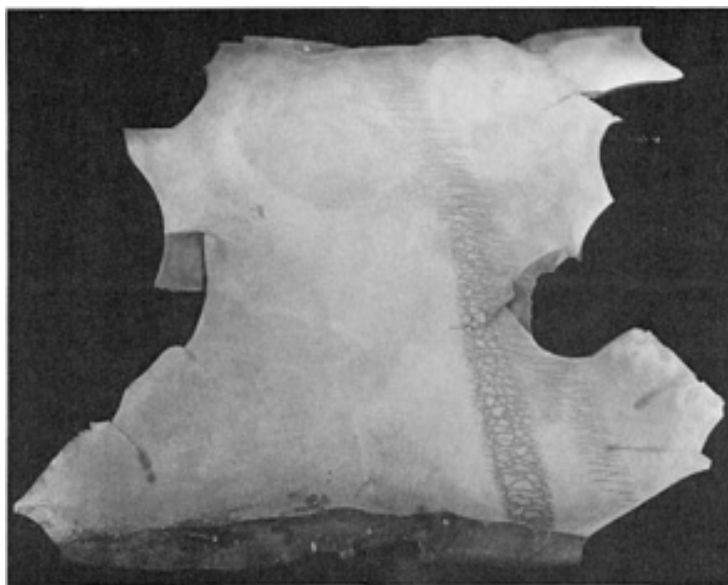
Fig. 66 The roll surface of the spall shown in Fig. 65 after macroetching with 10% aqueous HNO₃. Etching revealed a craze crack pattern similar to heat checks, caused by abusive service conditions. About 0.5x

Figure 65 shows another example of a line spall fracture from a hardened steel roll. Fine fatigue marks can be seen in the finger-shaped portion of the line spall fracture at the bottom of the macrograph. The marks indicate that the crack growth direction was from the arrow at the bottom of the picture and toward the top. After the linear portion in the center of the spall formed, final rupture occurred from the linear portion outward, as indicated by the ridge marks in the overload zone and their origin at the boundary of the linear portion of the spall. Figure 66 shows the outer roll surface of the spall, that is, the reverse side shown in Fig. 65. Macroetching of the surface revealed two intersecting craze crack patterns indicative of abusive service conditions.
