ASM HANDBOOK®

VOLUME
12

Fractography

Fractography, was published in 1987 as Volume 12 of the *ASM Handbook*. The Volume was prepared under the direction of the ASM Handbook Committee.

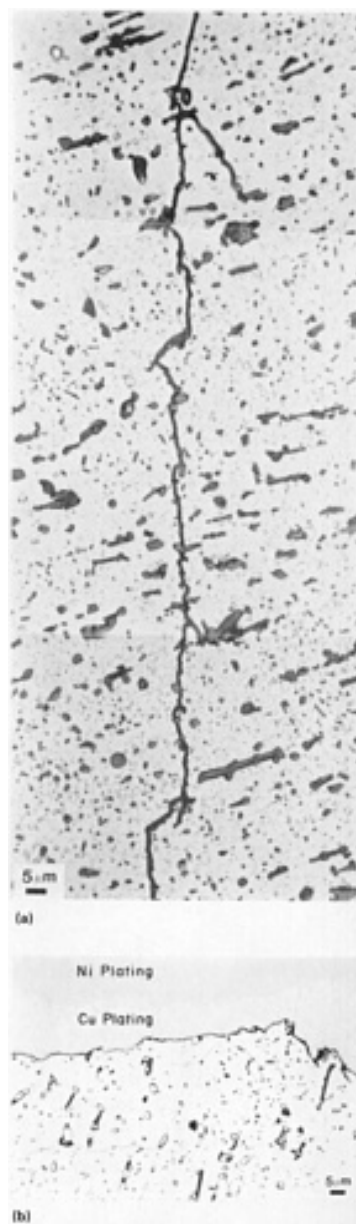
Fig. 71 Fatigue cracks in an unbroken (a) and completely broken (b) aluminum alloy. (a) Etched with Kroll's reagent. 680× (b) Etched with Keller's reagent. 510×

As-polished samples should be examined first with bright-field illumination and then with dark-filled illumination, differential interference contrast (DIC) or oblique light, and polarized light, if the specimen will respond to such illumination. Dark-field illumination is very useful and is highly suited to the examination of cracks and voids. Photography in dark field is more difficult, but not impossible if an automatic exposure device is available. Oblique light and DIC are very useful for revealing topographic (relief) effects. For example, Fig. 16 shows a fatigue crack in an aluminum alloy viewed with bright-field illumination and DIC where the specimen was not etched. Although the second-phase precipitates can be seen in both views, they are more clearly revealed with DIC (compare these views with the bright-field etched micrograph of this specimen shown in Fig. 71).

Figure 71(a) shows the same fatigue crack in an aluminum alloy as shown in Fig. 16, but after etching. The roughness of the crack pattern and the interaction with the intermetallic particles are evident. Figure 71(b) shows a similar fatigue crack in the same aluminum alloy after etching; but in this case, the specimen was completely broken, and only one side of the fracture can be observed. Comparison of Fig. 71(a) and 71(b) clearly shows that the nature of the crack pattern is much easier to observe in a partially broken specimen where both sides of the fracture can be observed. Figure 72 shows a fatigue crack in a ferrite-pearlite carbon steel after etching in which both sides of the crack can be observed. The irregular path of the crack through the ferrite phase is evident in Fig. 72 as compared to the nature of cleavage cracks in ferrite shown in Fig. 47.

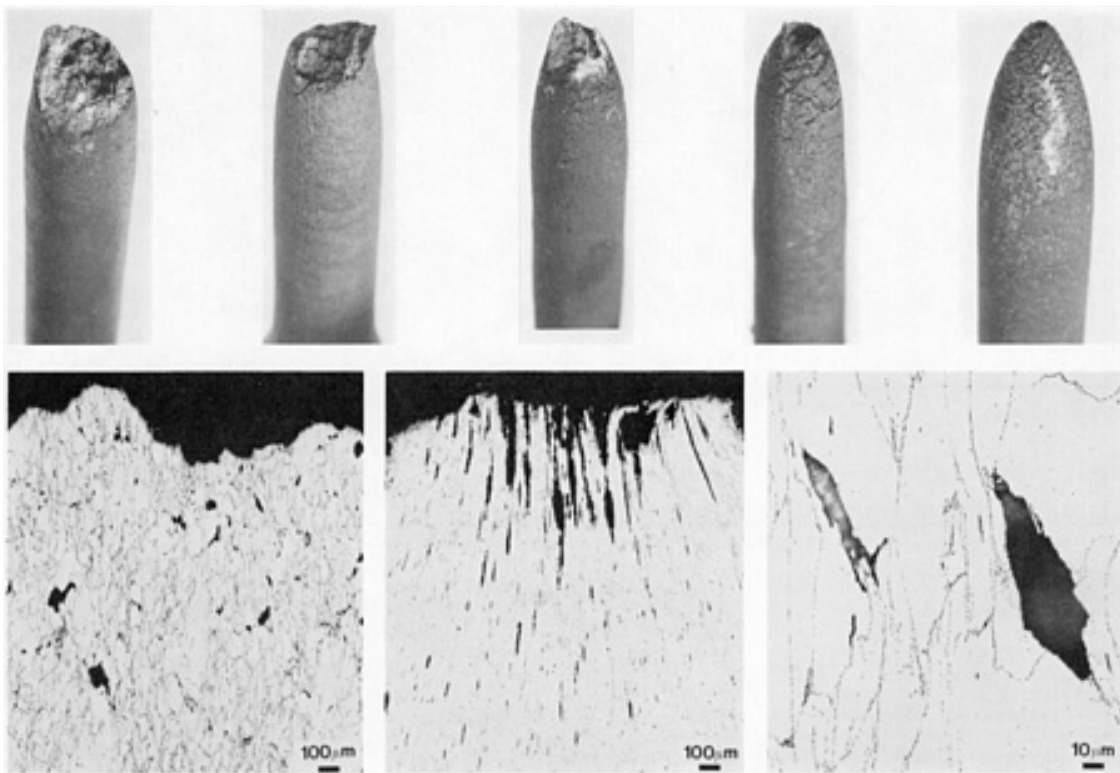
Fig. 74 Macrographs (top) and microstructures (bottom) of short-time type 316 stainless steel tensile specimens tested at various temperatures. Top, from left: specimens tested at 760 °C (1400 °F), 815 °C (1500 °F), 870 °C (1600 °F), 925 °C (1700 °F), and 980 °C (1800 °F). Bottom, from left: Specimen tested at 760 °C (1400 °F). 35 ×. Specimen tested at 980 °C (1800 °F) 35 ×. Specimen tested at 815 °C (1500 °F). 350 ×. Specimens at bottom etched with mixture of HCl, HNO₃, and H₂O.

The simplest measure of high-temperature properties is provided by the use of short-time tensile tests. Hot hardness tests are also quite useful. Figure 74 shows fractures of short-term high-temperature tensile specimens of type 316 stainless steel tested at 760 to 980 °C (1400 to 1800 °F). The reduction of area of the tensile fractures shown increases with temperature. Cup-and-cone fractures are not observed, however. The microstructures shown illustrate the formation of voids at the grain boundaries, which is typical of high-temperature tests. Precipitation of grain-boundary carbides (sensitization) can be clearly seen in the high-magnification view of the specimen tested at 815 °C (1500 °F). This is an example of a change in microstructure caused by high-temperature exposure.

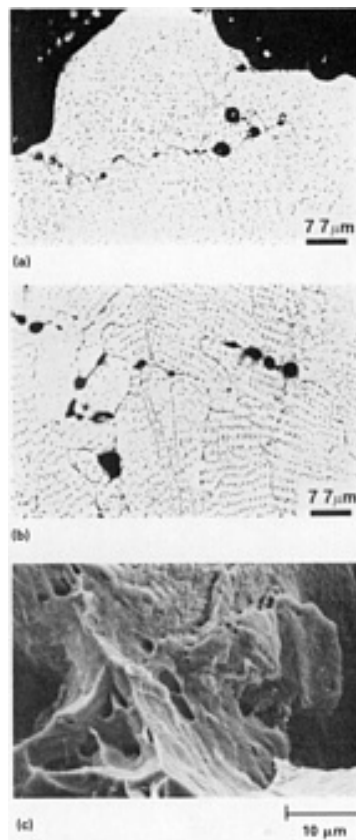
Fig. 76 Microstructure and fracture appearance of type 316 stainless steel tested in creep to fracture in air at 800 °C (1470 °F) at a load of 103 MPa (15 ksi). Time to rupture: 808 h. Light micrographs (a and b) illustrate r-type cavities caused by vacancy condensation on boundaries perpendicular to the stress axis. Both 90 × and electrolytically etched with oxalic acid. The SEM fractograph (c) illustrates the formation of the r-type cavities at the grain boundaries. 1260 ×. (W.E. White, Petro-Canada Ltd.)

Figure 76 illustrates r-type cavities at grain boundaries in type 316 stainless steel tested under creep conditions. The SEM fractograph shows the r-type cavities on the fracture surface, while the etched cross sections reveal the cavities at and behind the fracture face and their relationship to the grain boundaries. Figure 77 shows w-type cracks in type 316L stainless steel tested under creep conditions. The w-type cracks and the orientation to the stress axis (vertical in the micrograph) are easily observed in the light micrograph, but are not obvious in the SEM fractograph. Figure 78 shows grain-boundary triple-point cracking and extensive deformation in type 316 stainless steel tested at a slightly lower temperature. It is interesting to compare the three SEM fractographs in Fig. 76, 77, and 78. Figure 79 shows crack nucleation in a type 316 stainless steel specimen with heavy carbide precipitation. Cracking has occurred along the grain-boundary carbides, and the SEM fractography reveals a heavy concentration of carbides on the intergranular fracture surface.

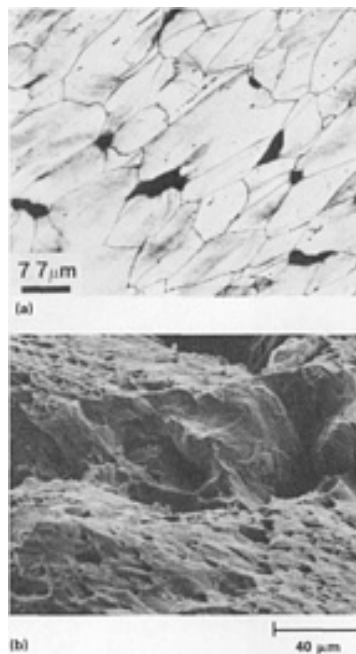
Fig. 78 Microstructure and fracture appearance of type 316 stainless steel tested in creep to fracture in air at 685 °C (1265 °F) at a load of 123 MPa (17.9-ksi). Time to rupture: 710 h. The light micrograph (a) shows triple boundary cracking with extensive bulk deformation and grain elongation. The SEM fractograph (b) illustrates classic shear dimple topography. (a) Electrolytically etched with oxalic acid. 110 ×. (b) 380 ×. (W.E. White, Petro-Canada Ltd.)

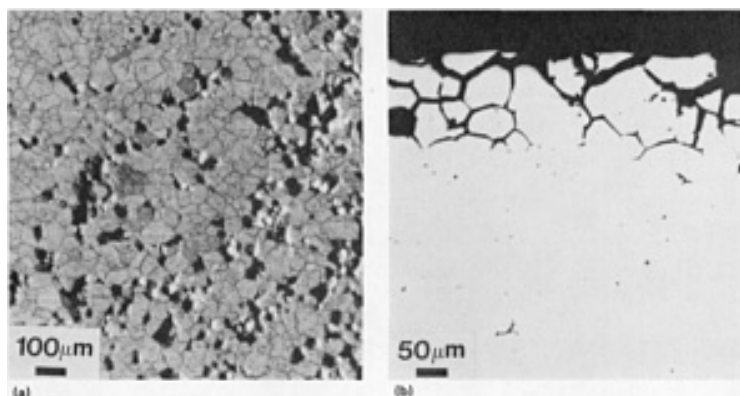
Fig. 82 Planar (a) and cross sectional (b) views of intergranular corrosion (grain dropping) in a sensitized austenitic stainless steel. As-polished. (a) 50×. (b) 100×

Figure 82 shows two views of an austenitic stainless steel exhibiting intergranular corrosion. Figure 82(a) shows the surface of the sample. The grain structure is visible due to the attack, and some grains have fallen out (referred to as grain dropping). The cross-sectional view (Fig. 82b) shows the depth of penetration of the attack along the grain boundaries.

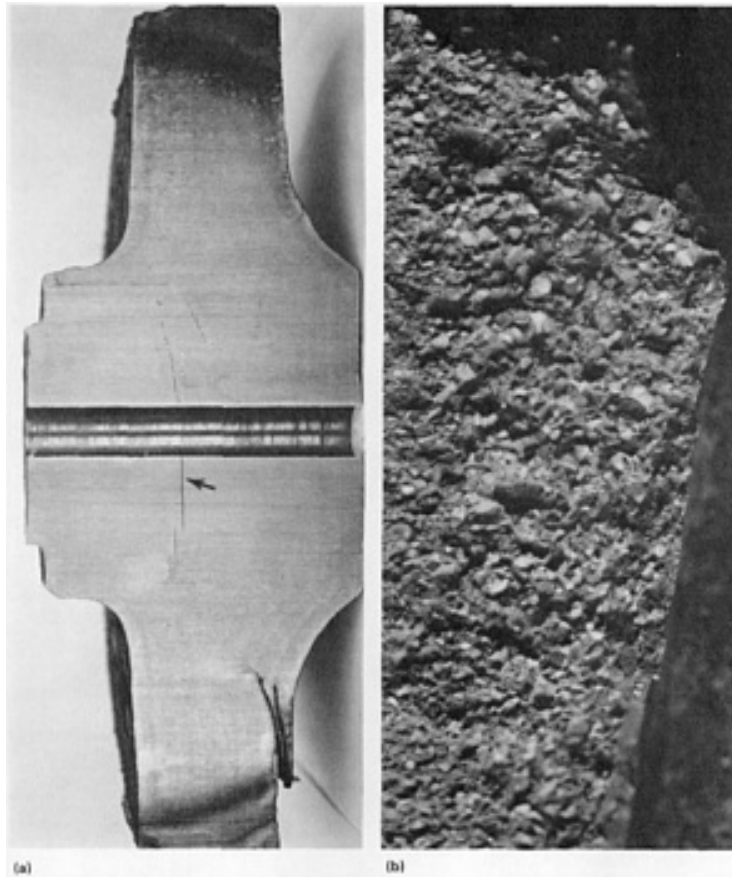
Fig. 86 Alloy steel compressor disk that cracked from overheating during forging. (a) Macrograph of disk (cracking at arrow). 0.4 \times . (b) Fracture surface of a specimen from the disk that was normalized, quenched, and tempered to 321 to 341 HB. The treatment revealed facets indicative of overheating. 5 \times

Figure 86 shows a section through the center of an alloy steel compressor disk that cracked during forging because of overheating. A specimen was cut from the disk and normalized, quenched and tempered (to a hardness of 321 to 341 HB), and fractured, revealing facets indicative of overheating (Fig. 86). Figure 87, which shows another example of facets, illustrates the fracture of a vanadium-niobium plate steel slab due to overheating. The accompanying micrograph shows that substantial carbon segregation and grain growth were present in the overheated region.

As discussed earlier, fracture tests are commonly used to detect overheating. A test specimen of appropriate size for subsequent fracturing is normalized, austenitized, quenched and tempered to about 321 HB, and fractured, usually at room temperature. The appearance of coarse-grain facets on the fracture, as shown in Figures 86, 87, and 88, is taken as proof of overheating.

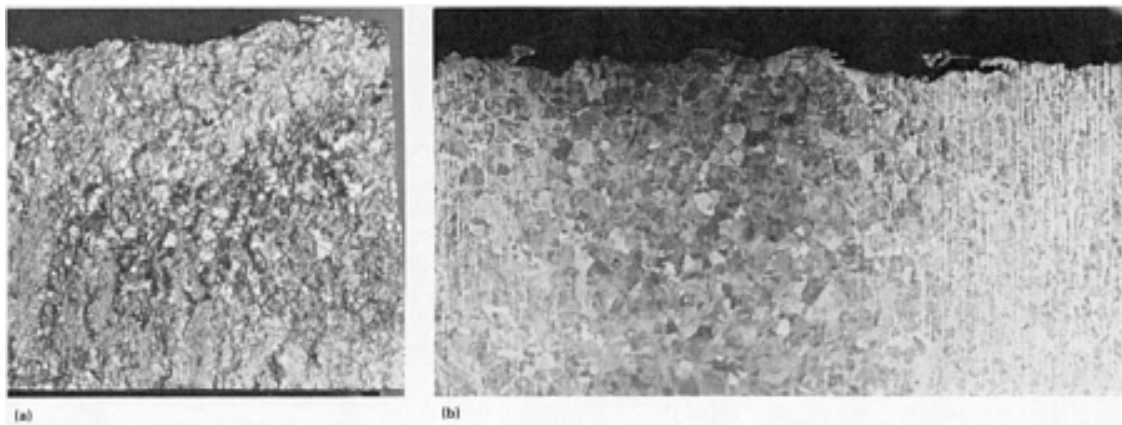
Fig. 87 Fracture (a) of a slab that was rolled from a vanadium-niobium plate steel. The coarse fracture facets indicate overheating before hot rolling. 1.25 \times . The etched section (b, with fracture along the top edge) shows carbon segregation in the center, as evidenced by the greater amount of pearlite. Note also the coarseness of the pearlite in the center. Etched with 2% nital. 3.5 \times

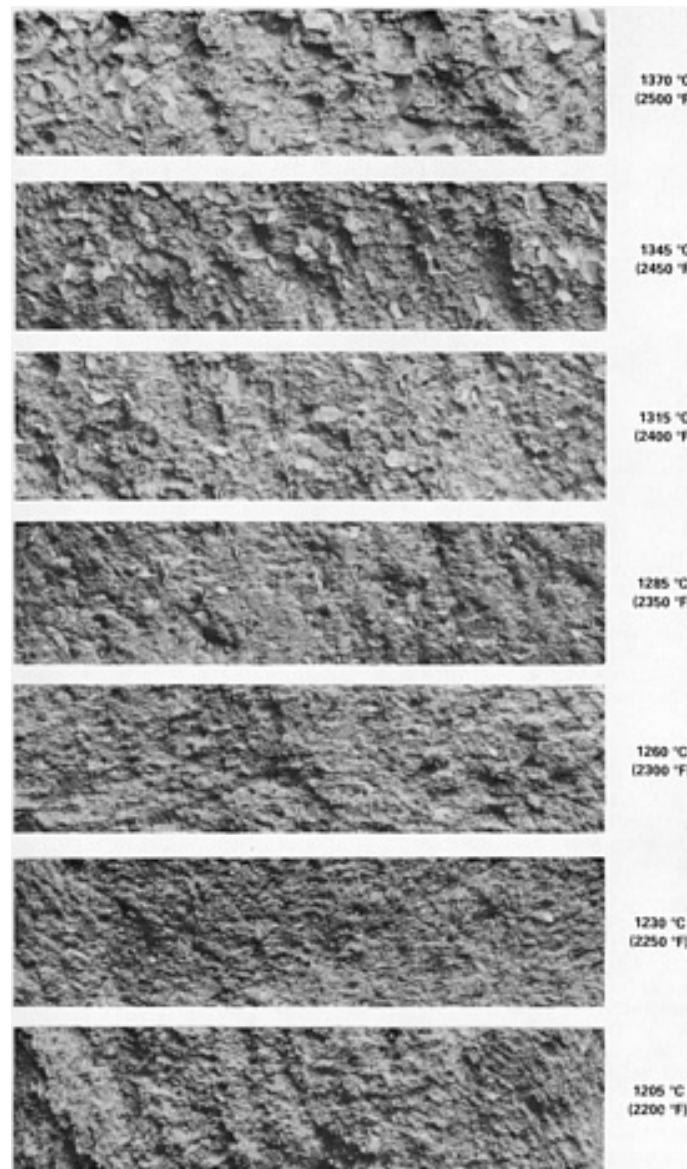
Fig. 88 Macrographs of specimens of ASTM A508 class II steel heated to the indicated temperatures, normalized, quenched, tempered to about 37 to 39 HRC, and fractured. Overheating facets are observed in all samples, but are not excessively large until the steel is heated to 1260 ° (2300 °F) or above. Source Ref 390

Another investigation showed interesting features of fractures of overheated ASTM A508 class II forging steel (Ref 390). The number of facets per square inch of test fracture depended on both the overheating temperature and the tempering temperature for the fracture test (also shown in Ref 392). For a given soak temperature, the number of facets per square inch decreased as the tempered hardness decreased. For the same tempered hardness, the facet density increased as the soaking temperature increased. Figure 88 shows a series of test fractures of ASTM A508 class II material soaked at 1205 to 1370 °C

(2200 to 2500 °F) and then quenched and tempered to a hardness of 37 to 39 HRC. Figure 89 shows SEM views of typical facets in samples soaked at 1205 and 1370 °C (2200 and 2500 °F). The sulfides in the dimples in the 1370- °C (2500- °F) specimen are clearly visible, but those in the 1205- °C (2200- °F) specimen are extremely fine. This difference arises from the greater dissolution of the original sulfides at the higher temperature. Because more of the sulfides are dissolved at higher temperatures, more are available for reprecipitation in the austenite grain boundaries upon cooling.

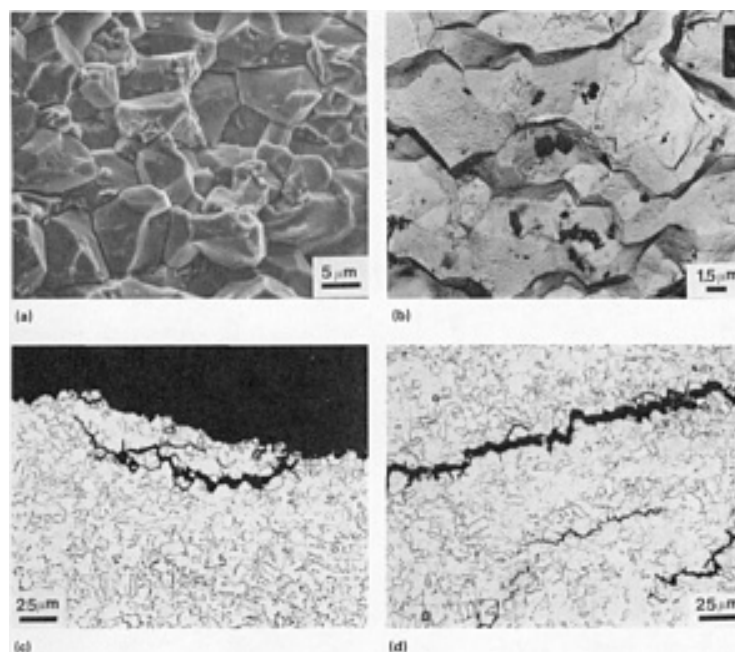
Fig. 100 Fracture in a thermally embrittled cobalt-free high-titanium maraging steel. (a) Secondary electron image of fracture surface, 1300 ×. (b) TEM extraction fractograph, 2150 ×. (c) Light micrograph of fracture edge, 260 ×. (d) Light micrograph of internal cracks, 260 ×. Light micrograph specimens etched with modified Fry's reagent

Figure 100 shows the fracture of a cobalt-free high-titanium maraging steel specimen that fractured because of thermal embrittlement. The light micrographs of the fracture profile and a secondary crack reveal the intergranular nature of the fracture. This is more easily observed by direct SEM examination of the fracture, but the TiC and Ti(C,N) on the intergranular fracture is more clearly revealed by the extraction fractograph. Analysis of the extracted grain-boundary precipitates is not hindered by detection of the matrix around the precipitate, as might occur with SEM-EDS analysis.

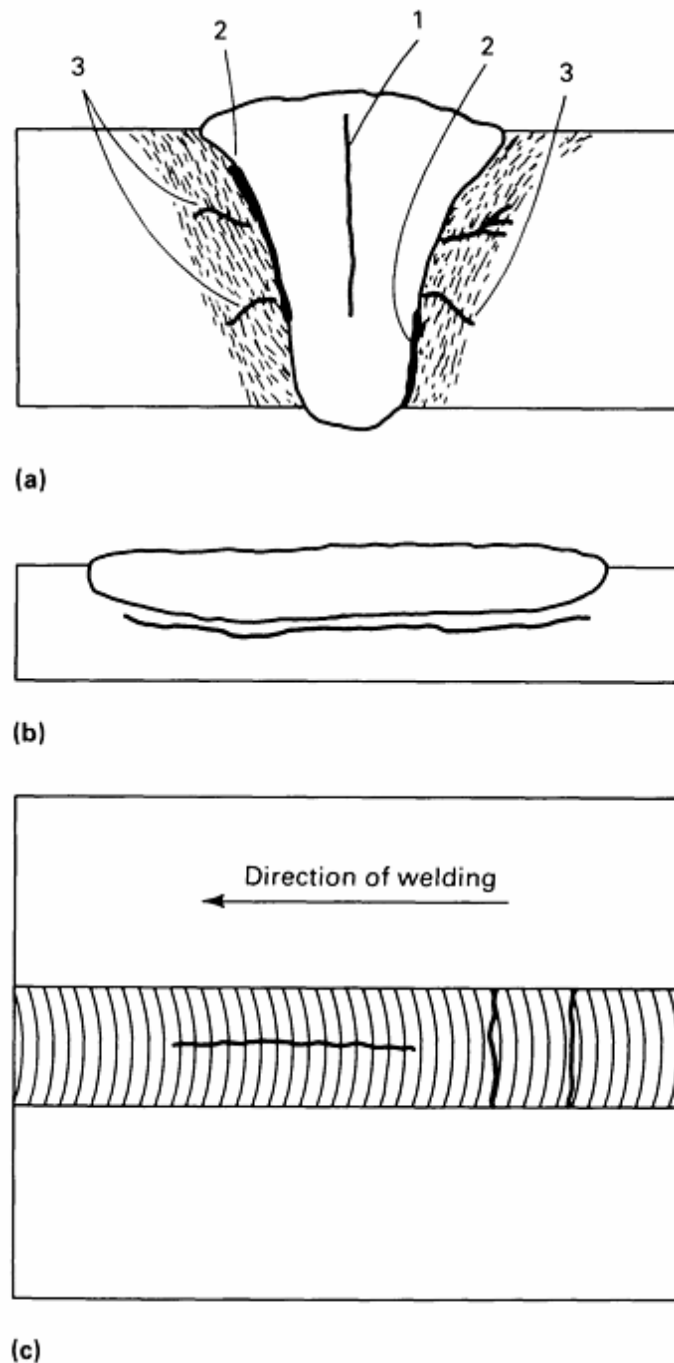
Fig. 102 Schematics illustrating the nomenclature used to describe weldment cracks. (a) Weld metal (1), fusion line (2), and HAZ (3) cracks. (b) Underbead crack. (c) Longitudinal and transverse weld metal cracks. Source: Ref 480

at higher temperatures and then grow to a detectable size at lower temperatures (Ref 470, 471, 472, 473, 474, 475, 476, 477, 478, 479). Cracking may occur during cooling to room temperature or a short time after reaching room temperature, or it may occur after a considerable time delay. Cold cracks may be found in the weld metal or in the HAZ (Fig. 102). Both transgranular and intergranular fracture paths have been observed.

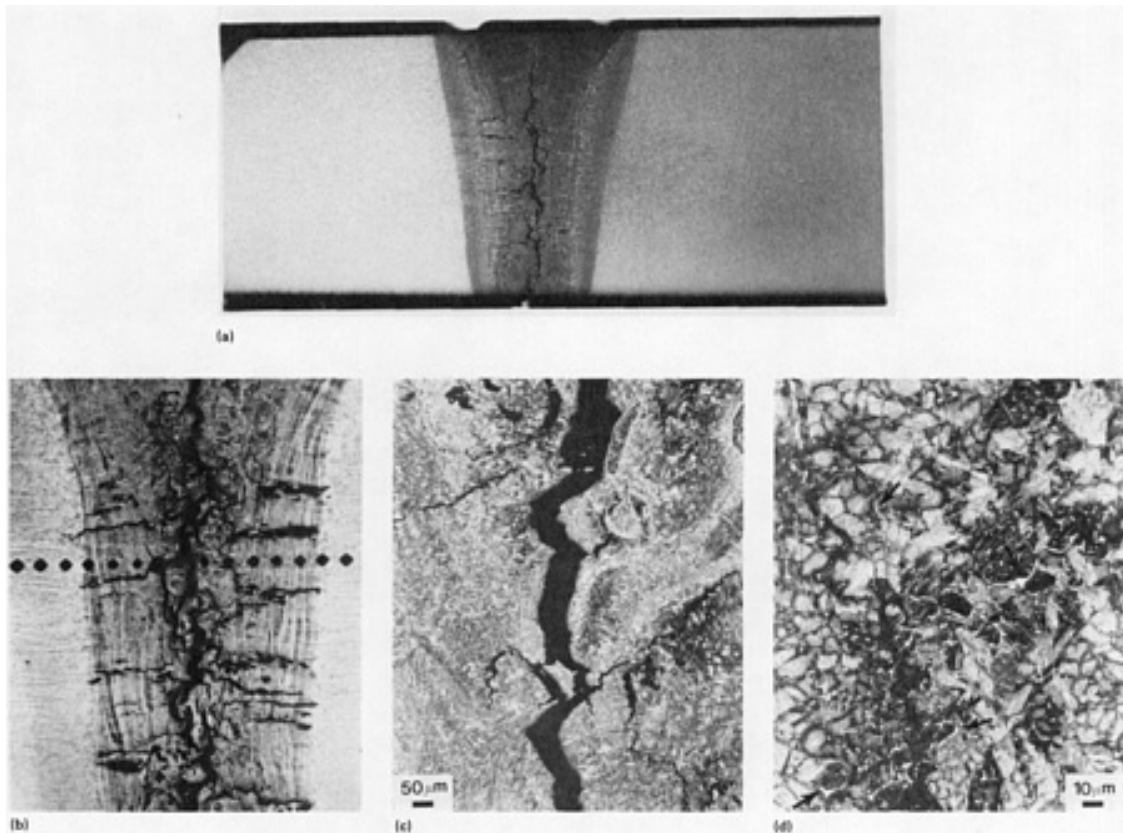
Fig. 104 Hot cracking of an electron beam weld due to accidental melting of the copper backing plate. Note the extensive intergranular cracking and the grain-boundary copper film. (a) 4 ×. (b) 13 ×. (c) 68 ×. (d) 340 ×

Light microscopy examination of cross sections is a very important aspect of diagnosing hot cracking. Figure 104 illustrates the use of light microscopy in the study of extensive hot cracking in an electron beam weld that was contaminated by liquid copper by accidental melting of the copper back-up plate. The cracks are clearly intergranular, and elemental copper can be found throughout the region in the prior-austenite grain boundaries. Figure 105 shows two examples of fine hot tears in the

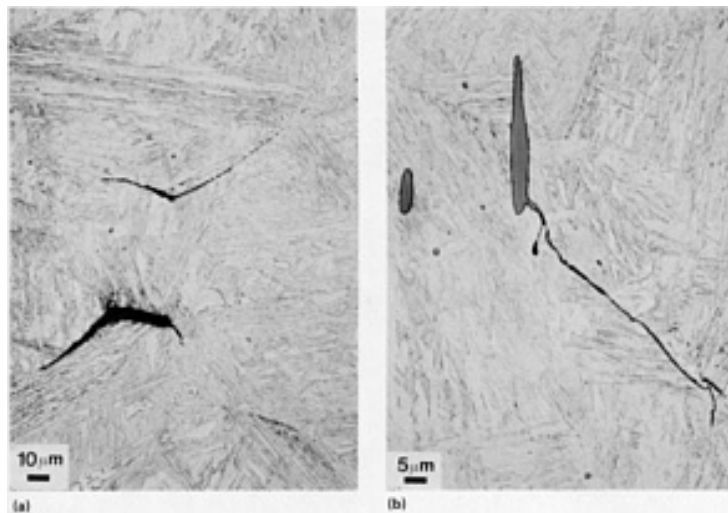
Fig. 105 Two examples of hot tears in the HAZ of gas-metal arc welded HY-80 steel. Note the crack associated with the manganese sulfide inclusion (b). Both etched with 1% nital. (a) 370×. (b) 740×. Courtesy of C.F. Meitzner, Bethlehem Steel Corporation

HAZ of a welded HY-80 plate steel.

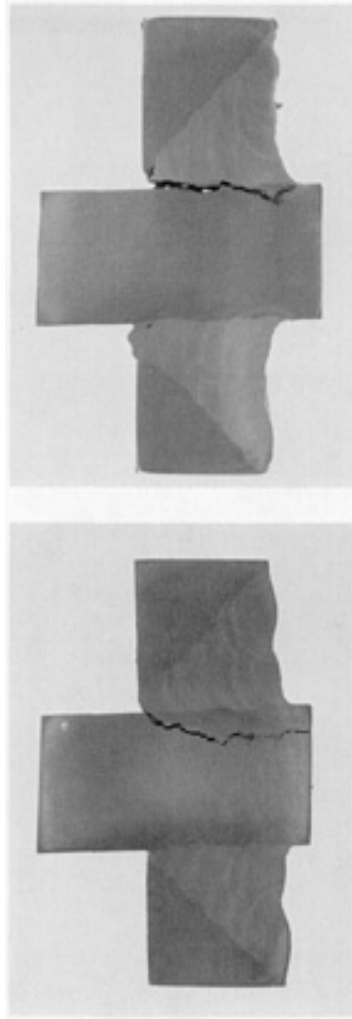
Fig. 107 Macrographs showing typical lamellar tears in structural steel

Cracking begins at the inclusion/matrix interfaces, as shown schematically in Fig. 106. The cracked interfaces that lie in the same plane grow and link together to form terraces. The high strain level, due to thermal contraction and joint restraint, produces ductile tearing of the matrix between the inclusion/matrix interfacial cracks. Further straining connects terrace cracks on different parallel planes by ductile shearing (Fig. 106). These shear walls produce the characteristic steplike appearance of lamellar tears (Fig. 107).

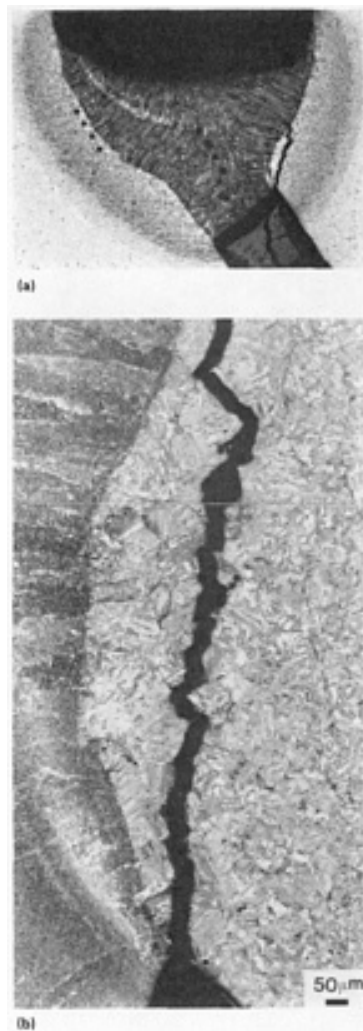
Fig. 108 Stress-relief crack in plate steel Lehigh restraint sample. The crack is intergranular, but the high restraint level suppresses crack branching. The square marks in the weld HAZ in (a) are hardness impressions. (a) 9 \times . (b) Etched with 2% nital. 74 \times

Steel microstructures that promote stress-relief cracking usually contain fine carbides that have precipitated within the grains in the HAZ; the grain boundaries are frequently denuded of carbides. This concentrates the creep strain at the weakened grain boundaries, producing extensive deformation, which is often accommodated by grain-boundary sliding, and intergranular cracking. Carbides may also lie along the grain boundaries, which promotes cracking. Alloy steels containing carbide-forming elements, such as chromium, molybdenum, and vanadium, are most susceptible. A metallographic example of the nature of stress-relief cracks is shown in Fig. 108.

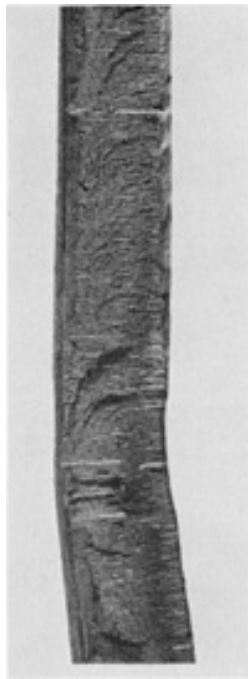
Fig. 111 Example of inclusion stringers (white streaks against the dark background) on a longitudinal test fracture. The specimen was blued to reveal the stringers.

Inclusion stringers of macroscopic size can be readily detected on a fractured specimen after heat tinting in the blue heat range (Ref 516, 517, 518). Several ASTM standards (A 295, A 485, A 535, and A 711) include test limitations for macroscopic inclusion stringers detected in this type of test. In most work with this test, the macroetch billet disks are hardened, fractured, and blued on a hot plate or in a laboratory furnace. Heating to 260 to 370 °C (500 to 700 °F) is usually adequate. The fracture face should be a longitudinal plane. The lengths of any visible stringers, which appear white against the blue fracture, are measured. Figure 111 shows an example of inclusion stringers detected by this procedure.

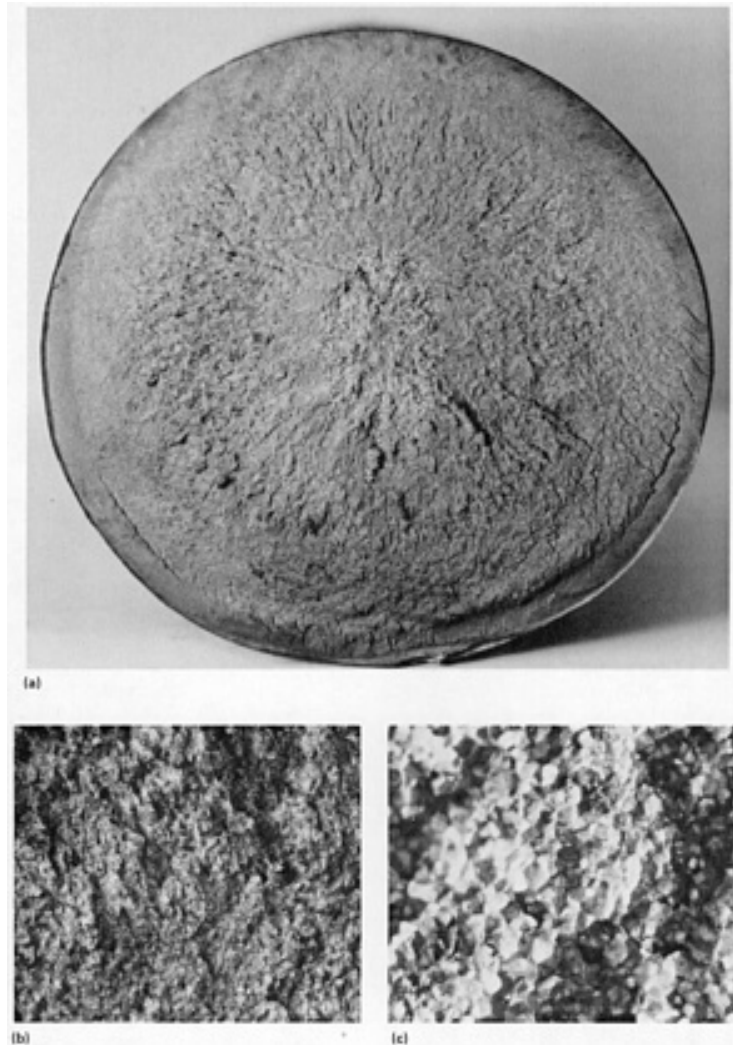
Fig. 115 AISI 1070 steel bar that broke during heat treatment due to gross chemical segregation. (a) Macrograph at actual size. (b) Fracture near the outside surface of the bar. 8 \times . (c) Fracture near the center of the bar. 8 \times . Note the coarse grain structure of the center region.

Figure 115 shows an example of the transverse fracture of an AISI 1070 steel bar that broke during heat treatment due to gross chemical segregation and overheating. The transverse fracture reveals a fine-grain appearance at the hardened outer periphery of the bar. The coarse intergranular appearance of the fracture in the interior is evident in Fig. 115. Radial marks can be seen emanating from the coarse-grain central region of the bar.

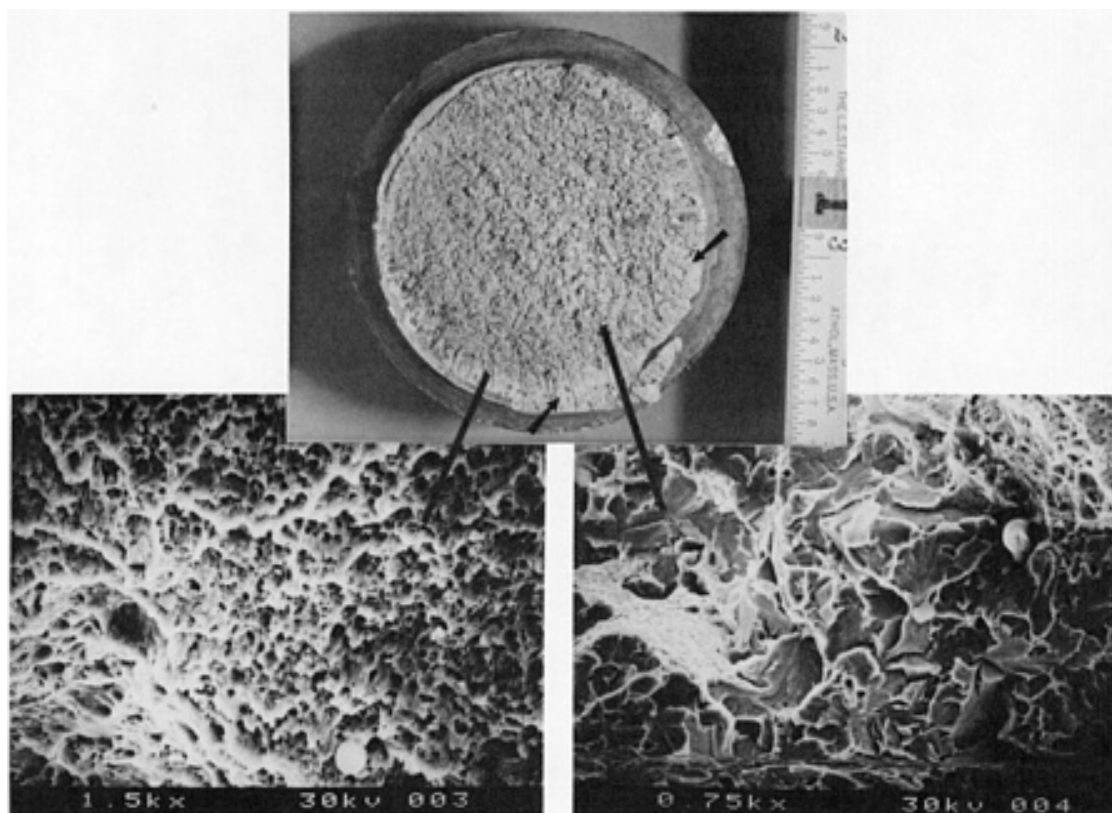
Fig. 5 Radial marks (arrows) in the fibrous zone of a bolt fractured under conditions of tensile overload. The morphologies of the different texture zones are shown in the SEM fractographs: ductile fracture (left) and transgranular fracture (right).

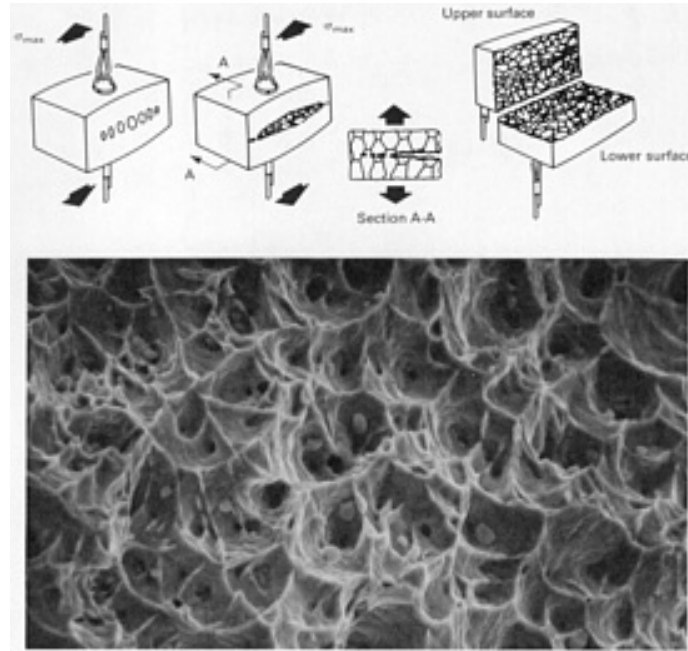
Fig. 9 Formation of dimples under conditions of tension using a copper test specimen. Note that the dimples are equiaxed. 750×

Equiaxed or hemispheroidal dimples are cupshaped, and they form under conditions of uniform plastic strain in the direction of applied tensile stress; equiaxed dimples are typically produced under conditions of tensile overload (Fig. 9). In comparison, elongated dimples shaped like parabolas result from nonuniform plastic-strain conditions, such as bending

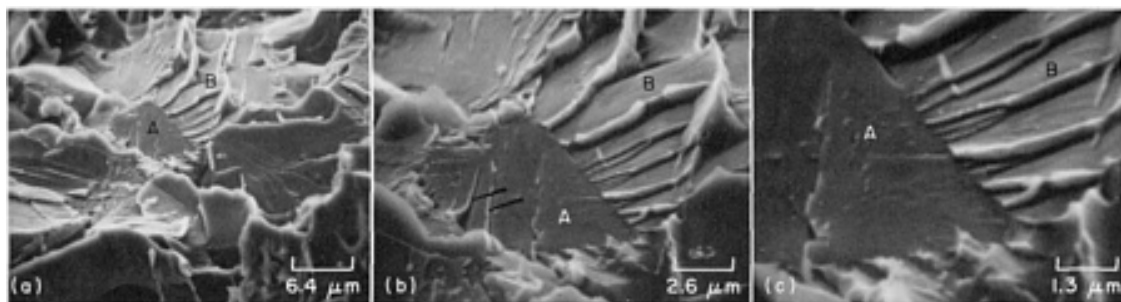
Fig. 13 Cleavage fracture in a notched impact specimen of hot-rolled 1040 steel broken at $-196\text{ }^{\circ}\text{C}$ ($-320\text{ }^{\circ}\text{F}$), shown at three magnifications. The specimen was tilted at an angle of 40° to the electron beam. The cleavage planes followed by the crack show various alignments, as influenced by the orientations of the individual grains. Grain A, at center in fractograph (a), shows two sets of tongues (see arrowheads in fractograph b) as a result of local cleavage along the $\{112\}$ planes of microtwins created by plastic deformation at the tip of the main crack on $\{100\}$ planes. Grain B and many other facets show the cleavage steps of river patterns. The junctions of the steps point in the direction of crack propagation from grain A through grain B, at about 22° to the horizontal plane. The details of these forks are clear in fractograph (c).

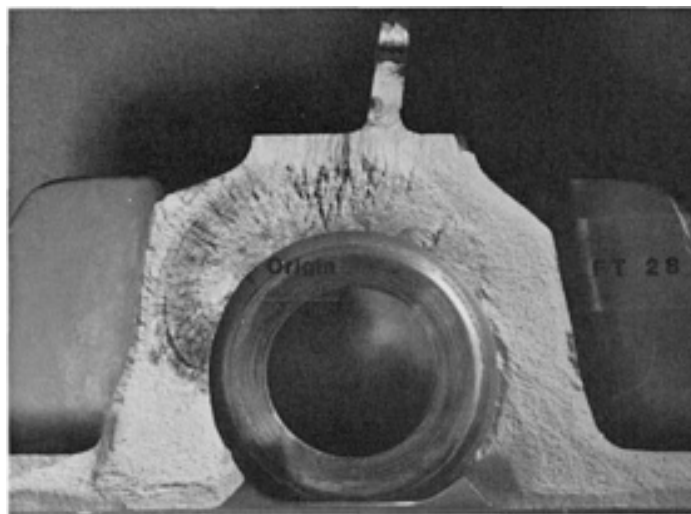
Fig. 14 Forged aluminum alloy 2014-T6 aircraft component that failed by fatigue. Characteristic beach marks are evident. See also Fig. 15.

The location of the origin is defined by interpreting features of the stage II crack propagation zone. Macroscopic beach marks, or clamshell markings, radiate away from the origin in concentric semicircles (Fig. 14). These are a special form of progression mark commonly associated with fatigue. When the propagation zone is examined by SEM at progressively higher magnifications, the beach marks can be resolved into hundreds or thousands of fatigue striations (Fig. 15).

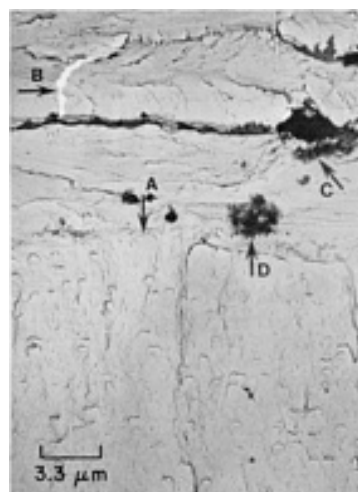
Fig. 6 Four types of artifacts found on two-stage plastic-carbon replicas. The appearance of the bottom half of

the fractograph (below arrow A) is the result of tears in the first-stage plastic replica and is not representative of the fracture surface. Arrow B indicates a crack in the carbon second-stage replica; arrow C, a particle from the improperly cleaned fracture surface; and arrow D, residual plastic from incomplete dissolution of the first stage. 3000×

The disadvantage most often encountered with any replication process is the presence of features on the replica that do not accurately reflect the details of the fracture surface, such as the artifacts shown in Fig. 6.

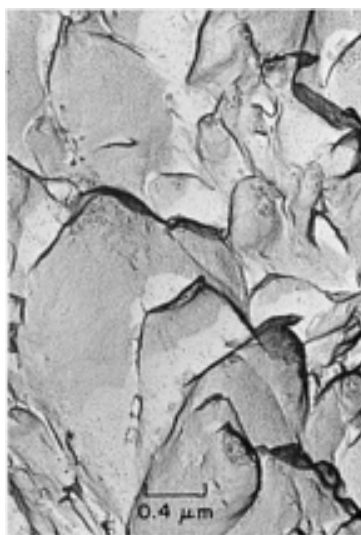
Fig. 8 Palladium-shadowed plastic-carbon replica of a fracture in nickel showing reticulated shadowing metal on dimples. Reticulation was caused by the melting of the shadowing metal in the microscope and the formation of globules. 22,500×

Artifacts that arise after a replica is inserted in the microscope include contamination, reticulation, and melting of materials contained in the replica. Contamination resulting from the action of the electron beam is unavoidable and increases with exposure time. Reticulation occurs when the shadowing metal gets hot enough to melt and form globules, such as those shown in Fig. 8. Reticulation can be avoided by using a less finely focused electron beam or by using platinum as the shadowing metal. Use of a less finely focused beam also avoids melting of other materials contained in the replica.

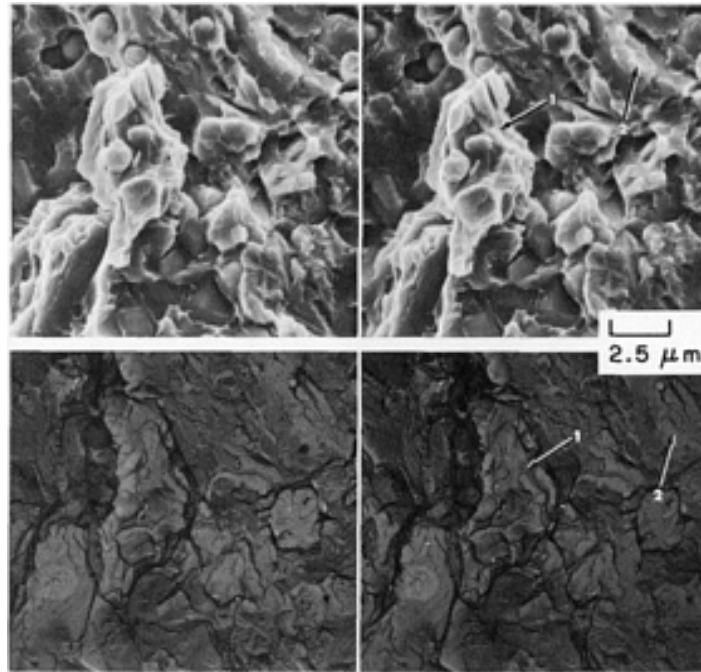
Fig. 10 Views of a different area, and at higher magnification, of the fracture surface shown in Fig. 9 and. This is a remarkably complex area, containing many small and varied quasi-cleavage facets and exhibiting a number of spheroidal inclusions. The most prominent feature is the high peak at arrow 1, which is reproduced in very faithful and identical detail in both stereo pairs. Note that the two inclusions between the twin tips of the peak are shown in both pairs but that similar inclusions slightly nearer the top of the SEM pair are missing in the TEM because of damage to the replica. The top center area of the SEM view appears to record a greater number of surface complexities than the same area in the TEM view; at arrow 2, however, the TEM view displays very fine fracture marks that cannot be found in the same location in the SEM view. Fig. 10 (top): SEM stereo pair. Fig. 10 (bottom): TEM stereo pair. Both 4000×

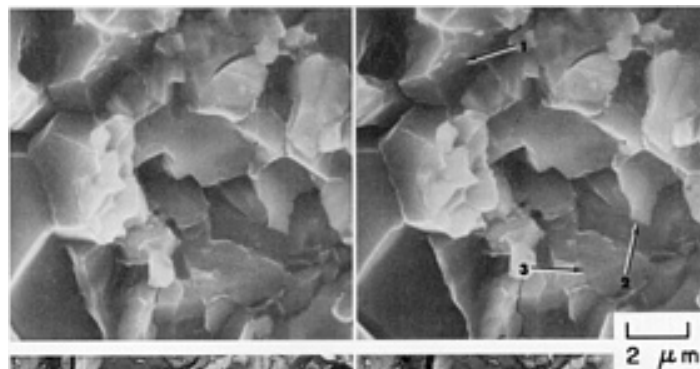
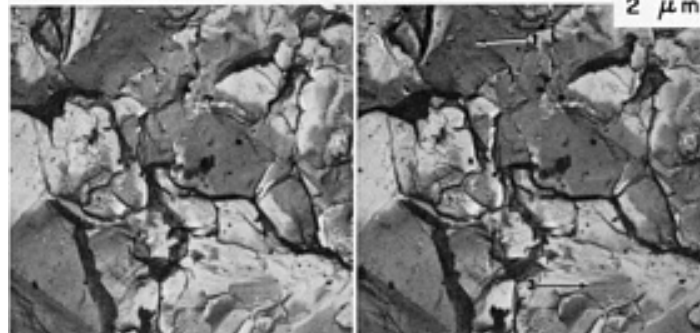
Fig. 14 A second set of views at higher magnification showing another area of the stress-corrosion cracking fracture in aluminum alloy 7075-T6 in Fig. 13. Similar to the preceding set, this set of views shows a variety of grain surfaces resulting from intergranular rupture. The TEM fractograph shows many minute corrosion pits on these separated-grain surfaces, none of which are resolved in the SEM pair. The dark zones between grains in the TEM pair are caused by folding of the replica at secondary cracks. Observe the excellent agreement between the SEM and TEM pairs as to contour and detail, particularly in the region at arrow 1. Arrow 2 marks a feature in the SEM that does not appear in the TEM, which is unusual. Again, differences in elevation are minimized in the TEM; the region at arrow 3 appears to be at the same level as the ridge above arrow 1, but the SEM shows that the region at arrow 3 is much lower. Fig. 14 (top): SEM stereo pair. Fig. 14 (bottom): TEM stereo pair. Both 5000×

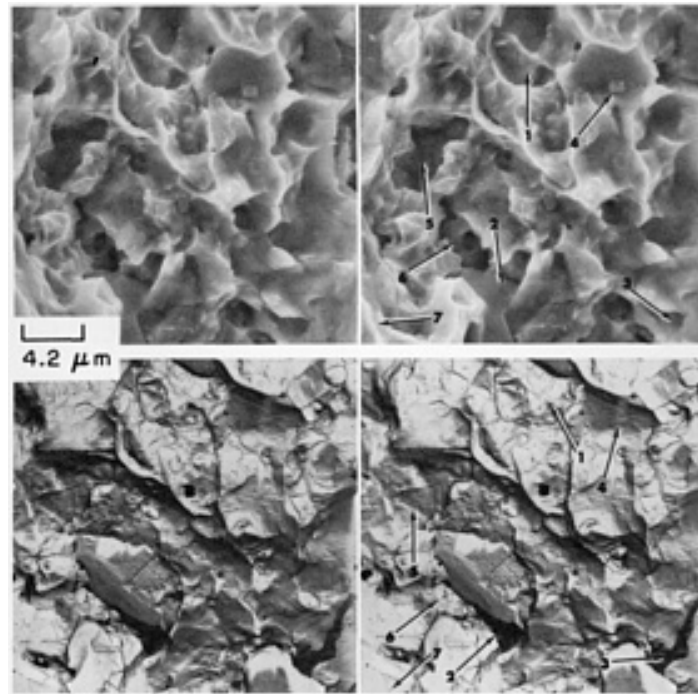
Fig. 15 Surface of a tension overload fracture in a notched specimen of annealed Ti-8Al-1Mo-1V alloy that was broken at room temperature. The tensile strength of the material was 1000 MPa (145 ksi). The fracture surface consists of dimples of various sizes, a few of which show some sidewall stretching. The SEM and TEM pairs are in close agreement as to details of contour; compare, for example, the contours in and around the depression at arrow 1. In the TEM fractograph, tears and folds in the replica obscure the surface in the crevices at arrows 2 and 3. Note that the cube-shaped second-phase particle at arrow 4 in the SEM is missing entirely from the TEM. Many superficial surface features clearly visible in the TEM pair are not resolved in the SEM. Some replica collapse is evident when the elevations at arrows 5 to 7 in the TEM fractograph are compared with those in the SEM. See also Fig. 16, Fig. 15 (top): SEM stereo pair, Fig. 15 (bottom): TEM stereo pair. Both 2400×

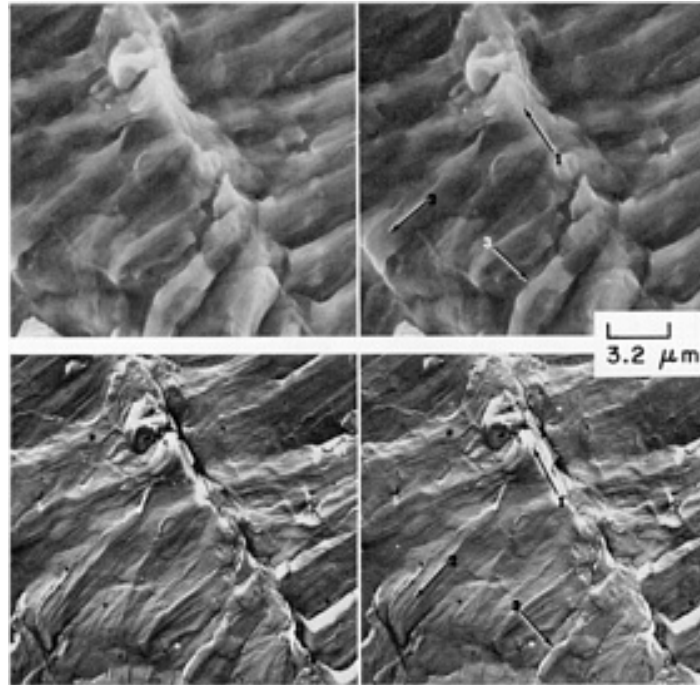
Fig. 18 A more highly magnified set of views of another area of the surface of the high-cycle fatigue fracture in annealed Ti-8Al-1Mo-1V alloy in Fig. 17. These stereo-fractographs show the junction of two adjacent fatigue striation patches that exhibit considerable irregularity in striation orientation in the neighborhood of the step separating the patches. Comparison of the SEM and TEM pairs shows good agreement in registry of contours, as can be seen at arrows 1 to 3. The fine marks along the ridges of the striations are sufficiently pronounced for many to be shown in the SEM fractograph, but others are not resolved there and are shown much more distinctly in the TEM pair. Fig. 18 (top): SEM stereo pair. Fig. 18 (bottom): TEM stereo pair. Both 3100 ×

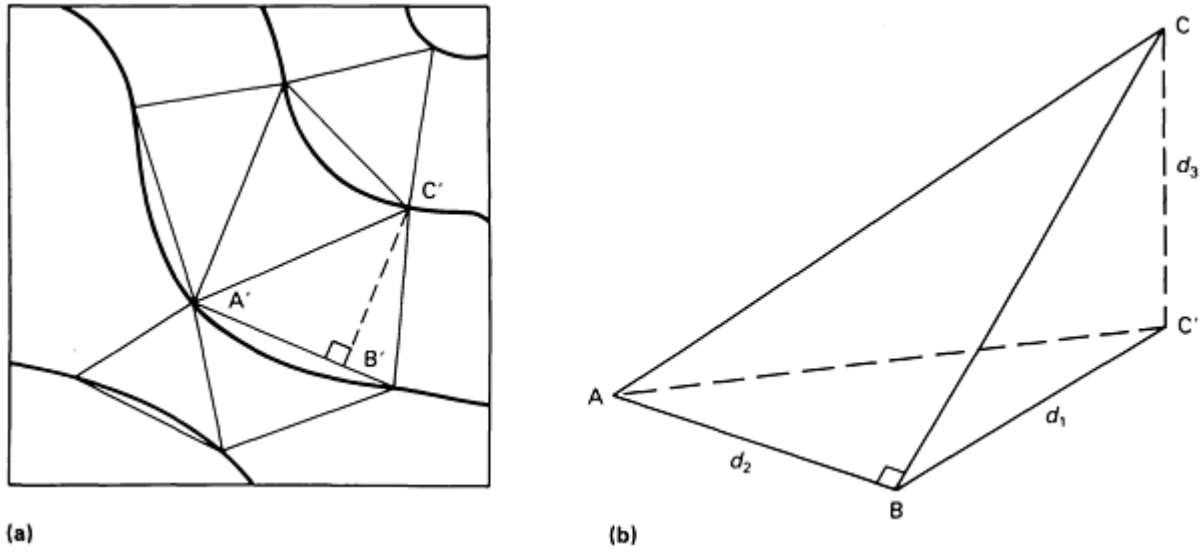
Fig. 13 Representation of a fracture surface with triangular elements between contour lines. (a) Projection of contours and triangles. (b) Three-dimensional view of triangle ABC

Another approximate surface composed of triangular elements has been proposed, but this approach uses a contour map rather than serial sections to form the triangles (Ref 13). The triangles are connected between adjacent contour lines, then divided into right angle subtriangles ($A'B'C'$) as shown in Fig. 13. The area of the triangular element ABC can be calculated because the sides \overline{AB} and \overline{BC} can be determined. The area of the entire model surface is then obtained by summation.

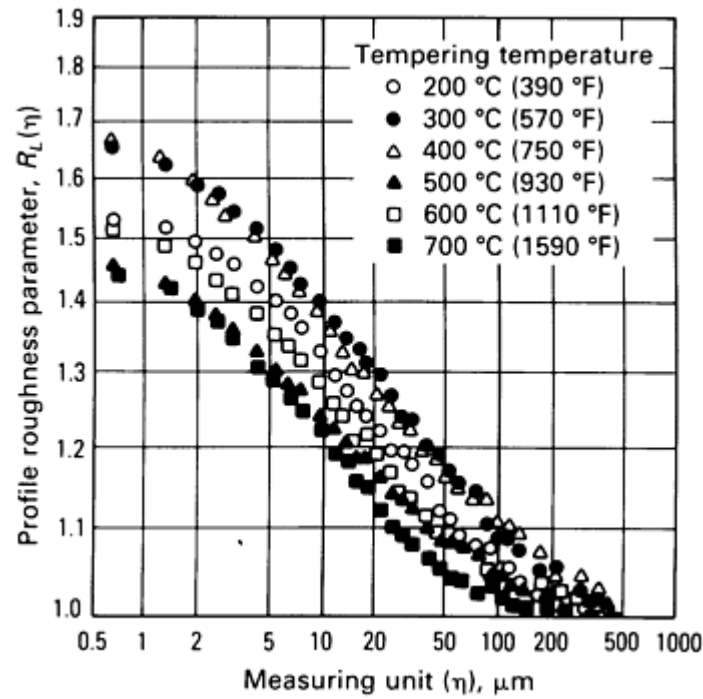
Fig. 3 Fractal plots for AISI 4340 steel specimens tempered at temperatures between 200 and 700 °C (390 and 1290 °F) for 1.5 h and fractured at room temperature showing RSC behavior

It is clear that a curve through the data points shown in Fig. 2 is not linear as postulated, even though the fitted regression line shows a correlation exceeding 99%. In fact, a tendency toward asymptotic behavior is evident at both termini of the curve. In an effort to clarify this situation, fracture profiles were obtained from a series of six AISI 4340 steel specimens tempered for 1.5 h at various temperatures between 200 and 700 °C (390 and 1290 °F). The upper limit of η was extended to 426.5 μm , making the spread in values greater than 645 times. The fractal plots for the six profiles are shown in Fig. 3, which clearly reveals the RSC shape. The curves are definitely not linear.

Conventional D values were calculated for each of the six curves shown in Fig. 3. Average slopes were determined by linear regression using the central portion of each curve. The D values obtained are given in Table 1 for comparison with other results. A minimum is apparent at 500 °C (930 °F). The significance of this minimum has been discussed in relation to microstructural and fractographic factors (Ref 8, 9).

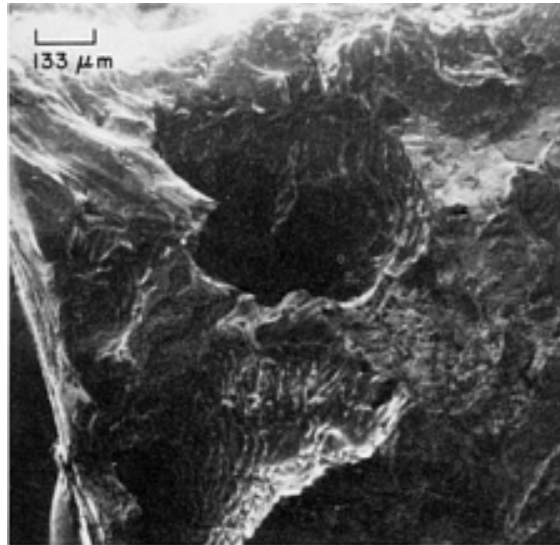
Fig. 9 Fracture produced at room temperature by bending iron containing 0.02% C, 0.14% S, and 0.04% O cast in a 7 × 7 × 20 cm (2.75 × 2.75 × 8 in.) ingot mold. A carbon-FeO reaction caused blowholes such as shown at top. Note the fine lamellar structure at bottom. See also Fig. 10. SEM, 75×

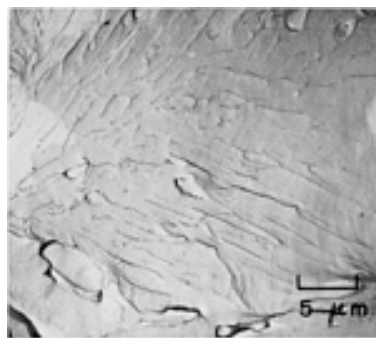
Fig. 27 Cleavage fracture in Armco iron broken at -45 °C (-49 °F). Instead of cleavage steps, tear ridges (occasionally forming river patterns) were produced here by microscopic plastic flow. TEM p-c replica, 2000×

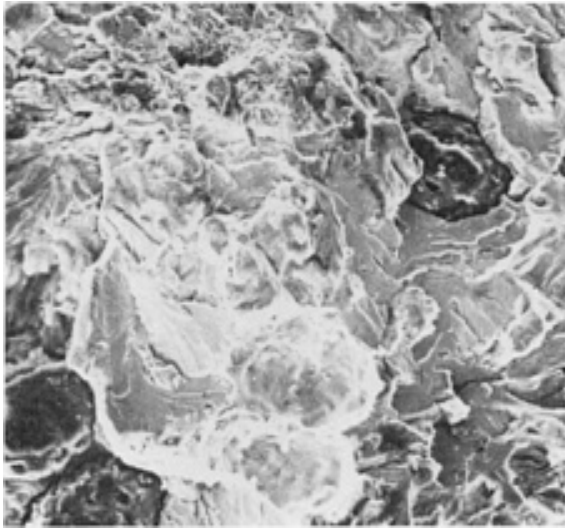
Brittle cleavage fracture of ductile iron spur gear (ASTM A536, grade 100-70-03) due to improper heat treatment. Tensile strength was 544 MPa (78.9 ksi), much less than the 690 MPa (100 ksi) required by the specification. Elongation was nil; the specification called for 3% min. The induction-hardened case on the teeth was shallower and harder than specified (50 + HRC versus 46 HRC), and the martensitic microstructure had not been tempered as specified. Direct cause of fracture was the presence of inverse chill (carbides in thick sections of the casting) associated with microporosity. This carbidic material, which formed at thermal centers due to segregation of carbide-forming elements, increased hardness, decreased tensile strength, and promoted brittle fracture. Proper heat treatments would have corrected the deficiencies in case structure and properties and would also have prevented the occurrence of inverse chill. Fig. 36: Fracture surface at core of gear directly below origin. Note transcrystalline (cleavage) mode of fracture. SEM, 200×. Fig. 37: Photomicrograph of core. Matrix is 100% pearlite. Note presence of inverse chill (carbides) and associated porosity. 2% nital, 200×. Fig. 38: Fracture face at casting surface and in the induction-hardened case. SEM, 20×. Fig. 39: Boxed area in Fig. 38. Note cleavage fracture appearance and nodule surrounded by cracked material believed to be carbidic. SEM, 200×. Fig. 40: Microstructure directly below fracture surface and in case. There is a carbide-appearing envelope around each nodule of temper carbon that formed as the inverse chill
