ASM HANDBOOK®

VOLUME
12

Fractography

Fractography, was published in 1987 as Volume 12 of the *ASM Handbook*. The Volume was prepared under the direction of the ASM Handbook Committee.

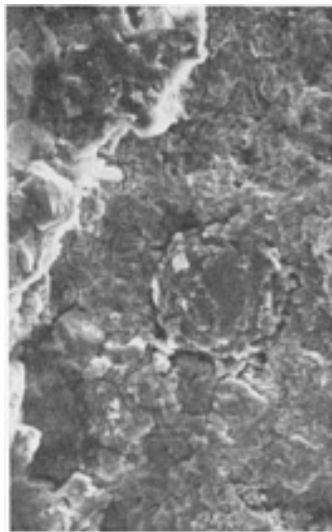
Brittle cleavage fracture of ductile iron spur gear (ASTM A536, grade 100-70-03) due to improper heat treatment. Tensile strength was 544 MPa (78.9 ksi), much less than the 690 MPa (100 ksi) required by the specification. Elongation was nil; the specification called for 3% min. The induction-hardened case on the teeth was shallower and harder than specified (50 + HRC versus 46 HRC), and the martensitic microstructure had not been tempered as specified. Direct cause of fracture was the presence of inverse chill (carbides in thick sections of the casting) associated with microporosity. This carbidic material, which formed at thermal centers due to segregation of carbide-forming elements, increased hardness, decreased tensile strength, and promoted brittle fracture. Proper heat treatments would have corrected the deficiencies in case structure and properties and would also have prevented the occurrence of inverse chill. Fig. 36: Fracture surface at core of gear directly below origin. Note transcrystalline (cleavage) mode of fracture. SEM, 200×. Fig. 37: Photomicrograph of core. Matrix is 100% pearlite. Note presence of inverse chill (carbides) and associated porosity. 2% nital, 200×. Fig. 38: Fracture face at casting surface and in the induction-hardened case. SEM, 20×. Fig. 39: Boxed area in Fig. 38. Note cleavage fracture appearance and nodule surrounded by cracked material believed to be carbidic. SEM, 200×. Fig. 40: Microstructure directly below fracture surface and in case. There is a carbide-appearing envelope around each nodule of temper carbon that formed as the inverse chill

decomposed. The two nodules at upper left also have retained austenite around them. Note the secondary crack extending between the casting surface and the carbide envelope of a temper nodule. 2% nital, 200× (G.M. Goodrich, Taussig Associates Inc.)

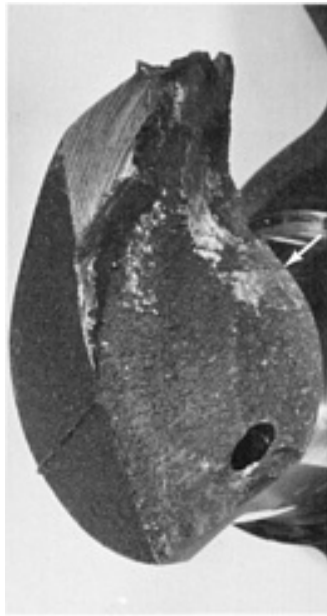
Fig. 43 Surface of a fatigue fracture in an experimental crankshaft broken in a fatigue test. The material is ductile iron with a hardness of 241 HB. The origin of the fatigue crack is at the edge of the journal, at arrow. Actual size

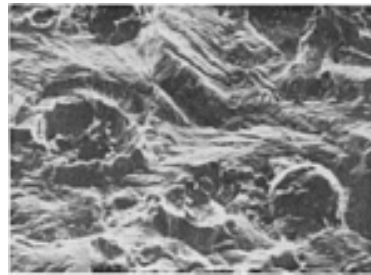
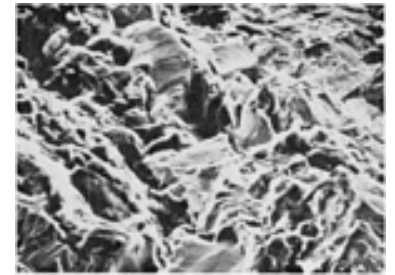
Fatigue fracture surfaces of pearlitic and ferritic ductile irons. Compositions of pearlitic irons: 3.63 to 3.80% C, 0.34% Mn, 2.02 to 2.66% Si. Compositions of ferritic iron: 3.75 to 2.82% C, 0.34% Mn, 2.30 to 2.66% Si. Striations noted in all cases. Fig. 47 and 48: Mixture of striations and fractured pearlite lamellae on fracture surfaces of commercial pearlitic ductile irons. Striations are the fine steplike features, not the macroscopic waviness or undulations. SEM, 207 \times and 198 \times . Fig. 49: A high load fatigue fracture surface of a ferritic ductile iron. SEM, 375 \times (F.J. Worzala, University of Wisconsin)

Comparisons of fatigue and monotonic (tension, bending, impact) fracture surfaces for various ferritic ductile iron microstructures. Fatigue fractures are characterized by striations (see Fig. 47, 48, and 49), by relatively little opening up or stretching of matrix material around nodules, and by nodules that appear to have had large pieces of graphite broken off of them. Mode of crack propagation in monotonic fractures is very ductile with considerable stretching of nodule-bearing cavities. The demarcation line between fatigue (FAT) and monotonic (FRA) fracture is noted in each of the three fractographs. Fig. 50: Commercial ferritic iron (2.30 to 2.66% Si) tested at room temperature. SEM, 90 \times . Fig. 51: Same material as in Fig. 50, but during tensile portion of test at -40 °C (-40 °F). SEM, 90 \times . Fig. 52: High-silicon ferritic ductile iron (3.5% Si). SEM, 90 \times (F.J. Worzala, University of

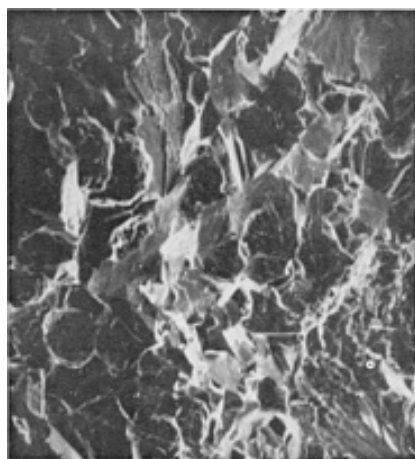
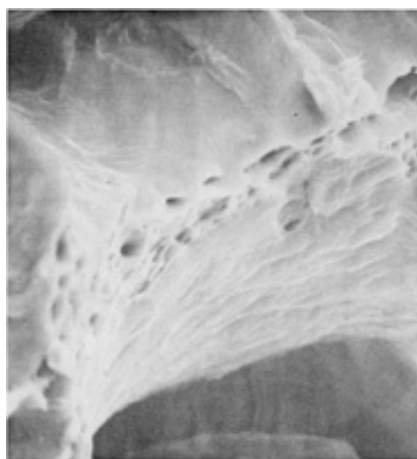
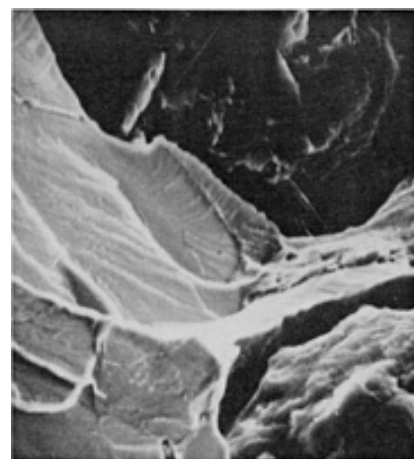
As test temperature falls below ambient, the slow monotonic fracture mode for ferritic ductile irons undergoes a gradual ductile-to-brittle transition. Fig. 62: Fracture surface of ferritic ductile iron tested at -40 °C (-40 °F). Note river patterns and plateaus characteristic of brittle fractures. SEM, 150 \times . Fig. 63 and 64: High-magnification views compare internodular areas of ferritic ductile irons tested at room temperature and at -40 °C (-40 °F), respectively. SEM, ~1900 \times (F.J. Worzala, University of

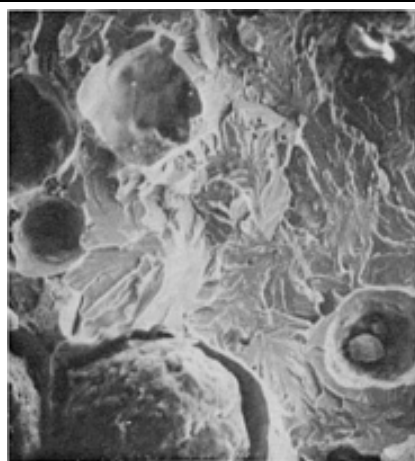
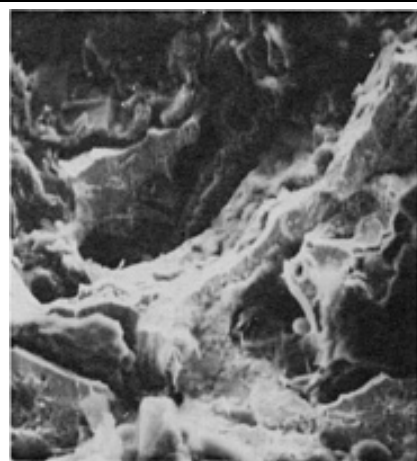
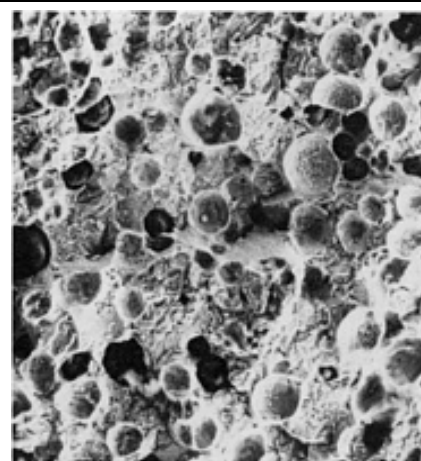
Slow monotonic (tension or bending) fracture characteristics of heat-treated ductile irons. Fig. 65: Normalized high-nodularity ductile iron tested at room temperature. Note cleavage facets extending to the nodule, secondary cracking, and evidence of nodule cavity elongation. This material is not as tough as ferritic or pearlitic ductile iron. SEM, 550 \times . Fig. 66: Fracture surface of normalized low-nodularity iron. Presence of nonspheroidal graphite fosters the creation of long ridges and valleys. These graphitic "lumps" apparently upset and redirect the crack plane. SEM, 550 \times . Fig. 67: Austempered ductile iron, with a microstructure of bainite and tempered martensite, is stronger but less ductile than ferritic or pearlitic ductile iron. Note fine cleavage features. When viewed macroscopically, the fracture surface is very flat and reflective. SEM, 270 \times (F.J. Worzala, University of Wisconsin)

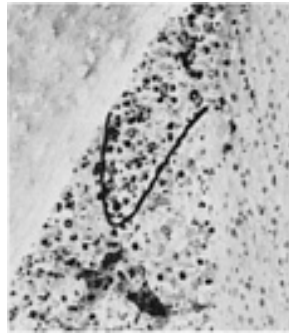
Fig. 88 Ductile-to-brittle transition in an annealed ferritic ductile iron (same alloy as in Fig. 83 and 84). Above demarcation line is region of dimpled rupture (the ductile fracture surface of the test sample after partial fracture at room temperature). Below line is region of quasi-cleavage (the brittle fracture surface of the test sample after final fracture at low temperature). SEM, 30× (R.C. Voigt and L.M. Eldoky, University of Kansas)

Fracture transition zone at center of the ferritic ductile iron sample in Fig. 88. Fig. 89: Subsurface fracture transition zone. SEM, 140×. Fig. 90: Higher magnification view of Fig. 89. Note how far microcracks formed at room temperature had propagated by time of final low-temperature fracture. SEM, 275×. Fig. 91: High magnification view of transition zone. Visible features include nodule decohesion and microplastic deformation and tearing ahead of the primary crack front. SEM, 1,100×

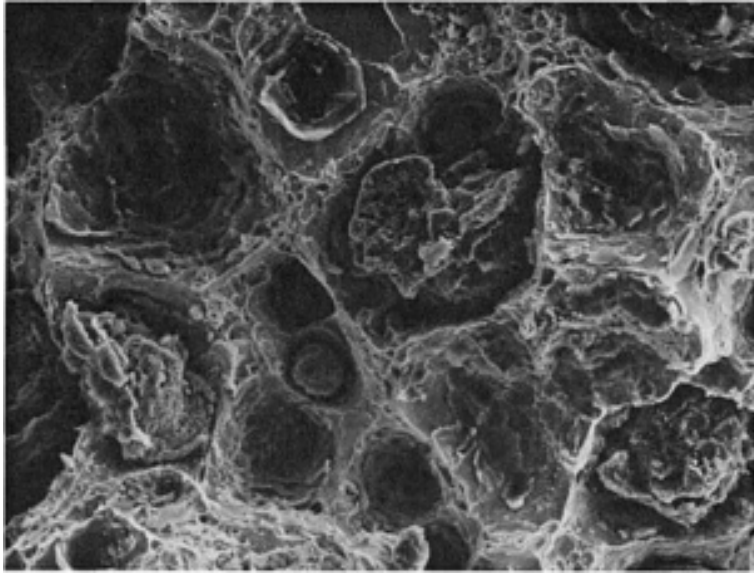
Fig. 94

Ductile fracture in ferritic ductile iron. Fig. 94: SEM, 160 \times . Fig. 95: Example of the finely dimpled ductile fracture that occurs between the much larger voids nucleated at graphite nodules. SEM, 2000 \times

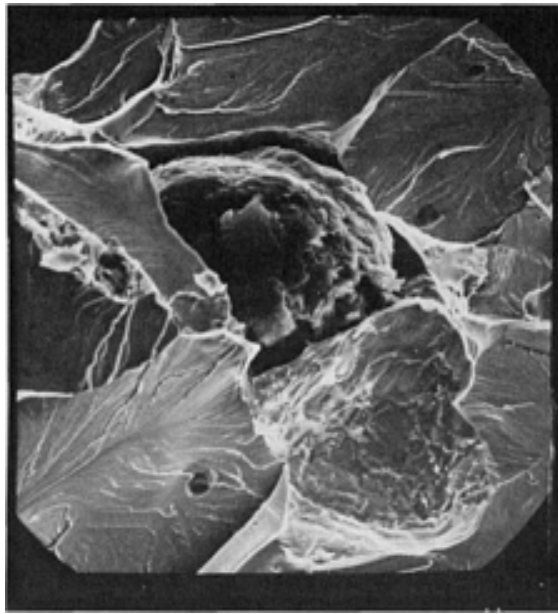
Fig. 97 Brittle cleavage fracture in ferritic ductile iron. SEM, 1000× (W.L. Bradley, Texas A&M University)

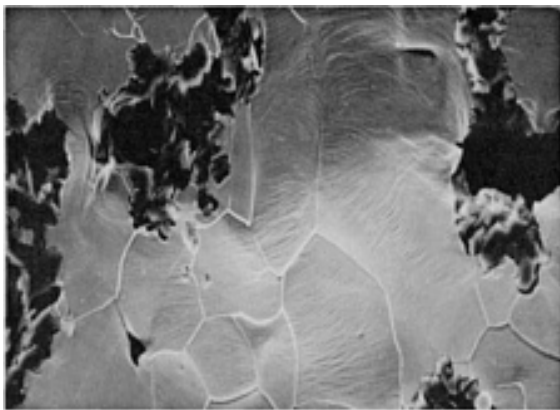
Fig. 98

Fracture sequence (increasing strain) illustrating localized plastic deformation and microcrack initiation and propagation ahead of the primary crack in a ferritic malleable iron (ASTM A47, grade

32510). Heat treatment was standard (graphitizing anneal, furnace cool). Hardness: 140 HB. Samples were polished, etched in 4% nital, and then strained. Figures 98, 99, 100, and 101 are in order of increasing amounts of strain. Note how cracks propagate through the graphite rather than around it as is the case for ductile iron (see Fig. 76, 77, 78, 79, Fig. 85, and 86). SEM, all at 580× (R.C. Voigt and B. Pourlaidian, University of Kansas)

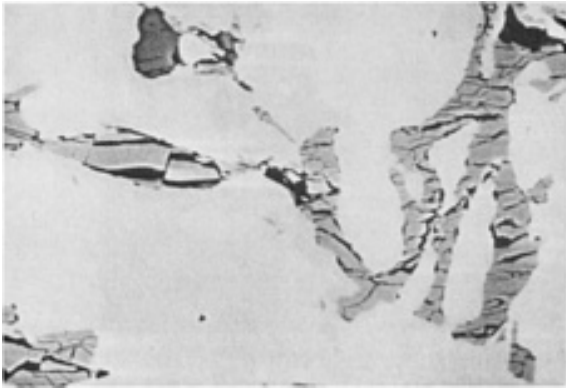
Fig. 107

Cracking in 75-mm (3-in.) diam balls made of a high-chromium white iron when subjected to severe, repeated impacts in a laboratory test. Fig. 106: Cracks through eutectic M_7C_3 carbides near the surface (dark region) of the ball. SEM, 2000× Fig. 107: Cracks parallel to the surface of the ball and extending through carbides located several millimeters beneath the surface. These cracks were caused by a combination of shear stress and the tensile stress due to rebounding. SEM, 2000×. Fig. 108: Crack path of an imminent near-surface spall. SEM, 1000× (H.W. Leavenworth, Jr., U.S. Bureau of Mines)

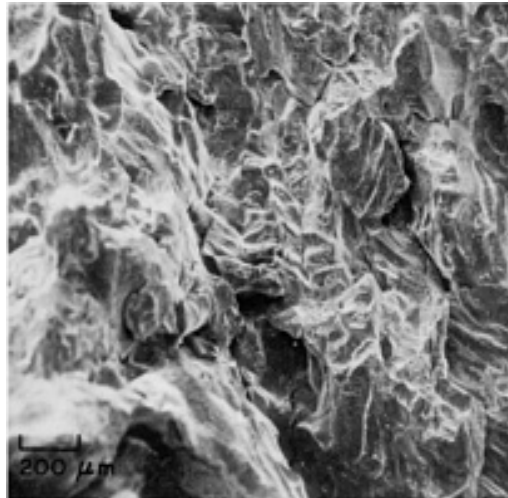
Fig. 112 Surface of fracture obtained in test bar of low-carbon steel containing 0.041% C, 0.62% Mn, 0.008% P, 0.028% S, and 0.032% Si (Mn:S ratio, 22.1:1). The test bar was remelted in its central zone in a Gleeble test unit, solidifying *in situ* in its quartz sleeve. Following controlled cooling from the freezing point, the test bar was pulled in tension at 925 °C (1700 °F). Although the path of this fracture was largely intergranular, there is also transgranular cleavage, and some facets show very fine dimples. SEM, 50×

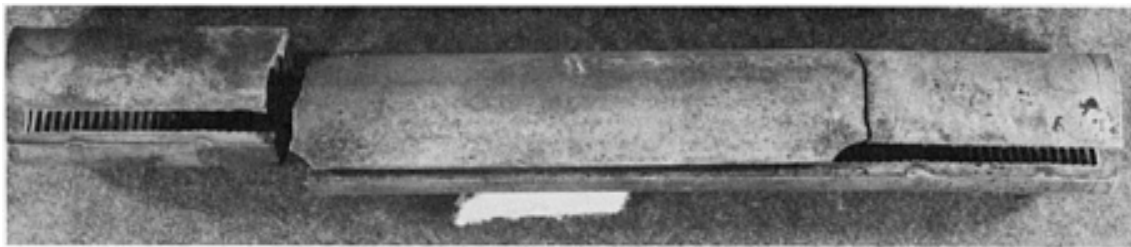
Fig. 113

In-service fatigue fracture of SAE 1010 tie rod adjusting sleeve for automobile steering system. Fig. 113: Tubular part was made by cold forming cold-rolled sheet. 1.8×. Fig. 114: Macrograph reveals fracture progressed at 90° to surface. (General Motors Research Laboratories)

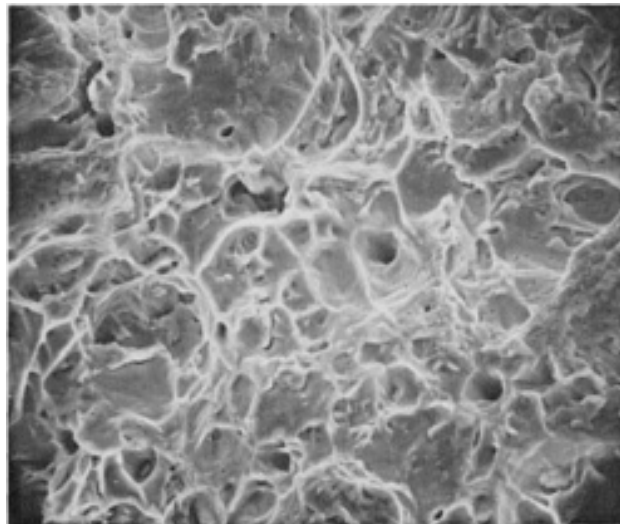
Fig. 116

Bending impact fracture of SAE 1010 tie rod adjusting sleeve for automobile steering system. This part, unlike that in Fig. 113 and 114, was made of cold-drawn seamless tubing. Compressive forces produced when wheel was struck during an accident caused sleeve failure. Fig. 115: Macrograph of mating fracture surfaces shows impact fracture progressed at 45° to surface. 2×. Fig. 116: Photomicrograph near point of origin reveals dimpled structure characteristic of a ductile, single load

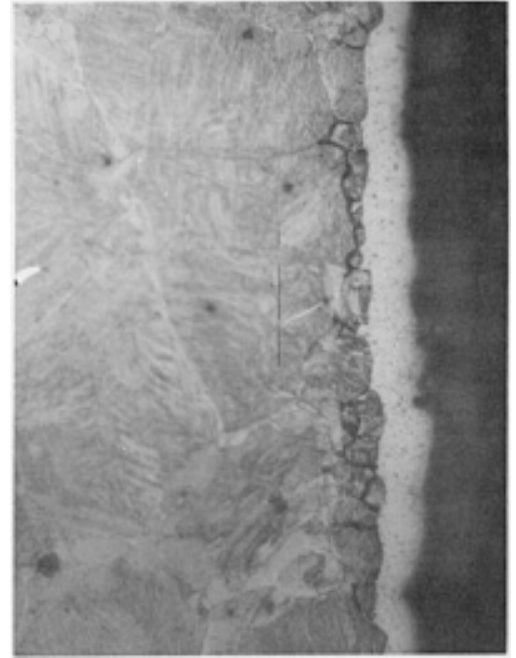
Fig. 134

Failure of ASTM A178 grade B boiler tubes due to grain-boundary embrittlement by copper. Thick waterside deposits on tube inner-diameter surfaces impaired heat transfer, causing overheating of the steel during boiler start-up. Underneath the scale was a layer of metallic copper, an element often present as a feedwater impurity and which can plate out on the inner-diameter surfaces of boiler tubes. Overheating of the tubes to above 815 °C (1500 °F) caused accelerated diffusion of the copper along grain boundaries in the steel, in some cases reaching the tube outer-diameter surface. The copper-embrittled grain boundaries could not withstand both the high temperature and internal tube pressure. Either a longitudinal rupture (Fig. 133) or circumferential cracking (Fig. 134) resulted, depending on the orientation of maximum copper infiltration. (F.W. Tatar, Factory Mutual Research Corporation)

SEM photomicrographs at inner-diameter surface of circumferentially cracked ASTM A178 grade B boiler tube in Fig. 134. Fig. 135: Note intergranular penetration by copper; some oxidation is present near surface. 100×. Fig. 136: Higher-magnification photomicrograph reveals a 25-μm (1-mil) thick

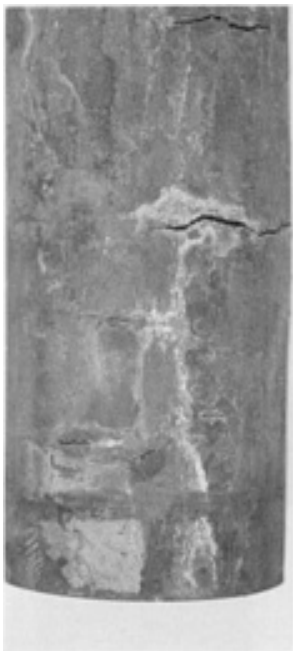
Fig. 135

layer of metallic copper on the tube inner diameter. 2% nital. 300× (F.W. Tatar, Factory Mutual Research Corporation)

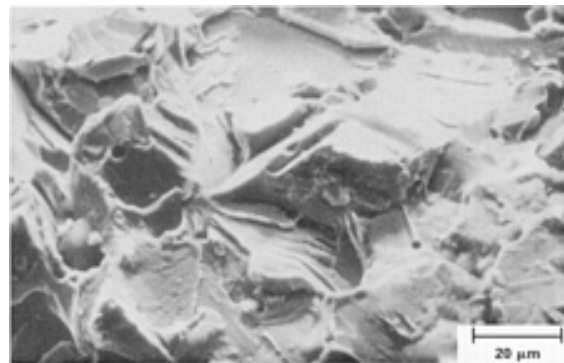
Fig. 149

Copper contamination introduced during casting led to brittle fracture of a normalized 0.25% C carbon steel part. The boxcar side frame failed during a freight train derailment. The foundry mold had accidentally been contaminated with copper. During solidification of the casting, some of the copper dissolved in the steel while the remainder was entrapped as liquid metal and either penetrated austenite grain boundaries or solidified as copper inclusions. Dissolved oxygen in the grain-boundary copper reacted with iron to form a black scale consisting largely of Fe_3O_4 and Fe_2O_3 . Fracture initiated during the derailment, and upon reaching the copper-contaminated region it followed the scale network, delineating prior-austenite grain boundaries. Under repeated impacts, the fracture advanced further by low-cycle fatigue until part failure occurred by cleavage. Fig. 146: "Rock candy" portion of fracture surface where fracture followed scale network, defining copper-contaminated prior-austenite grain boundaries. SEM, 1100×. Fig. 147: Vein of copper along prior-austenite grain boundary near rock candy portion of fracture surface. Section polished and etched with 2% nital. SEM, 275×. Fig. 148: Transverse crack emanating from copper inclusion is visible at center of photo. Large shrinkage cavities at left and right played no role in fracture. Fig. 149: Region on fracture surface exhibiting cleavage. SEM, 550× (A. Johnson, University of Louisville)

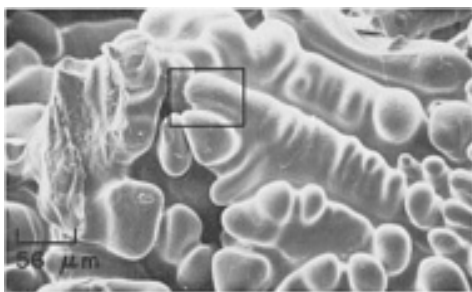
Fig. 150

Surface of a brittle fracture in a specimen of low-carbon steel whose central zone was remelted in a Gleeble test unit, resolidified, cooled *in situ* to 1425 °C (2600 °F) and held for 20 s at that temperature, and then fractured in tension. This specimen contained 0.024% P. Figure 150 (shown at 180×) indicates that the fracture followed an interdendritic path through regions that had not yet solidified at 1425 °C (2600 °F). The rounded dendrite surfaces thus exposed are obvious, and the only evidence

Surface of a brittle fracture in a specimen of low-carbon steel whose central zone was remelted in a Gleeble test unit, resolidified, cooled *in situ* to 1425 °C (2600 °F) and held for 20 s at that temperature, and then fractured in tension. This specimen contained 0.024% P. Figure 150 (shown at 180 \times) indicates that the fracture followed an interdendritic path through regions that had not yet solidified at 1425 °C (2600 °F). The rounded dendrite surfaces thus exposed are obvious, and the only evidence of a torn surface is in a small area at extreme left. Figure 151, which is a higher-magnification view (900 \times) of the area within the rectangle in Fig. 150, shows patterns of what were confirmed by x-ray fluorescent analysis to have been, at the moment of fracture, liquid droplets of manganese oxysulfide on the dendrite surfaces. These patterns were the only evidence of segregation that was discovered within the fracture.

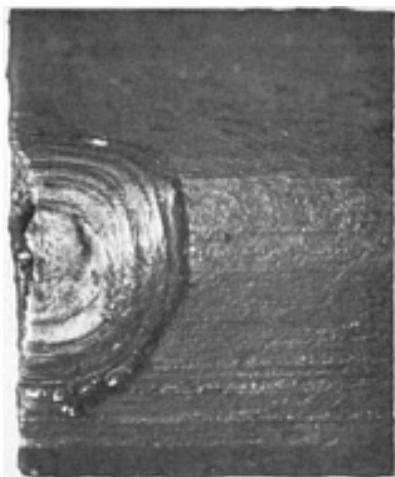
Fig. 169

Figure 169 is a view of the weld at arrow in Fig. 167. Note that the fracture (in profile at left) passes through the center of the weld. Figure 170 is a portion of the fracture surface at the weld, after polishing and etching (2% nital). A crack is visible (at arrow) at the tip of the cavity. Hardness was 187 HB in the base metal, 516 HB in the heat-affected zone, and 363 to 534 HB in the weld. Both at 5×

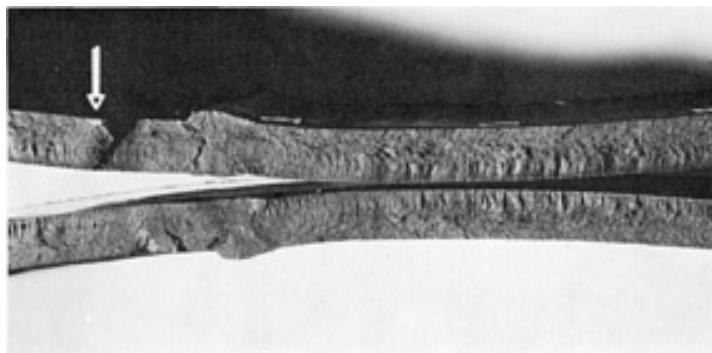
Fig. 171 Mating surface of a crack in a shell plate of an ASTM A515, grade 70, steel pressure vessel used in dehydration of natural gas. Normally, operating pressure was 1.5 MPa (220 psi) and operating temperature was -12 to +4 °C (10 to 40 °F). The crack was exposed by sectioning after a leak was discovered. See Fig. 172, 173, 174, 175, and 176 for views of the portion near arrow at left. 0.4×

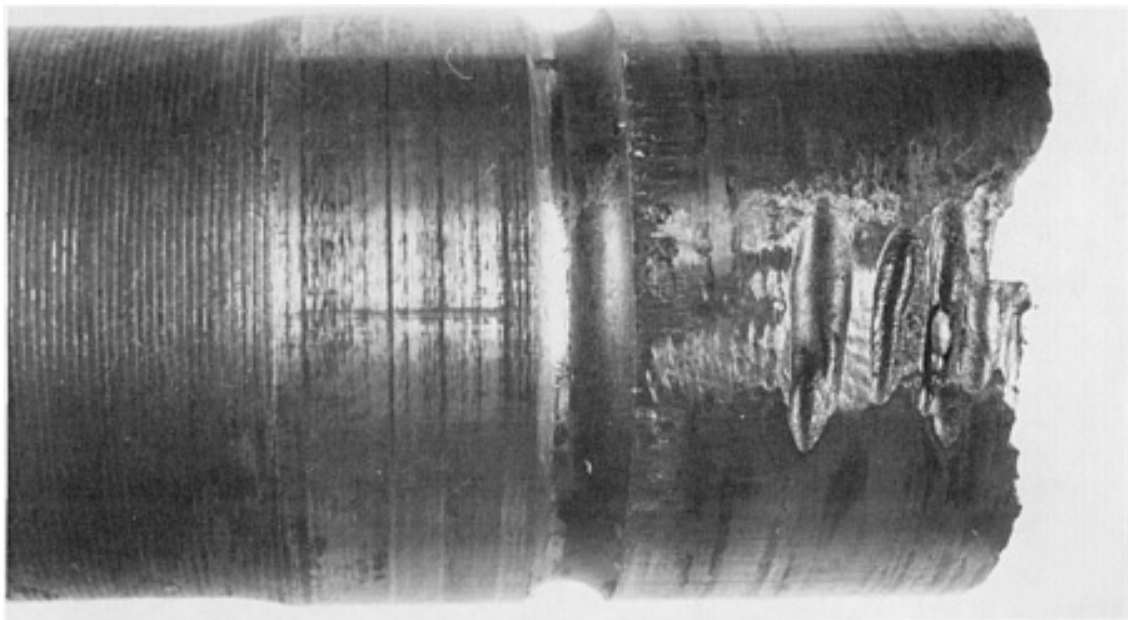
Fig. 192

Fatigue fracture of automotive axle shaft due to improper wheel bearing removal. Material: modified AISI 1038. Heat treatment: induction hardened and tempered to a surface hardness of 50 to 58 HRC. Replacement of a press-fit wheel bearing was accomplished with the aid of a cutting torch. Fatigue failure initiated in subsequent service at one of the pitlike defects created by the intense flame of the torch. Fig. 191: Fracture surface of axle shaft. Note extend of fatigue and relatively small final fracture area, indicating that operating loads were normal. Fig. 192: Axle surface with bearing removed (edge of fracture surface at right). Visible are several of the burn/melt defects caused by use of a cutting torch to assist in bearing removal. The procedure is not recommended. (Z. Flanders, Packer

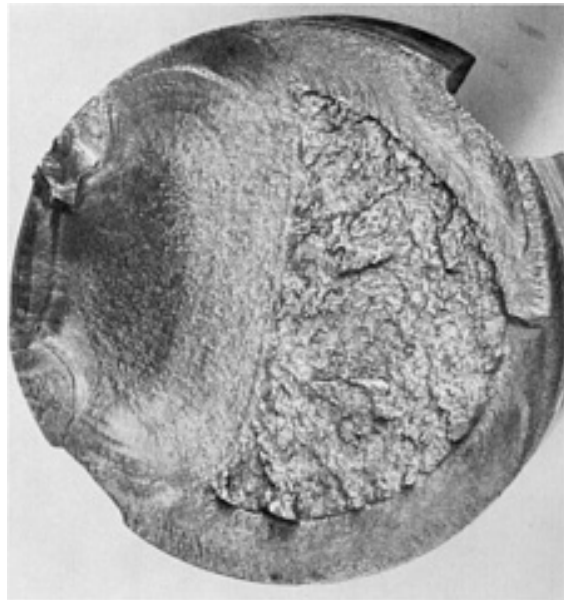
Fig. 200 Surface of a fatigue fracture in a keyed axle of AISI 1041 steel induction hardened to 50 HRC. An accidental arc strike on the axle surface, at left, initiated a fatigue crack, which grew about halfway through the cross section before fast fracture occurred in the hardened zone; fast fracture progressed from both sides of the fatigue crack, as shown by chevron marks. 1.3×

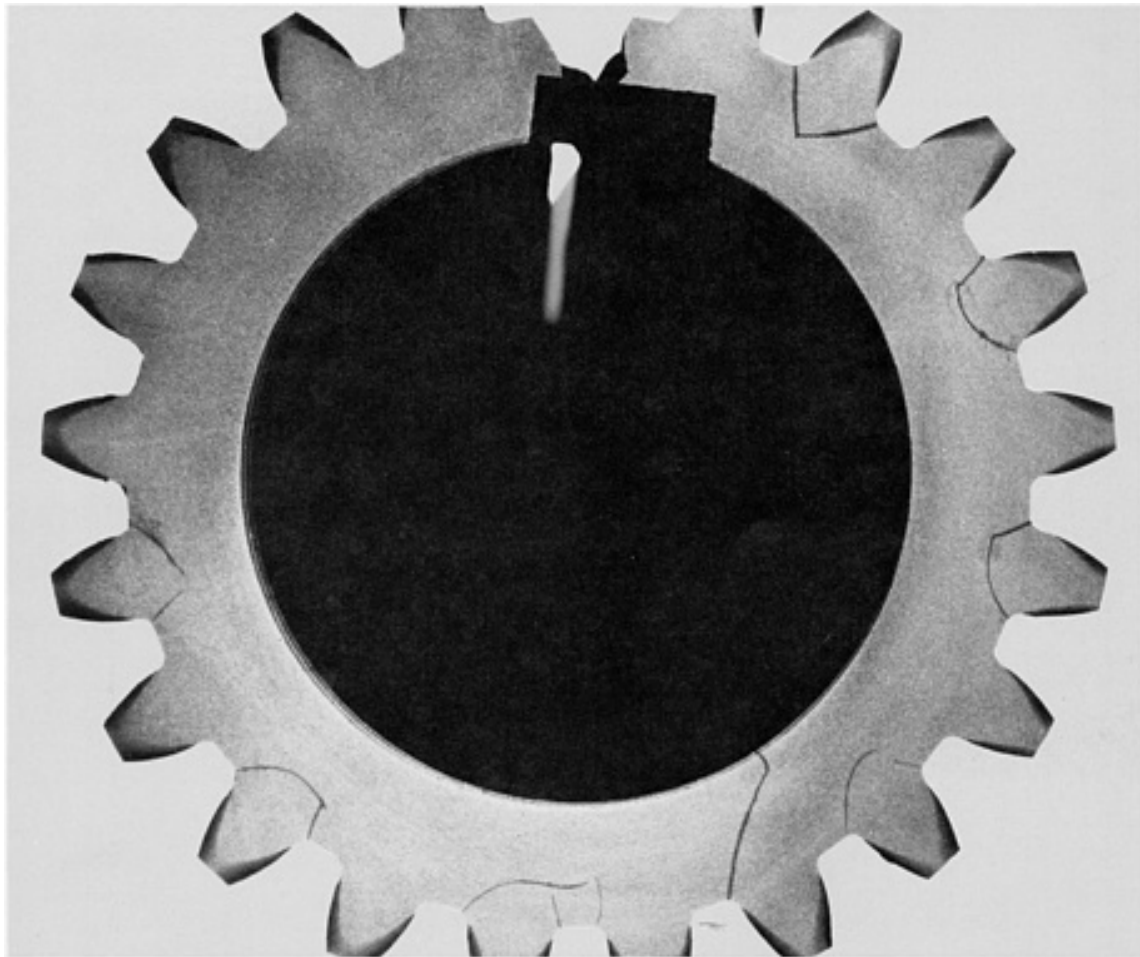
Fig. 211

Figure 211 is a polished and etched cross section of a partially flame-hardened crane gear of AISI 1045 steel in which fatigue cracks formed at the roots of many teeth after one year of service. The cracks have been sharply delineated by etching. Note that hardening did not extend even to the root fillet of any tooth. Figure 212 is a polished and etched cross section of a portion of a gear that was subjected to full-contour flame hardening; note the better tooth form, with fully radiused tooth roots. Both etched

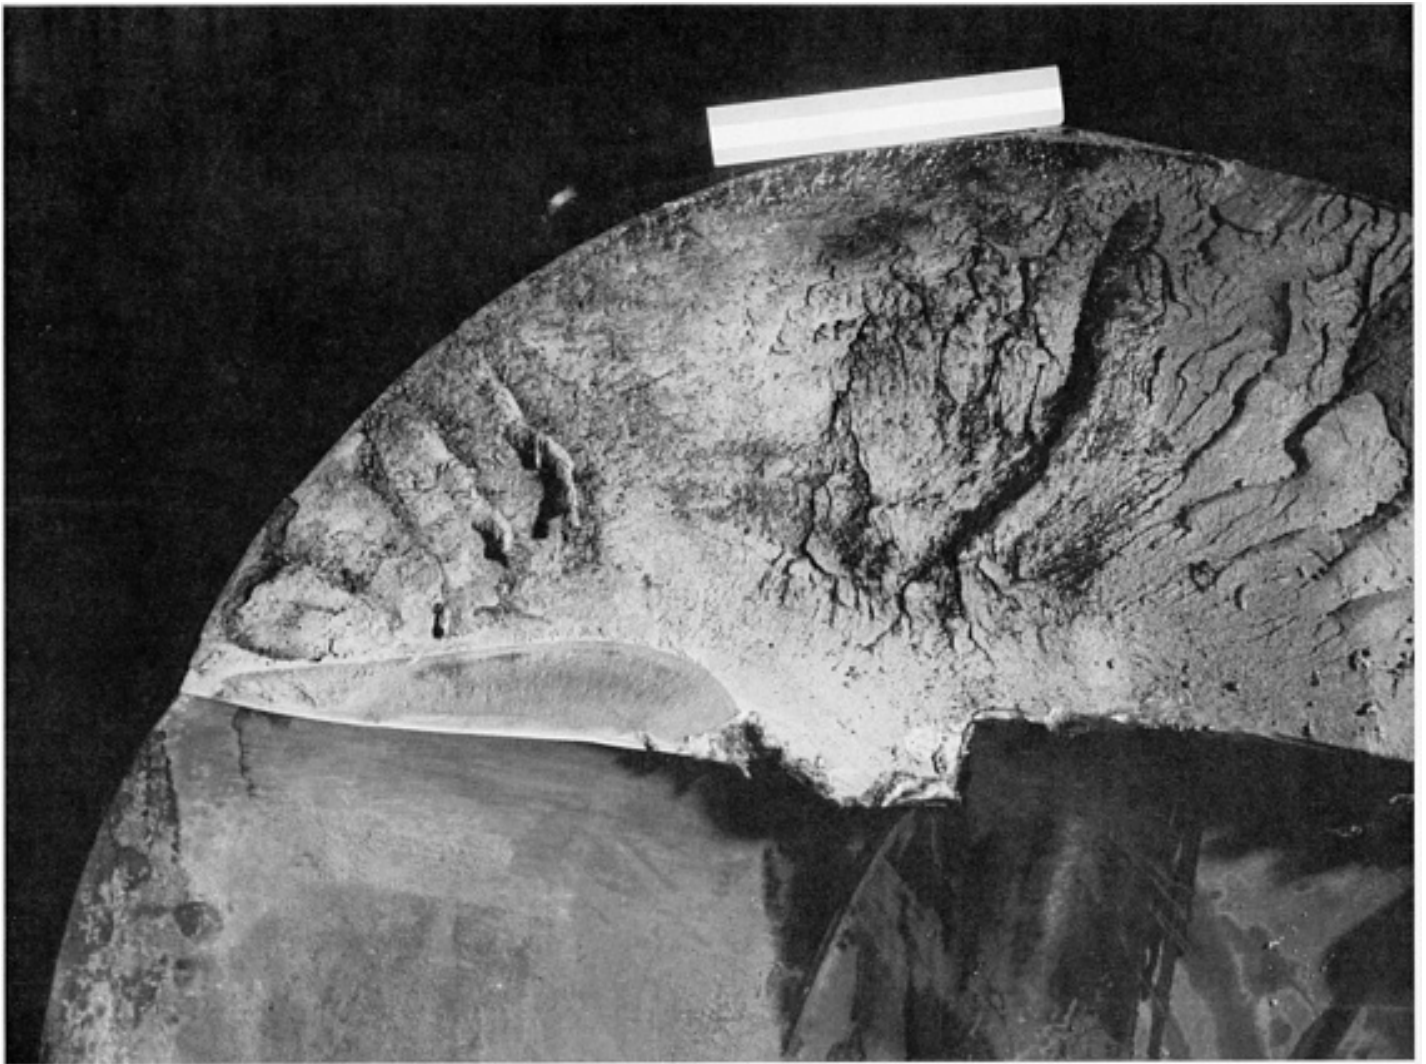
Fig. 213 Fracture surface in the jaw end of a blooming-mill spindle of forged AISI 1045 steel. This spindle was 8.2 m (27 ft) long, 890 mm (35 in.) in diameter at the jaw end, and 1065 mm (42 in.) in diameter at the drive end. The white 6-in. rule at top indicates the massive size of the spindle. After the spindle had been normalized, the inner surface of the jaw was flame hardened. The fracture originated at the jaw surface, at the lower edge of the fatigue zone (left of center). See also Fig. 214. 0.4×

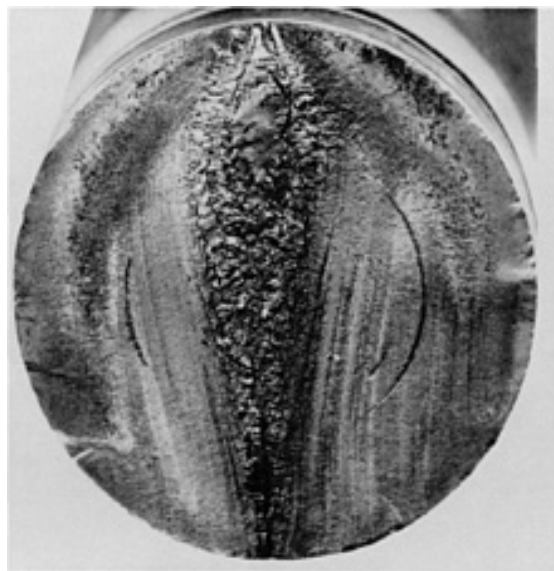
Fig. 217 Reversed bending fatigue of a 40-mm (1.6-in.) diam AISI 1046 steel shaft (30 HRC). Note the symmetrical fatigue pattern of beachmarks on each side, with the final rupture on the diameter. This indicates that each side of the shaft was subjected to the same maximum stress and to the same number of load applications. (D.J. Wulpi, Consultant)

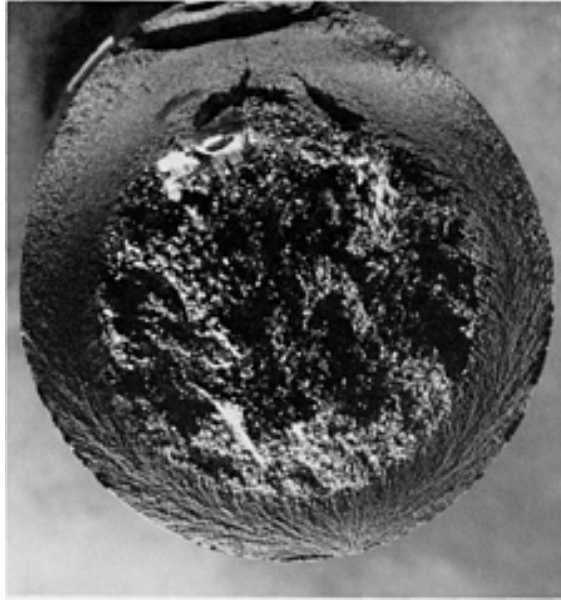
Fig. 220 Fracture surface of the modified SAE 1050 axle shaft shown in Fig. 221. Note chevrons pointing to fracture origin in the fine structured case. See also Fig. 222, 223, 224, 225, 226, and 227. 2.75×

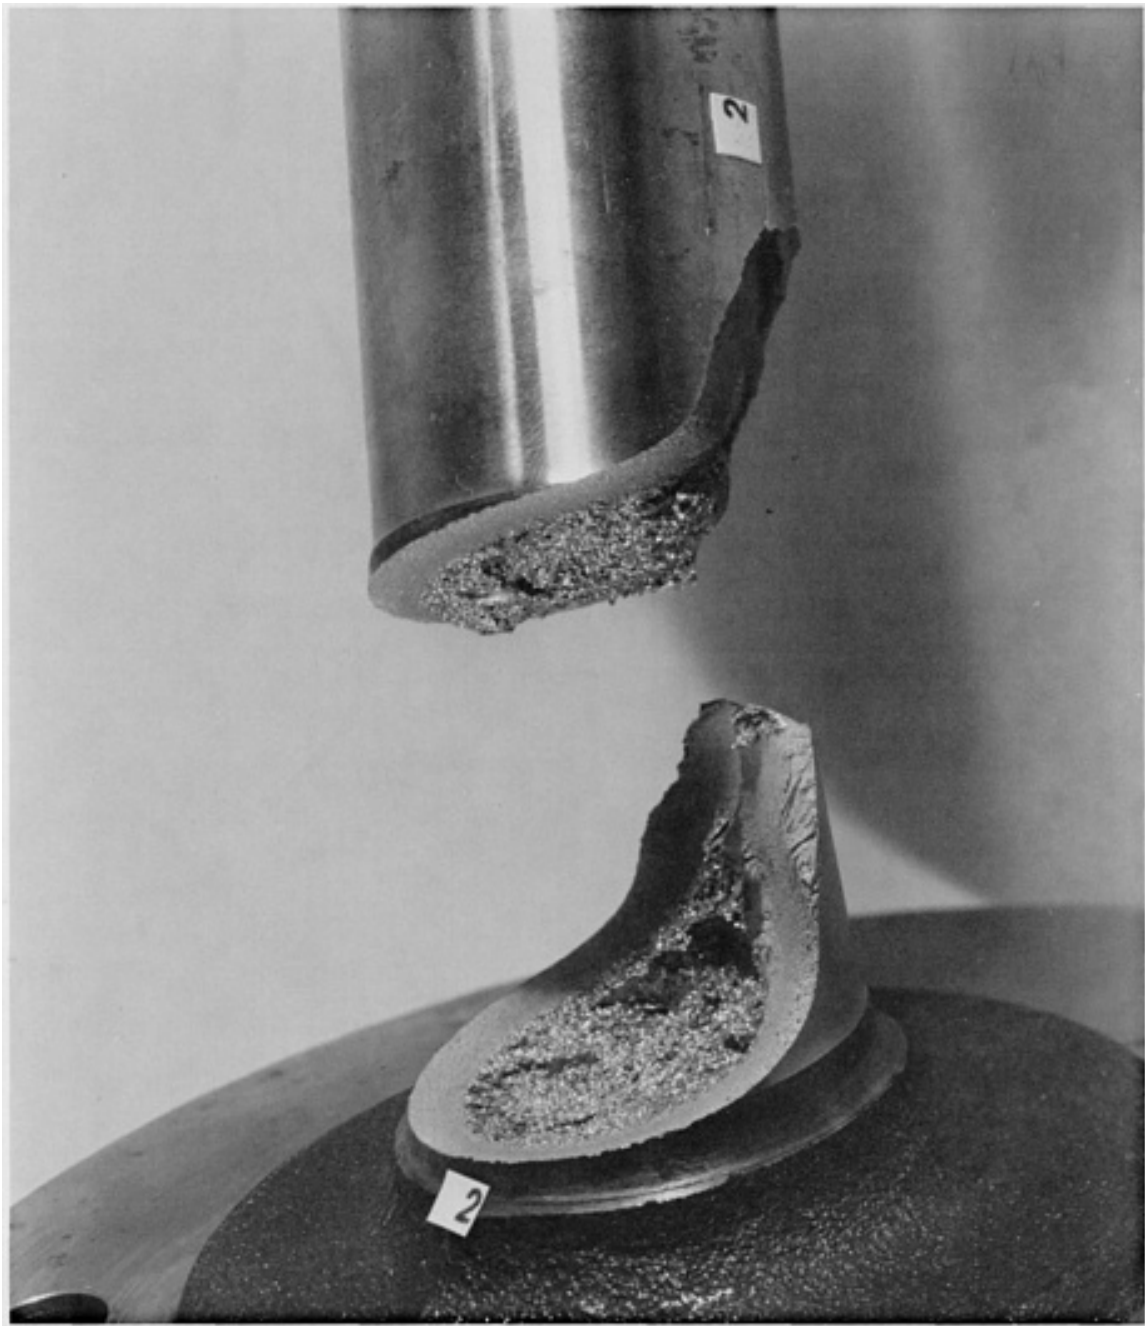
Fig. 221 Brittle fracture of a modified SAE 1050 axle shaft due to single bending impact load. Steel nominal composition: 0.50% C, 0.95% Mn, 0.25% Si, 0.01% S, and 0.01% P. The hot-rolled and upset shaft had an induction-hardened martensitic case (60 HRC) and a pearlite-ferrite core (20 HRC). Failure occurred at the flange end. Part was broken in the laboratory. Shown in this fractograph are the fracture surfaces, including a compression chip. See also Fig. 220, 222, 223, 224, 225, 226, and 227. Actual size (General Motors Research Laboratories)

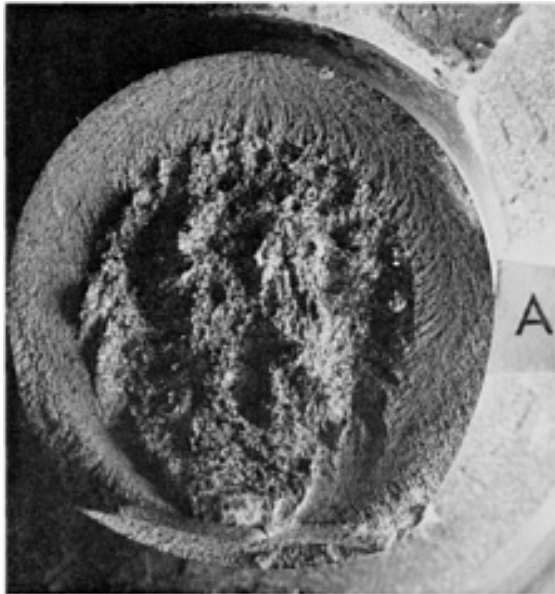
Fig. 228

Classic bending overload fracture of automotive axle shaft (direct-on bearing design). Material and heat treatment: modified AISI 1050, induction hardened and tempered to 60 HRC at the bearing diameter. The part was broken in the laboratory. Fig. 228: Fracture surface with chevrons in case-hardened zone pointing to single origin at top. Fine- and coarse-grained structures in case and core regions, respectively, indicate that heat treatment was properly performed. Fig. 229: Side view of fractured axle shaft in Fig. 228. (Z. Flanders, Packer Engineering Associates, Inc.)

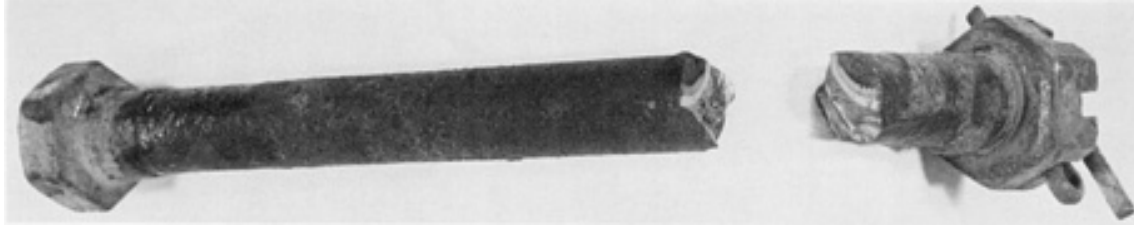
Fig. 235

Fatigue failure of a heat-treated automotive bolt (30 HRC). The medium-carbon steel part had been slightly bent prior to onset of fatigue. Fig. 235: Fractured bolt. 0.9 \times . Fig. 236 and 237: Matching fracture faces. 3 \times (General Motors Research Laboratories)

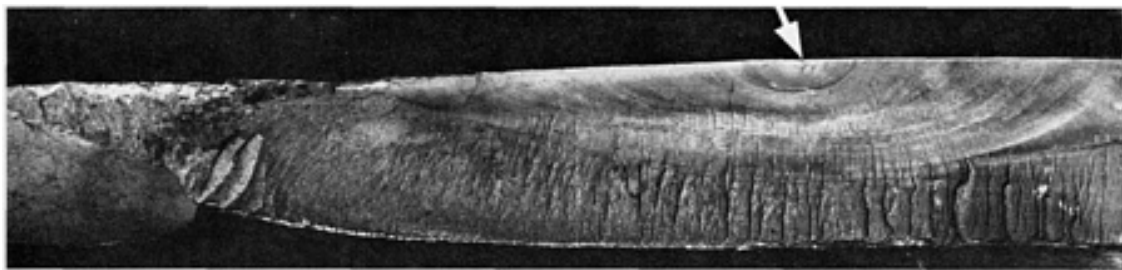
Fig. 245 Surface of a fatigue fracture that occurred, after 732 h of service, in a tooth of the induction-hardened AISI 1053 steel left-side bull gear of a tractor. Hardness of the tooth was 57 HRC at the tip and 50 HRC at a depth of 13.3 mm (0.52 in.). Hardness in the root fillet was approximately 56 HRC near the surface and 50 HRC at a depth of 11.5 mm (0.45 in.). The arrow indicates the origin of the fatigue crack. See also Fig. 246, 247, and 248. $\sim 2.5\times$

Fig. 246 Surface of a fatigue fracture (similar to that in Fig. 245) that occurred, after 841 h of service, in a tooth of the right-side bull gear of the same tractor. This gear also was made of AISI 1053 steel and induction hardened. Hardness of this gear was similar to that of the gear in Fig. 245 except that the depths at which hardness was 50 HRC were 12.2 mm (0.48 in.) below the tip of the tooth and 9.5 mm (0.37 in.) below the surface of the root fillet. The arrow indicates the fatigue-crack origin. The damage to the tooth just below the one that fractured probably resulted from jamming by a fragment from the fracture. $\sim 2.5\times$

Fig. 247 Area of the fracture surface of the left-side bull gear in Fig. 245, taken near the fatigue-crack origin. Visible are several inclusions believed to have contributed to the formation of the fatigue crack. See also Fig.

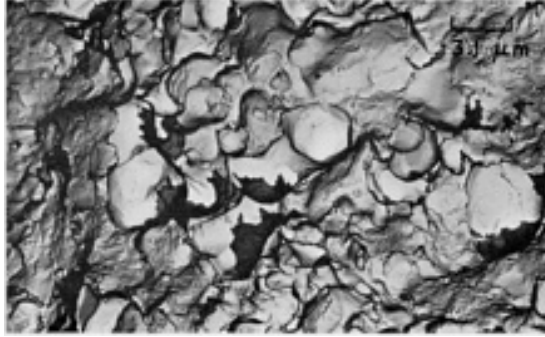
Fig. 248 Portion of the area in Fig. 247, but at higher magnification, showing the inclusions more clearly. Similar inclusions were found near the crack origin in the fracture surface of the right-side bull gear in Fig. 246. TEM p-c replica, 3200×

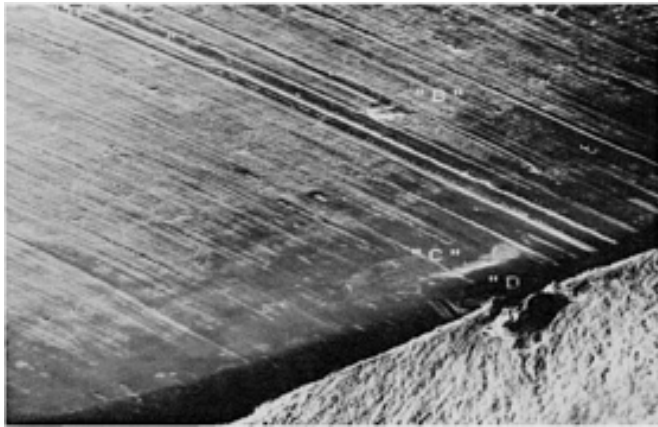
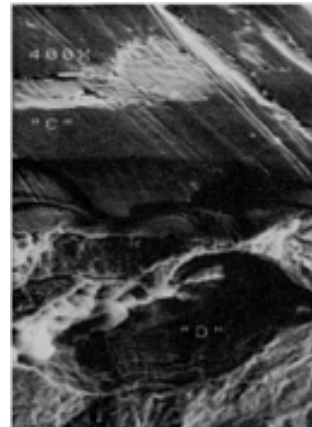
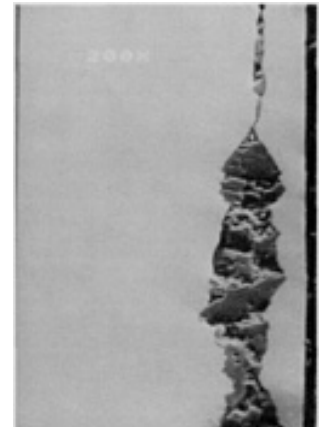
Fracture of power spring made of tempered AISI 1074. Initially, a "scab" or some other type of mechanical damage was suspected as the cause of failure because of the surface appearance of the steel. However, SEM examination revealed that fracture was due to a large nonmetallic inclusion (probably alumina, type B) located within 6 to 13 μm (0.25 to 0.50 mils) of the surface. Fig. 283: Surface of fractured power spring and portion of fracture area showing origin. Note surface damage near "C" and prominent feature, "D," at edge near fracture origin. SEM, 50×. Fig. 284: Close-up of feature at fracture edge in Fig. 283 reveals the subsurface inclusion at "D" and its effects on surface appearance ("C"). SEM, 400×. Fig. 285: Longitudinal microsection near origin. SEM, 200× (J.H. Maker, Associated Spring, Barnes Group Inc.)

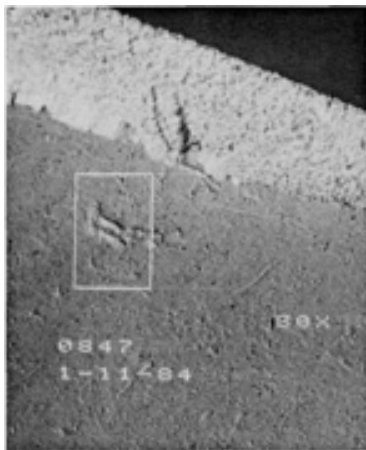
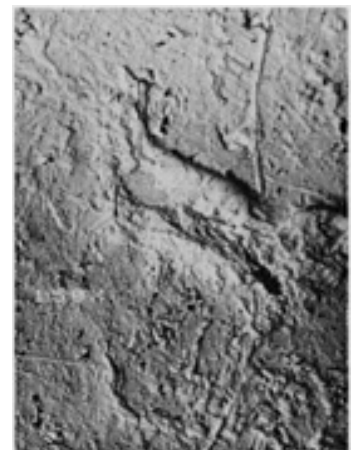
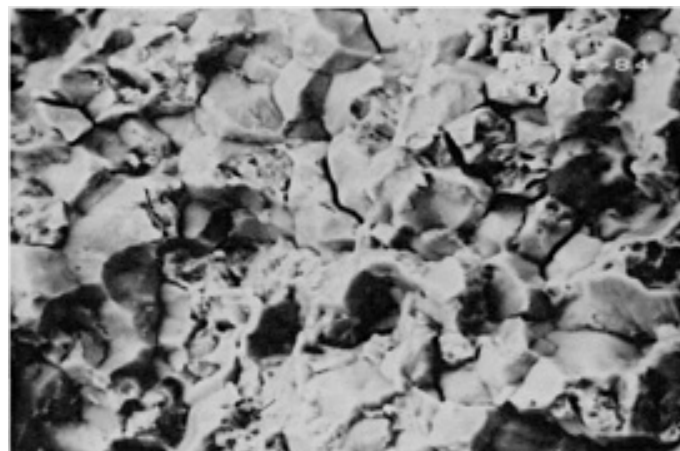
Hydrogen embrittlement fracture of AISI 1074 part. The part was formed in the annealed condition, quenched and tempered to 48 HRC, and then electroplated. A surface imperfection in the steel was initially thought to have played a key role in the fracture. However, SEM examination revealed an intergranular fracture mode indicative of hydrogen embrittlement due, in this case, to insufficient postplate baking. Fig. 286: Fractured part after stripping of electroplated coating. Note surface imperfection (boxed) near edge. SEM, 30× Fig. 287: Close-up of boxed area in Fig. 286. SEM, 150×. Fig. 288: High-magnification view of fracture surface reveals that part actually failed intergranularly due to hydrogen embrittlement. Note secondary cracking. SEM, 1500× (J.H. Maker, Associated Spring, Barnes Group Inc.)

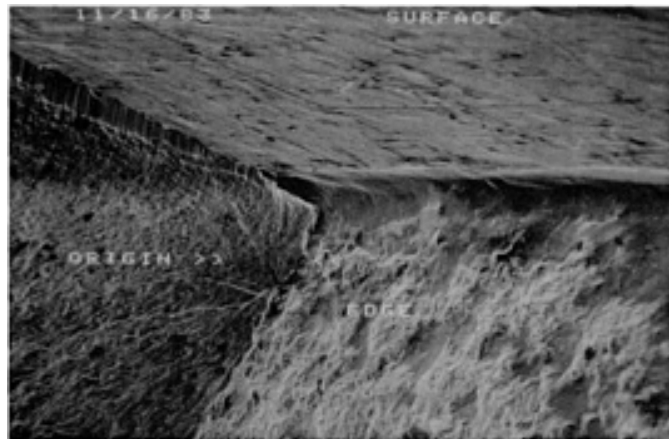
Fig. 291 Fatigue failure of flat, cantilever-type AISI 1070 spring due to inadequate removal of blanking fracture. Failure initiated at a point on the edge of the spring. SEM, 100× (J.H. Maker, Associated Spring, Barnes Group Inc.)

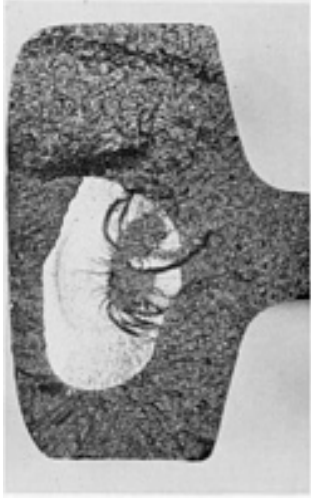
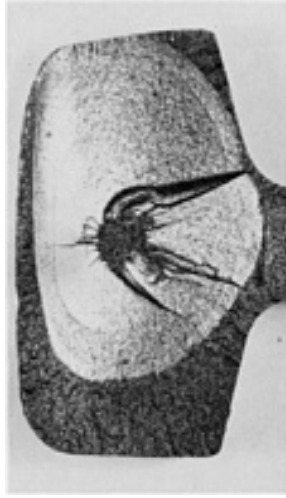
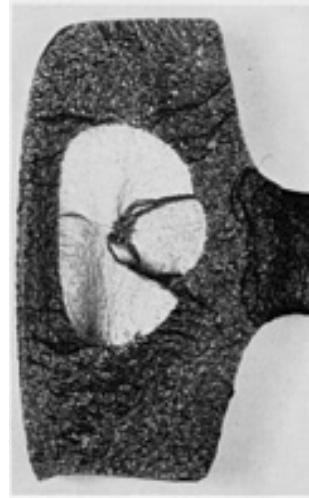
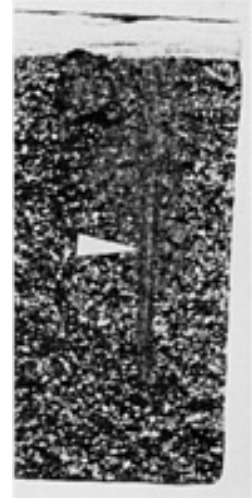
Figure 292, 293, and 294 show surfaces of "transverse fissures" that occurred in the heads of AREA 59-kg (131-lb) railroad rails made of AISI 1075 steel. All three fissures were caused by the presence of hydrogen-induced flakes (or "fisheyes"), which appear as dark gray areas within the bright zones. These bright zones are fatigue cracks that were initiated by the flakes. Beach marks are visible in the fatigue zones, particularly near the initiations of final fast fracture. Figure 295 shows the surface of a longitudinal fracture in an AREA 59-kg (131-lb) rail of AISI 1075 steel that had been hydrogen embrittled. That white arrowhead points to an unusually large nonmetallic stringer that acted as a site for hydrogen segregation. All shown at actual size

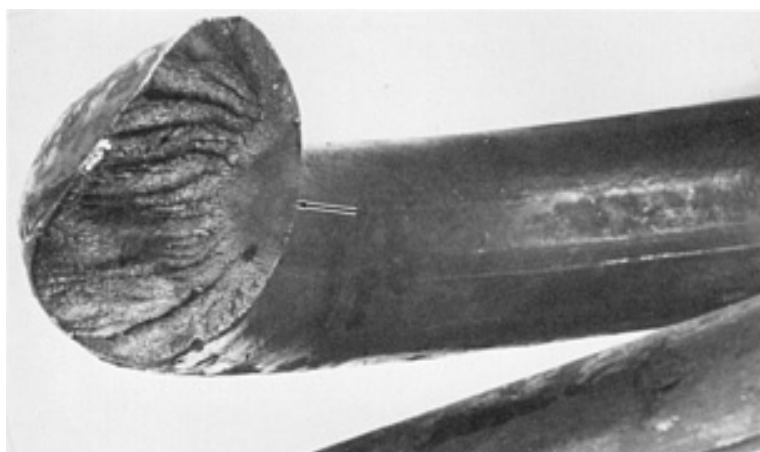
Fig. 306 Surface of a fatigue fracture, which occurred after about 1 year of service, in an AISI 1095 steel

spring of a 225-Mg (250-ton) shear. A fatigue zone is evident at the inner (right) edge of the fracture surface (at arrow). This is a normal location for a fatigue-crack origin in a coiled spring, and the fracture may be rated as typical. The fatigue crack penetrated a distance of approximately 13 mm ($\frac{1}{2}$ in.) into the spring before final fast fracture occurred. See also Fig. 307. Actual size

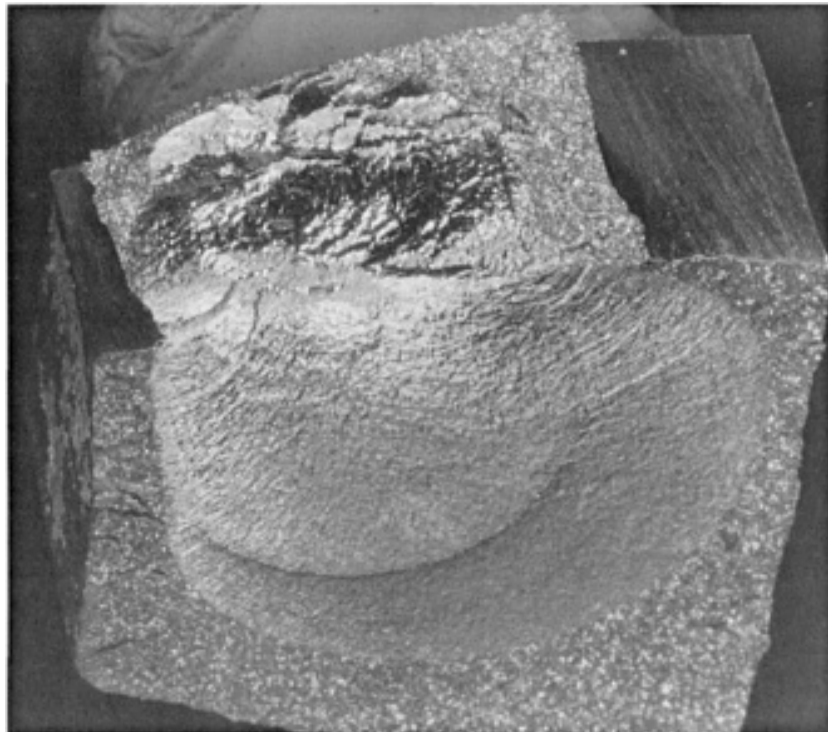
Fig. 308 Deep "shell crack" and "detail fracture" in head of railroad rail removed from service. Composition of standard carbon rail steel: 0.60 to 0.82% C, 0.70 to 1.00% Mn, and 0.10 to 0.23% Si. Gage side of rail is at left. A 5- to 10-mm ($\frac{1}{4}$ - to $\frac{3}{8}$ -in.) thick layer has been removed from the running surface to expose the shell crack (top). Deep shells such as this one typically nucleate at stringers or microinclusions and propagate approximately parallel to the running surface. Some shells form a branch crack, or detail fracture, in the transverse plane (lower portion of figure) that can cause a service break if not detected in time. Detail fractures typically have featureless crack propagation surfaces, but may exhibit beach marks (as in this example) that reflect the traffic pattern or temperature (thermal stress) changes during service. See also Fig. 309 and 310.

Detail fracture (see Fig. 308) in head of railroad rail that had been removed from revenue track and installed in test track to determine crack growth rate under heavy train traffic. Material: high-carbon rail steel (0.69 to 0.82% C.). Fig. 309: Featureless region inside contour 1 outlines crack at time of removal from service. Contours 1 through 9 and the unlabeled contours that follow identify crack propagation steps during testing. Contours separate inclined ridges that result from the unique traffic pattern on the test track. The detail fracture grew in fatigue to 80% of rail head area before breaking under the test train. 2.4×. Fig. 310: Longitudinal section along diagonal line in Fig. 309. Contours 1 through 9 are identified. Note ridge structure of crack surface that results from combined stage I and stage II fatigue crack propagation. The less prominent, horizontal ridges in Fig. 309 result from combined stage I/stage III propagation. 13× (J.M. Morris, U.S. Department of Transportation)
