ASM HANDBOOK®

VOLUME
12

Fractography

Fractography, was published in 1987 as Volume 12 of the *ASM Handbook*. The Volume was prepared under the direction of the ASM Handbook Committee.

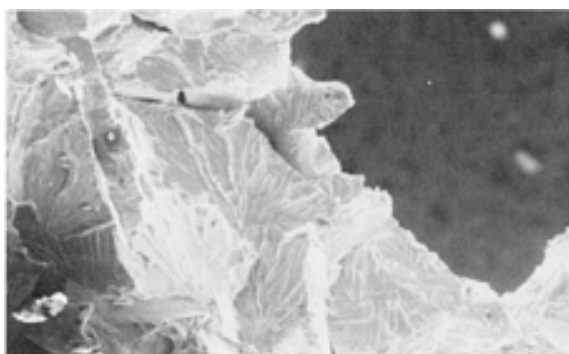
Fig. 321

Brittle fractures of AISI 4130 hitch post shafts due to thermal stresses from welding imposed on an improperly heat-treated region. The tapered shaft had a maximum diameter of about 305 mm (12 in.) and a length of approximately 1 m (40 in.). It was forged, rough machined, heat treated--845 °C (1550 °F), water quench, temper at 595 °C (1100 °F)--and a small bracket was welded to the larger diameter end. Fracture occurred after a short time in service or, in some cases, immediately after welding. Cause: Incomplete austenitization left a coarse structure at the shaft center characterized by a high residual stress level and low ductility. Thermal stresses accompanying welding initiated brittle cracks in this region, which then propagated to the surface. Fig. 320: Transverse section of field failure. Fig. 321: Fracture surface near center

of shaft. Failure mode is brittle fracture. Note river patterns. SEM, 100 \times . Fig. 322: Fractograph of near-surface region of shaft. Failure mode: dimple rupture. SEM, 100 \times (R.W. Bohl, University of Illinois)

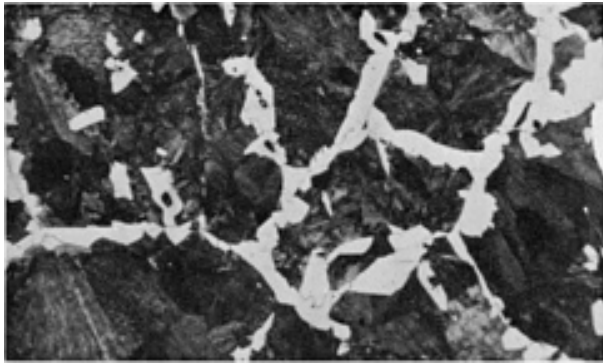
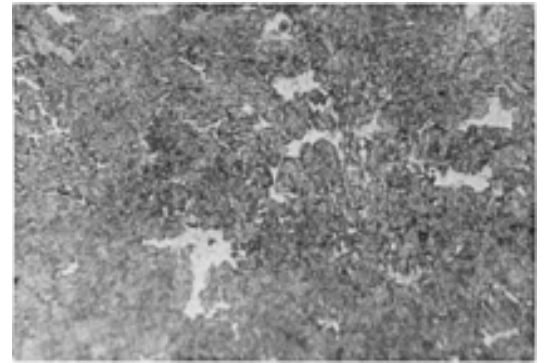
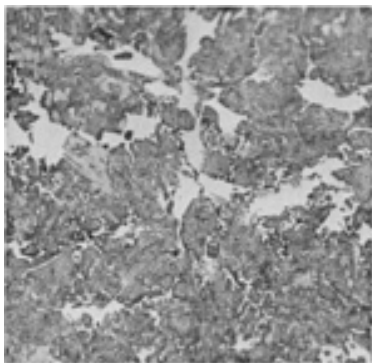
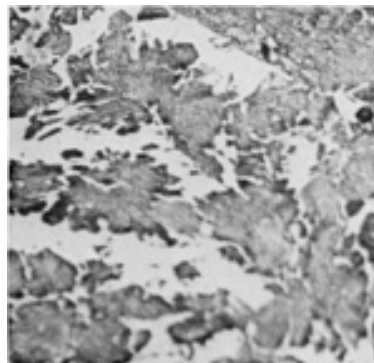
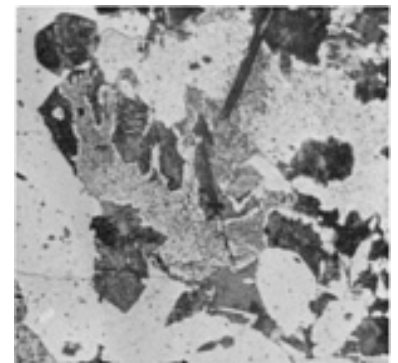
Metallographic study of hitch post shaft failure in Fig. 320, 321, and 322. All etched in 2% nital. Fig. 323: Coarse, as-forged structure of AISI 4130 shaft. 100 \times . Fig. 324, 325, 326, and 327: Microstructures at increasing depths beneath surface of fractured shaft. Gradual coarsening is evidence of superficial austenitization. Fig. 324: 4 mm (0.15 in.). 150 \times . Fig. 325: 11 mm (0.45 in.). 150 \times . Fig. 326: 30 mm (1.2 in.). 150 \times . Fig. 327: 75 mm (3 in.). 225 \times (R.W. Bohl, University of Illinois)

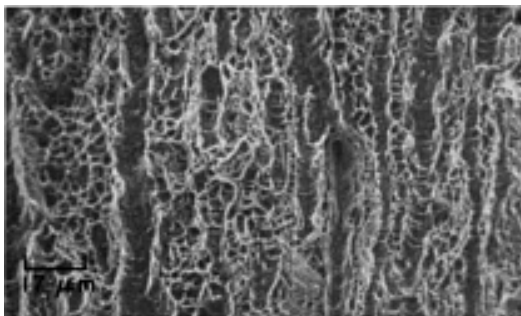
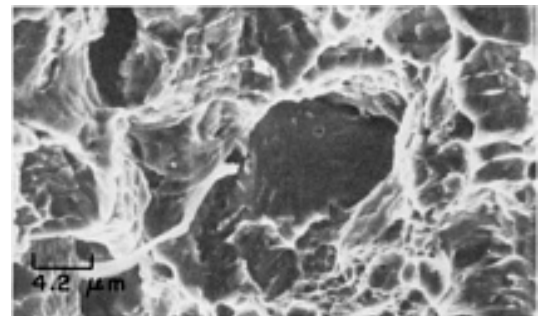
Two SEM views, at different magnifications, of the surface of a fracture in a specimen of AISI 4130 steel that was austenitized at 845 °C (1550 °F), oil quenched, and tempered for 2 h at 250 °C (480 °F). The fracture was produced in a toughness test in air; the rate of crack growth was in the range of rapid, unstable fracture. Dimples in an extremely wide variety of sizes and channels formed by linear coalescence of voids are evident. See Fig. 330, 331, 332, 333, 334, and 335 for the fracture behavior of this material when tested in a hydrogen atmosphere. Fig. 328: 600 \times . Fig. 329: 2400 \times

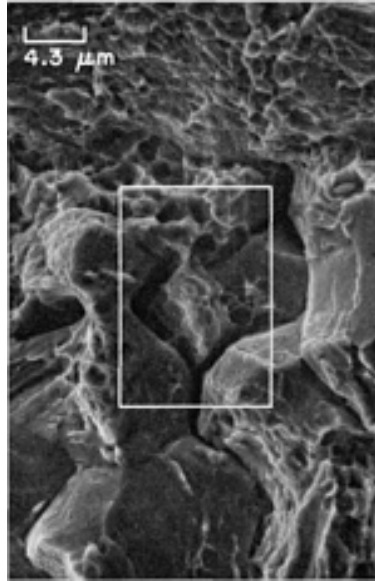
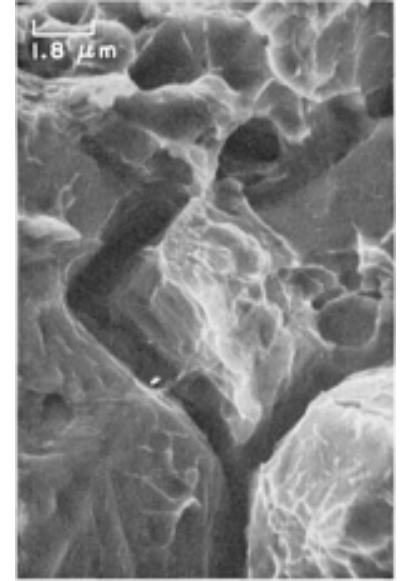
Fracture surfaces of two specimens of AISI 4130 steel that were given the same heat treatment as described in Fig. 328 and 329. The specimen shown in Fig. 330 was tested in 1 atm of hydrogen at 25 °C (75 °F); the specimen shown Fig. 331 and Fig. 332 was tested in 1 atm of hydrogen at 80 °C (175 °F). Note that the area within the rectangle in Fig. 331 is shown at higher magnification in Fig. 332. In contrast to those in Fig. 328 and 329, these fracture surfaces show completely intergranular fractures with deep secondary cracks between the grains. The fracture in Fig. 331 and 332 also shows a considerable number of dimples that were formed by microvoid coalescence. See Fig. 333, 334, and 335 for the fracture behavior of this material in an atmosphere of partially dissociated hydrogen. Fig. 330: SEM, 1000×. Fig. 331: SEM, 2350×. Fig. 332: SEM, 5600×

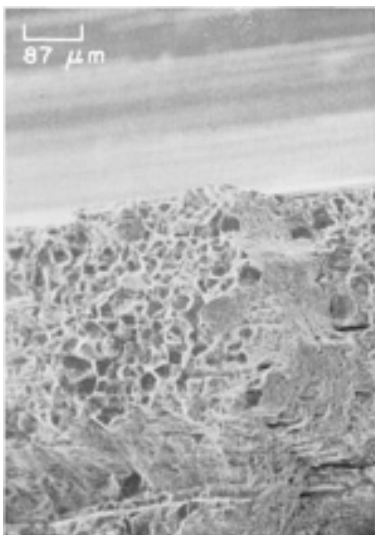
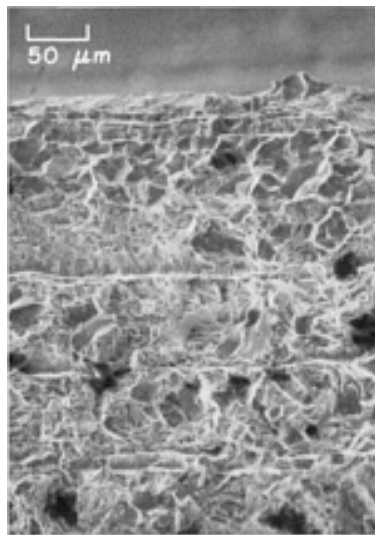
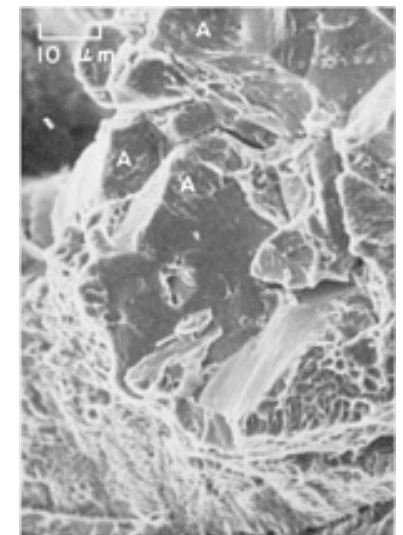
Three SEM views, at different magnifications, of the surface of a fracture in a specimen of the same steel and heat treatment as in Fig. 328, 329, 330, 331, and 332, tested for stable crack-growth rate in 0.1 atm of partially dissociated hydrogen at 80 °C (175 °F). Similar to the fracture in Fig. 331 and 332, this fracture shows facets of intergranular rupture intermingled with areas of dimples. The bottom of the notch in the specimen is visible at top in Fig. 333 and Fig. 334. The horizontal marks in the fracture surface parallel with the notch could be indications of temporary arrests of crack penetration. The hairline indications (marked A) visible in Fig. 335 are fine tear ridges typical of hydrogen embrittlement. Fig. 333: 115×. Fig. 334: 200×. Fig. 335: 1000×

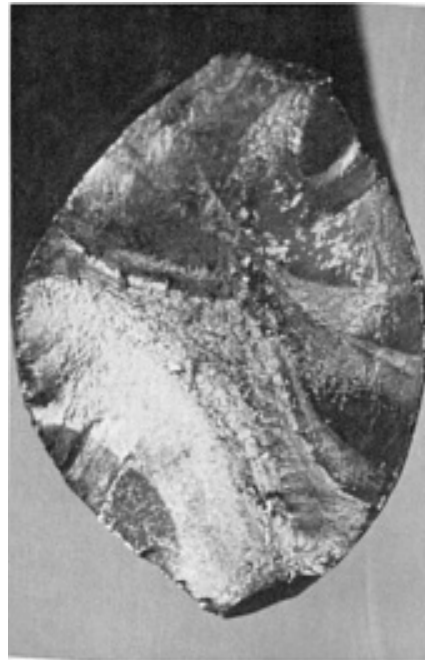
Fig. 341 Surface of a fatigue fracture in a suspension component of AISI 4140 steel heat treated to a hardness of 273 HB. Two fatigue zones are evident, at lower left and at upper right; the remainder of the fracture surface is the zone of final fast fracture. 5×

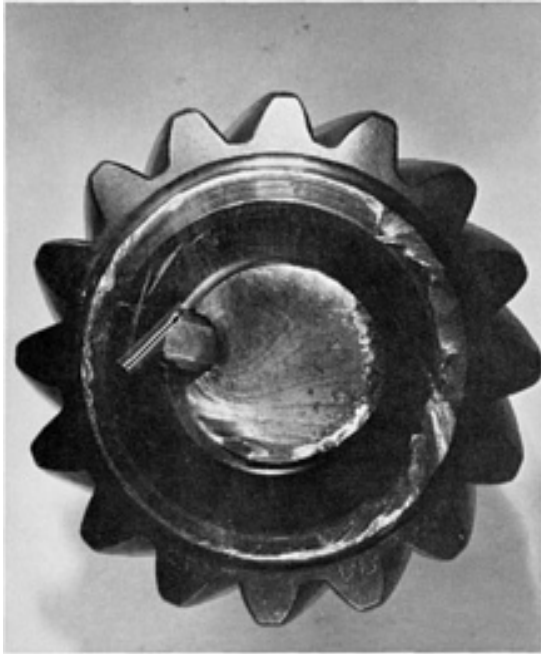
Fig. 345

Two views of a surface of the fatigue fracture in the tail-rotor drive-pinion shaft in Fig. 342, taken with the key and the pinion gear in place. The fatigue-crack origin (arrows) is in the keyway, slightly to the right of the corner formed by the edge of the keyway and the outside surface of the shaft. Not visible here are deep tool marks and machining tears on the inside of the keyway, which were the sources of the stress concentrations responsible for initiation of the fatigue crack. The smooth fracture surface shown in these views is typical of those produced by high-cycle fatigue in combined bending and torsion. Fig. 345: 2 \times . Fig. 346: 10 \times

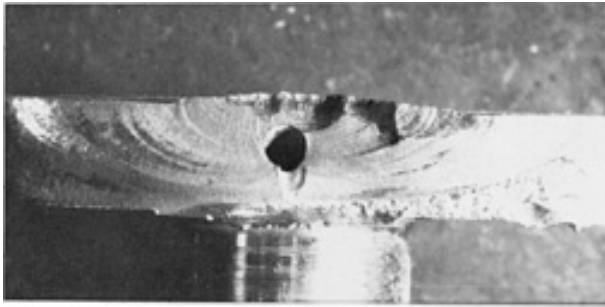
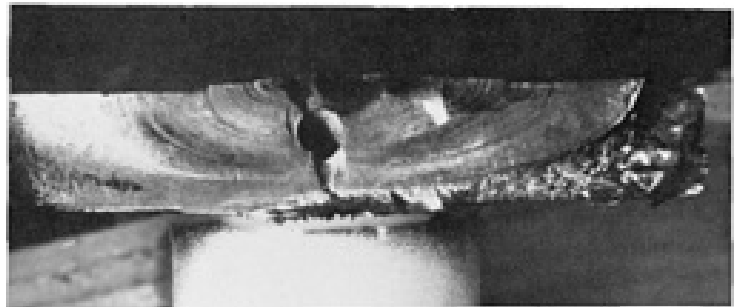
Fig. 349

Figure 349 is a view of the surface of the fracture in Fig. 348, showing several small crack nuclei above the oil hole. Fatigue cracks from these nuclei merged to form a single crack front, which nearly penetrated the entire cross section of the throw before final fast fracture occurred. Figure 350 is another view of the surface of the fracture in Fig. 348, photographed using illumination that reveals more of the details of the area of final fast fracture than does Fig. 349. The fatigue crack was initiated at a bottom fillet of the No. 2 main-bearing journal, which was chromium plated. Fig. 349: $\sim 1.7\times$. Fig. 350: $\sim 1.3\times$

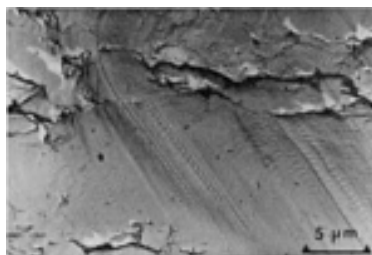
Fig. 356 Tire tracks on fatigue fracture surface of AISI 4140 quenched and tempered at 700 $^{\circ}\text{C}$ (1290 $^{\circ}\text{F}$). This feature is unique to fatigue fractures and is frequently observed in cases where crack propagation rate was high and few or no striations formed (as in low-cycle fatigue). In these instances, tire tracks represent valuable evidence that fatigue was indeed the operative failure mode. TEM replica, 2080 \times (I. Le May, Metallurgical Consulting Services Ltd.)

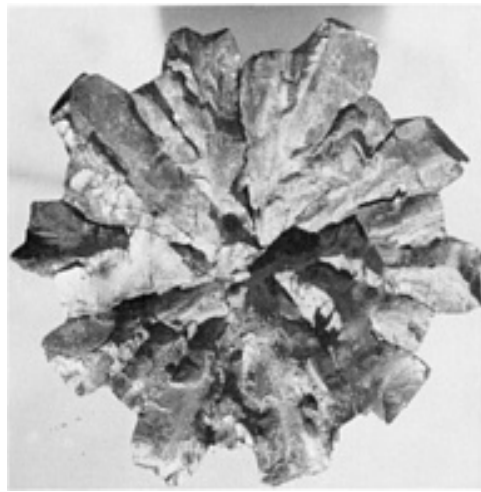
Fig. 372

Figure 372 shows a fractured AISI 4150 steel splined shaft heat treated to a hardness of 43 HRC. Note that there is a secondary transverse crack below the main fracture. Figure 373 is a view of one surface of the fracture in Fig. 372, showing a very complicated starlike pattern. Close examination of the many arms of the "star" reveals the presence of fatigue beach marks produced by crack fronts that propagated separately but simultaneously. Particularly evident are the beach marks on the arms at bottom, which are shown at higher magnification in Fig. 374. Sharp radii at the bases of the spline appear to have been the origins of the fatigue cracks. Fig. 372: 0.5 \times . Fig. 373: 1.5 \times . Fig. 374: 3.5 \times

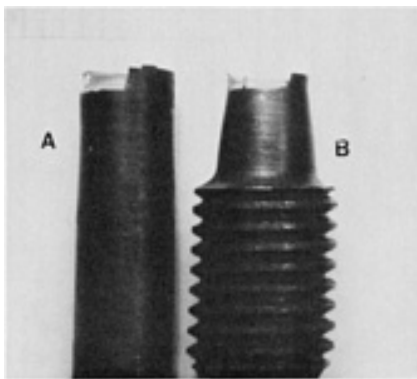
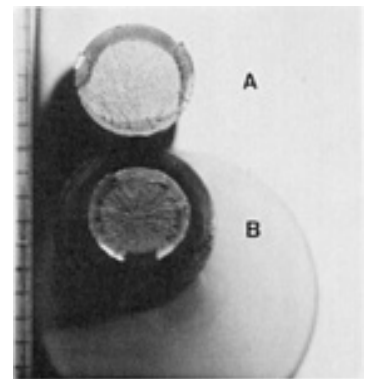
How hydrogen damage affects fracture in AISI 4340. Shown are side views (Fig. 378) and fracture surfaces (Fig. 379) of 13-mm (0.505-in.) diam tensile specimens. Specimen A was tempered at 400 °C (750 °F) for 114 min in argon. Note specimen B's more ductile behavior in the tensile test. See also Fig. 380, 381, 382, 383, and 384. Both at actual size (S. Harding and S.W. Stafford, University of Texas)

Fractographic analysis of AISI 4340 specimen tempered in hydrogen (specimen A) in Fig. 378 and 379. Fig. 380: Fracture surface showing region of ductile crack growth and crack initiation site (A), region of rapid crack growth indicated by presence of radial lines (B), a shear lip (C), and the direction of crack propagation in the region of rapid crack growth (arrow D). 2.5 \times . Fig. 381: Fractograph of region of subsurface crack initiation (B in Fig. 380). Note large transgranular crack and very small dimples. SEM, 550 \times . Fig. 382: Fractograph reveals predominantly cleavage (transgranular) rupture (facet indicated by arrow) in hydrogen-embrittled specimen of AISI 4340. SEM, 220 \times (S. Harding and S.W. Stafford, University of Texas)

Fractographic analysis of AISI 4340 specimen tempered in argon (specimen B in Fig. 378 and 379). Fig. 383: Fracture surface showing an area of microvoid coalescence and crack initiation at the central fibrous zone (A), radial lines emanating from the center and indicating rapid crack growth (B), and a shear lip (C). This was a typical cup-and-cone fracture. 3 \times . Fig. 384: Fractograph reveals equiaxed dimples characteristic of ductile fracture in tension. 224 \times (S. Harding and S.W. Stafford, University of Texas)

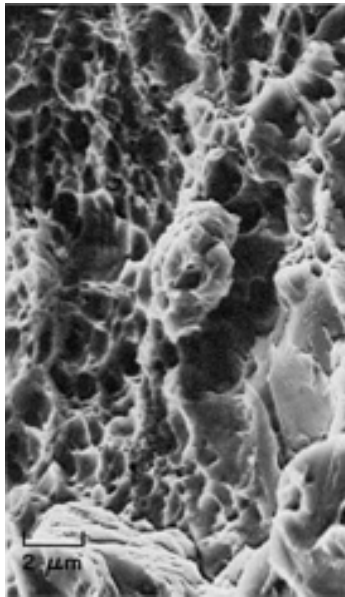
Fig. 390 Higher-magnification view of the area within the rectangle in Fig. 389, showing more distinctly that the dimples are present in a wide variety of sizes. SEM, 5000×

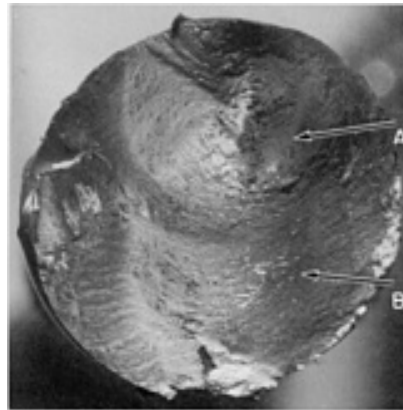
Fig. 394 Torsion-overload fracture in AISI 4340 steel oil quenched from 845 °C (1550 °F) and tempered at 635 °C (1175 °F) to a tensile strength of 931 MPa (135 ksi). In general, the fracture surface is flat and shiny. See Fig. 395 and 396 for TEM views of areas A and B.

Fig. 395 TEM p-c replica of an area near letter A (in region of final rupture) in the torsion-overload fracture shown in Fig. 394, showing dimples, some of which are slightly elongated but many of which are essentially equiaxed. 6500×

Fig. 396 TEM p-c replica of an area near letter B in Fig. 394. The flat and noticeably elongated shear dimples present here are to be expected in this region, which in Fig. 394 (at lower magnification) shows an appreciable amount of torsional deformation. 6500×

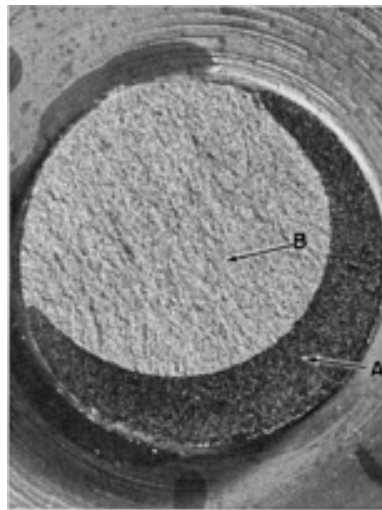
Fig. 397 Impact fracture in AISI 4340 steel machined to a 50-mm (2-in.) diam, 38-mm ($1\frac{1}{2}$ -in) long cylinder with a 13-mm ($\frac{1}{2}$ -in.) diam, 25-mm (1-in.) long central projection from one end. Specimen was heat treated 45 min at 815 °C (1500 °F) and water quenched, but not tempered; then projection was broken by hammer blow. The dark crescent (A) is a quench crack, light area (B) is the impact fracture. See also Fig. 398, 399, 400, 401, and 402. 5×

Fig. 398 TEM p-c replica taken from area A (the quench-crack crescent) in the impact fracture surface shown in Fig. 397. Here, the crack is completely intergranular in nature, having faithfully followed the grain interfaces. Traces of oxidation are evident. See also Fig. 399 and 400. 6500×

Fig. 399 TEM p-c replica from a different region in area A (the quench-crack crescent) in the fracture surface shown in Fig. 397. Here, as well as in Fig. 398, the crack path has been along the grain interfaces. Scattered marks here resemble the hairline indications associated with either hydrogen embrittlement or stress-corrosion cracking. 6500×

Fig. 400 TEM p-c replica taken near the root of the quench crack, marked A, in Fig. 397. In addition to separated-grain facets, localized regions of transgranular tearing are visible. The grain facets are clean of oxidation, although they display a few hairline indications. 6500×

Fig. 401 TEM p-c replica taken at the root of the quench crack, marked A, in Fig. 397, and the beginning of the impact fracture, marked B there. At left are the last vestiges of intergranular cracking, and at right is the beginning of quasi-cleavage cracking in this very brittle specimen. 6500×

Fig. 402 TEM p-c replica from deep within the impact fracture area, B, in Fig. 397, showing the quasi-cleavage characteristics of this brittle, untempered specimen. No large facets are visible; this suggests that the specimen had a fine grain size. Many steps exist in the crack path. 6500×

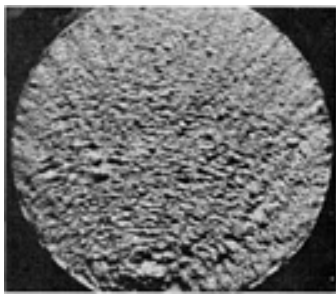
Shown above are fracture surfaces of three notched tensile-test specimens prepared from AISI 4340 steel that had been austenitized, quenched, and tempered at $315\text{ }^{\circ}\text{C}$ ($600\text{ }^{\circ}\text{F}$) to provide the following room-temperature properties: yield strength, 1558 MPa (226 ksi); unnotched tensile strength, 1758 MPa (255 ksi); notched tensile strength, 1765 MPa (256 ksi). The specimens were broken by tension overload at the temperature indicated beneath the fractographs. The fracture surface shown in Fig. 432 is completely fibrous. Lowering the test temperature from $180\text{ }^{\circ}\text{C}$ ($356\text{ }^{\circ}\text{F}$) to $90\text{ }^{\circ}\text{C}$ ($194\text{ }^{\circ}\text{F}$) resulted in the formation of a very narrow, obscure fibrous rim enclosing a zone of radial marks (see Fig. 433). Lowering the test temperature further, to $26\text{ }^{\circ}\text{C}$ ($79\text{ }^{\circ}\text{F}$), produced a fracture made up entirely of radial features (see Fig. 434). All at $8\times$

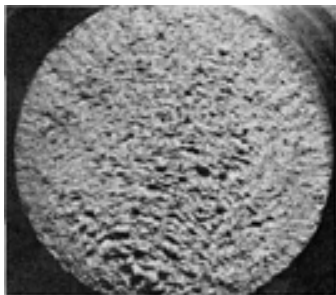
Shown above are fracture surfaces of three notched tensile-test specimens prepared from AISI 4340 steel that had been austenitized, quenched, and tempered at $480\text{ }^{\circ}\text{C}$ ($895\text{ }^{\circ}\text{F}$) to provide the following room-temperature properties: yield strength, 1234 MPa (179 ksi); unnotched tensile strength, 1310 MPa (190 ksi); notched tensile strength, 1903 MPa (276 ksi). The specimens were broken by tension overload at the

temperatures indicated beneath the fractographs. The specimen shown in Fig. 435 was broken at 0 °C (32 °F) but, in contrast to the specimen in Fig. 434, which was tempered at 315 °C (600 °F), yielded a completely fibrous fracture. The fracture shown in Fig. 436 which was produced at -80 °C (-112 °F), shows a fibrous rim surrounding a zone of radial marks. The fracture shown in Fig. 437, which was produced at -196 °C (-321 °F), shows only radial marks. All at 8×

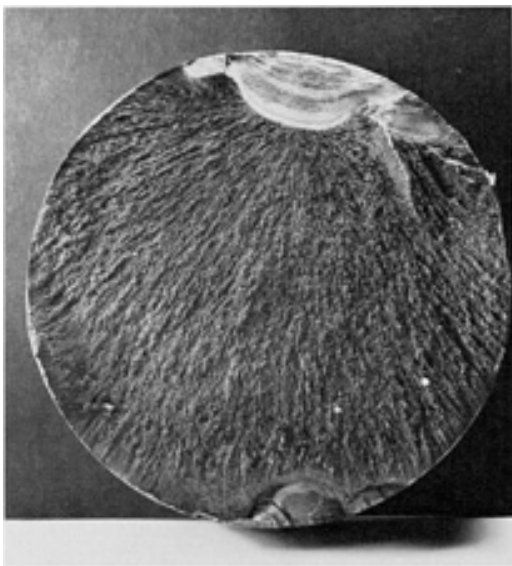
Two views of the surface of a fatigue fracture in a 145-mm ($5\frac{3}{4}$ -in.) diam threaded piston rod of AISI 4340 steel heat treated to 341 HB. The full-face view in Fig. 453 shows plainly the beach marks in the region of the primary fatigue crack, at top. Secondary fatigue cracks are visible on either side of it, as well as the bottom. The oblique view in Fig. 454 reveals that the fatigue cracks began at the roots of the threads, the origin of the primary crack being two threads to the right of the abutting secondary cracks. Although these reduced-size views do not permit detailed scrutiny, it seems evident that the thread roots were too sharp, causing stress concentrations locally. Beyond the fatigue-zone limits, failure was by radial fibrous fast fracture. Fig. 453: $\sim 0.5\times$. Fig. 454: $0.67\times$

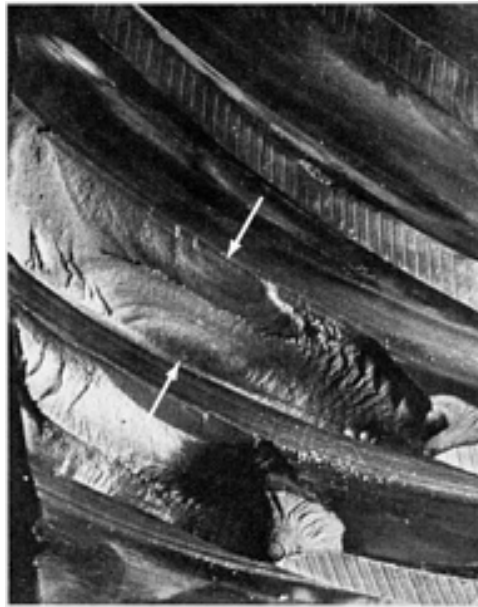
Fig. 477 Fatigue fractures in a spiral bevel pinion gear of AISI 4820H steel, case hardened to a depth of 1.1 to 2.0 mm (0.045 to 0.080 in.). Case hardness, 56 HRC; core hardness, 30 HRC. Fatigue cracks began in tooth roots (which were not shot peened), often forming on either side of a tooth (arrows) and meeting in the middle of the tooth. A deeper case and shot peening of the entire gear were recommended. Actual size.

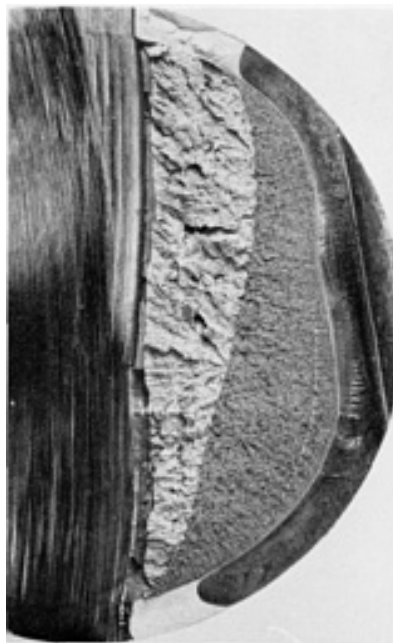
Fig. 478 Case-hardened pin of AISI 5046 steel with a hardness of 61 HRC in the case, 248 HB in the core, showing fatigue zone. The pin was cut, then broken (light area at center). Sectioning of the pin revealed subcase fatigue cracking. 2.25×

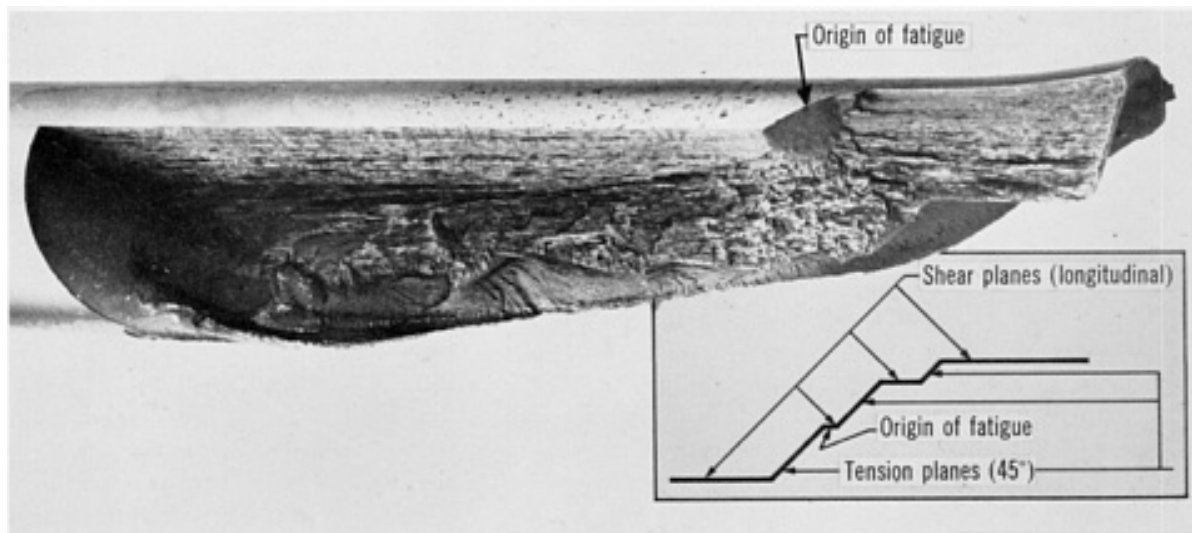
Fig. 481 Surface of a torsional-fatigue fracture in the cylindrical portion of a 35-mm ($1\frac{3}{8}$ -in) diam torsion-bar spring of AISI 50B60 steel heat treated to a hardness of 53 HRC. The fatigue crack originated in a very small (0.38 mm, or 0.015 in. long) facet (labeled "Origin of fatigue") on a longitudinal shear plane and progressed alternately on 45° tension planes and longitudinal shear planes, as indicated in the diagram. Note that the semicircular fatigue patch surrounding the origin lies in the 45° plane. 1.25×

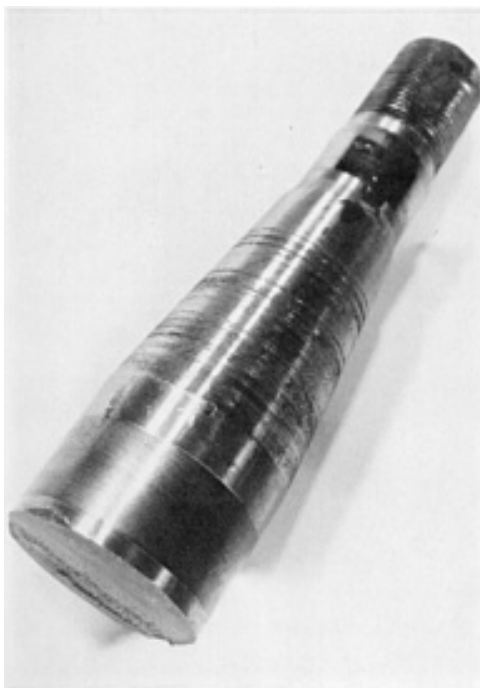
Fig. 508

Fatigue fracture of truck front wheel spindle. The SAE 81B45 part was quenched and tempered to 30 HRC. Fig. 508: Broken wheel spindle. 0.9×. Fig. 509: Fracture surface. 2.5× (General Motors Research Laboratories)

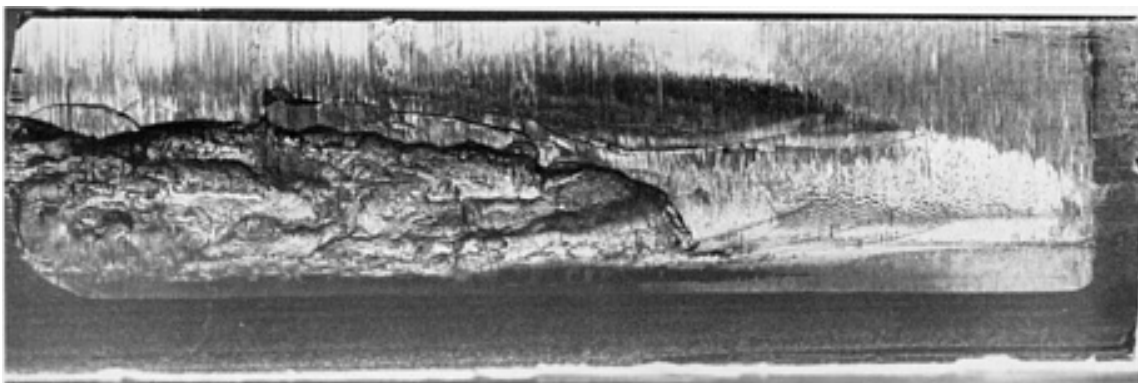
Fig. 512 Surface of a spalling-fatigue fracture in a single tooth of a heavily loaded final-drive pinion of AISI 8620 steel, carburized and hardened to 60 HRC in the case, showing vertical scratches, which indicate that appreciable abrasive wear took place also. The surface ripples at right suggest that a small amount of plastic flow occurred under the applied load. ~4×

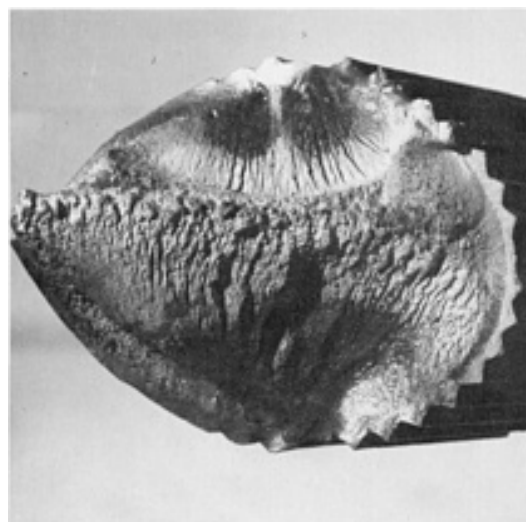
Fig. 515 Surface of torsional-fatigue fracture in a splined shaft of AISI 8620 steel that was carburized and case

hardened. Multiple fatigue cracks evidently formed at the roots of the splines and then joined to penetrate much of the case before final fast fracture occurred. 2×

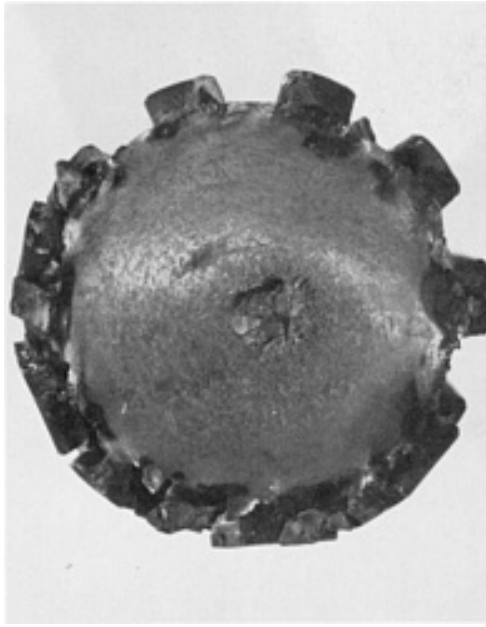
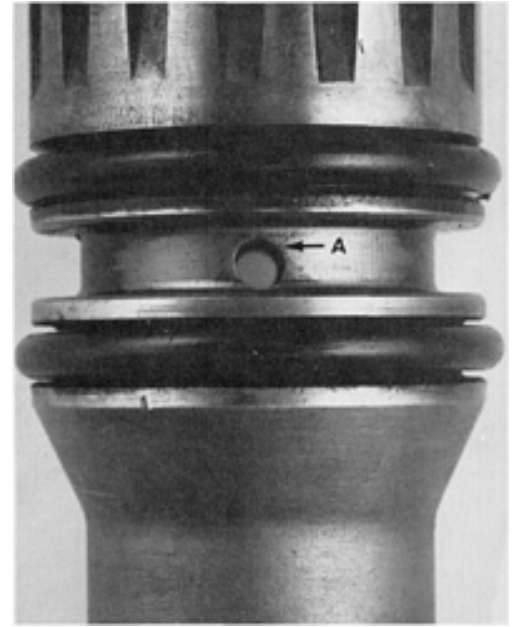
Figure 516 is a view of a broken splined shaft of AISI 8620 steel, surface carburized to a case depth of 1.07 mm (0.042 in.) and hardened to 63 to 65 HRC; core hardness was 96 HRB. Specified case hardness was 57 to 62 HRC. The fracture resulted from torsional overload. Figure 517 is a view of a surface of the fracture in Fig. 516. Brittle fracture of the splines occurred first; later, the soft, ductile core fractured in the transverse shear plane. Figure 518 is a view of the O-ring region of the shaft in Fig. 516. A 45° torsion crack is visible (at A) at the edge of an oil hole; this crack is proof of the torsional nature of the loading that was imposed on the shaft. Fig. 516: 0.25×. Fig. 517 and 518: 1.5×

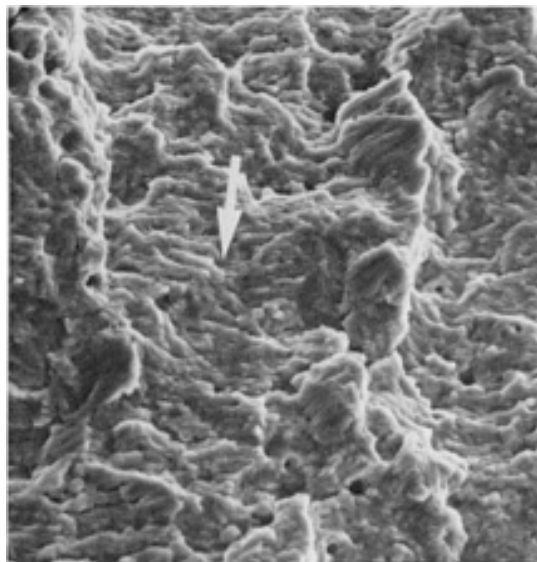
Fig. 519 Fatigue striations in AISI 8620. The roughly horizontal ridges reveal how the crack front advanced with each load application. The crack propagated in the direction of the arrow. SEM, 2100× (D.J. Wulpi, Consultant)

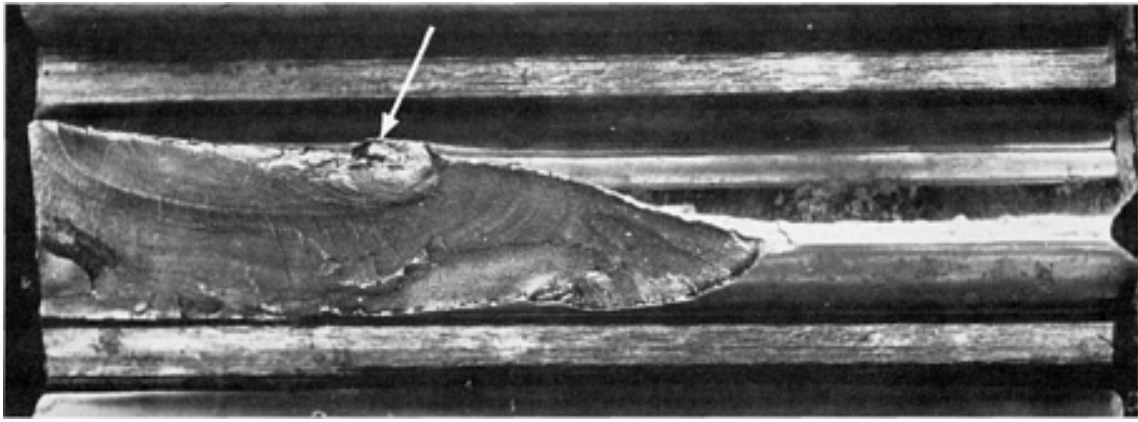
Fig. 524 Surface of a bending-fatigue fracture in a tooth of a sprocket-drive pinion of AISI 8650 steel induction hardened to 58 to 60 HRC. The fatigue-crack origin is at a deep pit (arrow) in the tooth surface. Severe end loading produced other, smaller pits in the surfaces of the teeth. Beach marks indicate that the fatigue crack penetrated a large portion of the tooth before a piece broke off. 1.6×

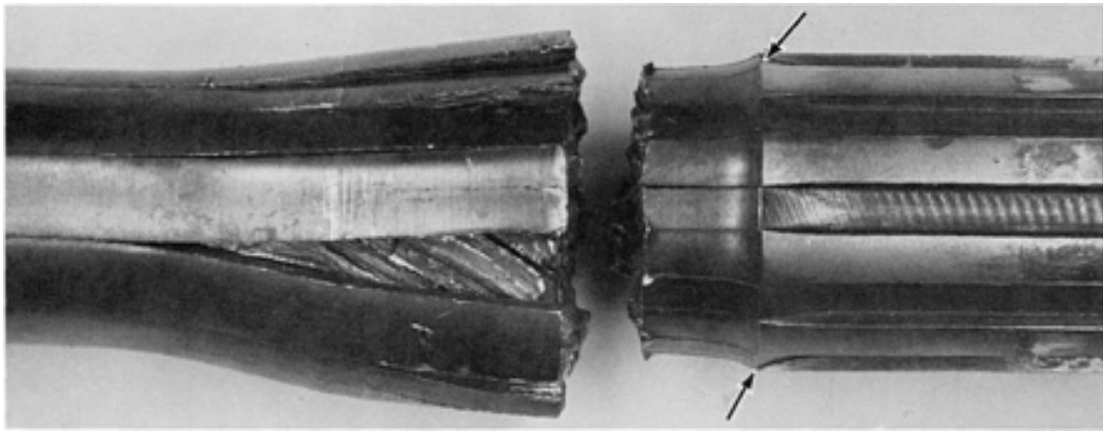
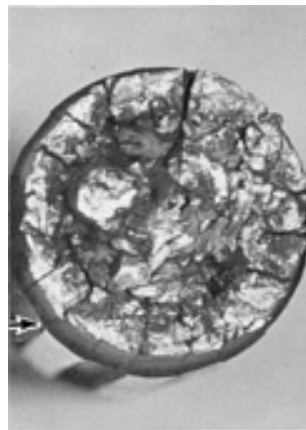
Fig. 525

Figure 525 is a fatigue fracture in the splined main drive shaft of a lift truck. The material is heat treated AISI 8645 steel. Hardness was 44 HRC throughout, except at the surfaces of some of the splines, where the hardness was 38 HRC. There was no apparent reason for the low hardness of these splines; decarburization, which was suspected initially, was not revealed by metallographic examination. Note the longitudinal cracks in the portion at left. Experimentally broken longitudinal sections of the shaft showed very "woody" fracture surfaces. Figure 526 is a view of the fracture surface of the right portion of the shaft in Fig. 525. Sharpness of fillets is evident, such as at the arrows in both figures. See also Fig. 527, 528, and 529. Both at 1.25×

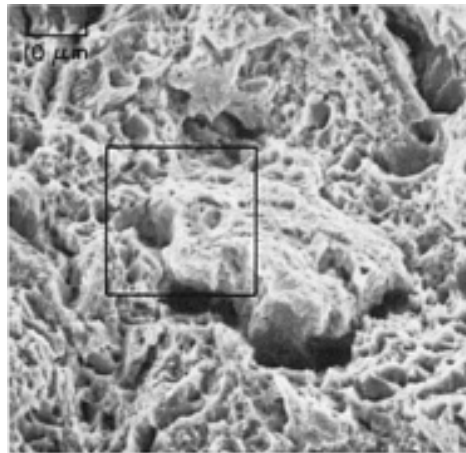
Fig. 531 Area adjacent to one of the radial features in Fig. 530, showing dimples, which are typical of tensile-overload fracture. Note the scattered secondary cracks, which appear to be unusually deep. See also Fig. 532, a higher-magnification view of area in the rectangle. SEM, 1000×

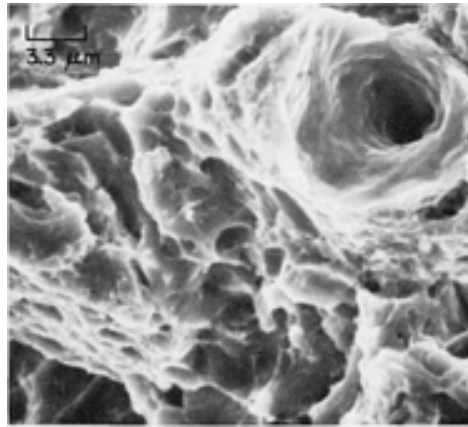
Fig. 535 Higher-magnification view of the area in the rectangle in Fig. 534. Range in dimple size is more clearly evident here. Large dimple at upper right was presumably initiated by a large inclusion (not shown). SEM, 3000×

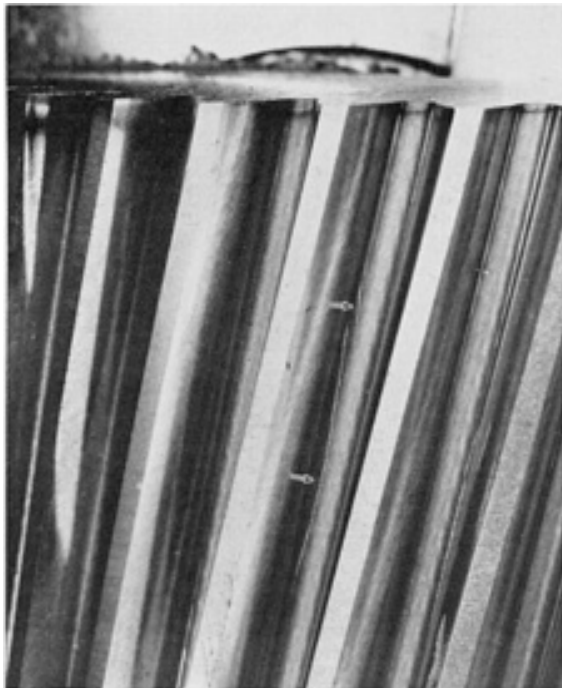
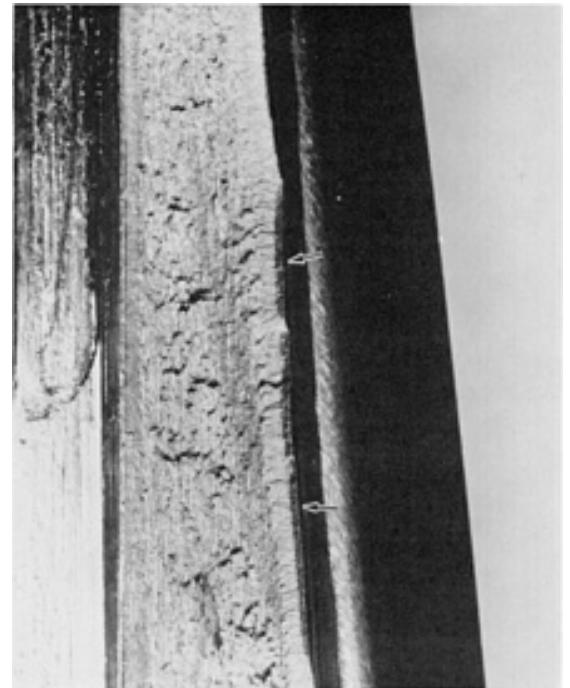
Fig. 536

Grinding cracks in AISI 9310 helical pinion. Part was rough machined, carburized, hardened and tempered (56 to 58 HRC), and finish ground. Cracks, due to abusive final grinding, were discovered in a tooth root during nondestructive testing. Fig. 536: Helical pinion. Arrows point to cracks. 2×. Fig. 537: Fracture surface of opened crack (arrows) reveals a crack depth of 0.5 to 0.9 mm (0.020 to 0.035 in). 5× (P.J. Walling, Metcut Research Associates, Inc.)

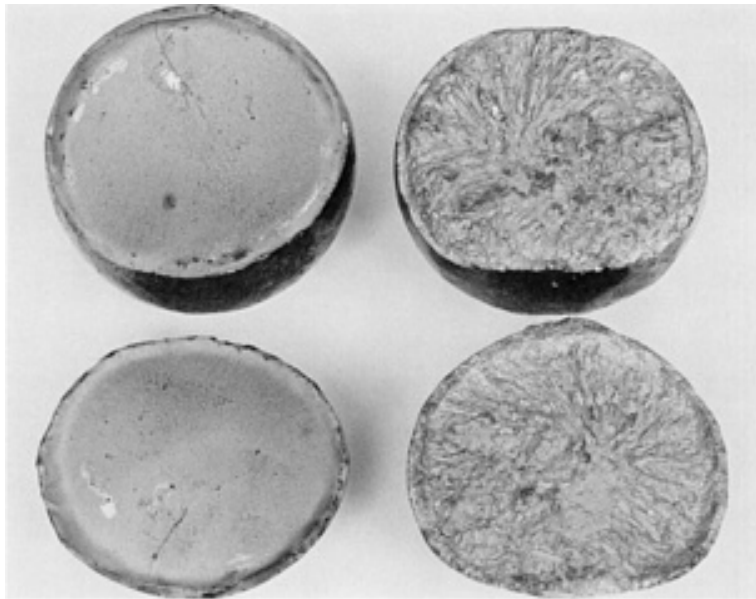
Fig. 541 Mating fracture surfaces of commercial 75-mm (3-in.) diam grinding balls. Fracture was caused by severe ball-on-ball impacts in laboratory tests. Left top and bottom: Commercial forged and heat-treated low-alloy steel ball. Composition: 0.63% C, 0.90% Mn, 0.76% Si, 0.66% Cr, 0.018% P, and 0.011% S. Right top and bottom: Experimental manganese steel ball, cast and heat treated. Composition: 0.97% C, 5.3% Mn, 1.9% Cr, 1.0% Mo, 0.48% Si, 0.03% P, and 0.018% S. Outer rim of ball was under compression due to heat treatment and plastic deformation from impacts. (H.W. Leavenworth, Jr., U.S. Bureau of Mines)

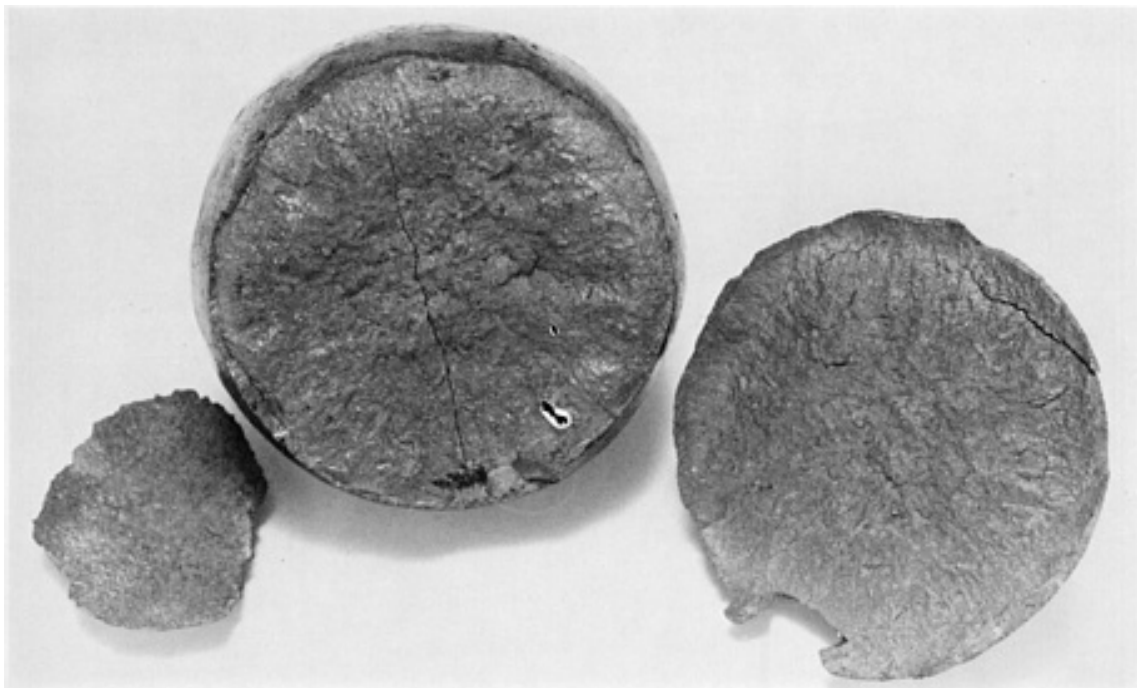
Fig. 542 Catastrophic failure of 75-mm (3-in.) diam manganese steel grinding ball after 51,440 severe ball-on-ball impacts in a laboratory test. Composition: 1.21% C, 5.3% Mn, 1.8% Cr, 1.1% Mo, 0.46% Si, 0.1% Ni, and 0.1% Cu. Fracture initiated at an interior crack. (Note another such crack on the fracture surface at center.) The interior of the ball was under tension. The outer rim was under compression due to heat treatment and plastic deformation from impacts. (H.W. Leavenworth, Jr., U.S. Bureau of Mines).

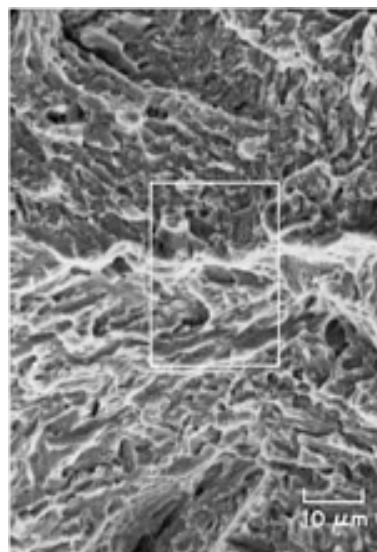
Fig. 552 This view at higher magnification of the area outlined by the rectangle in Fig. 551 reveals that many of the dimples are highly elongated, exhibiting locally some features suggestive of cleavage. Area in rectangle here is shown enlarged in Fig. 553. SEM, 1000×

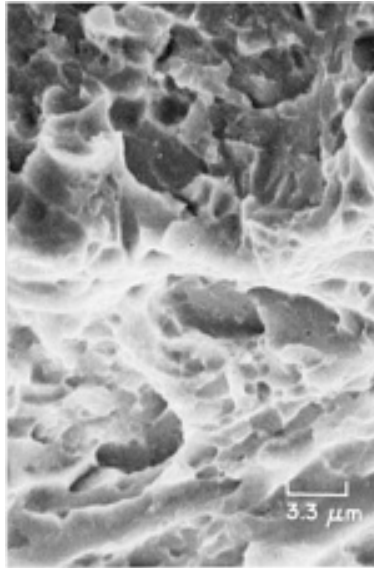
Fig. 553 Area outlined by the rectangle in Fig. 552, shown at triple the magnification. At this enlargement, many extremely fine dimples are visible, formed along the margins of large voids. SEM, 3000×

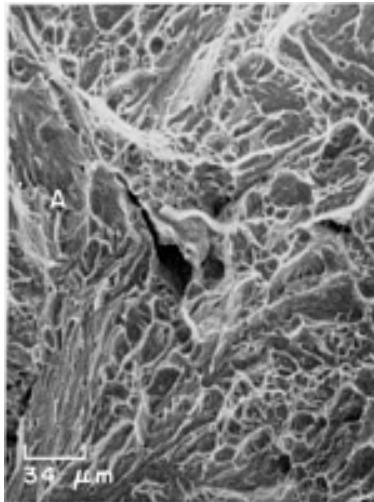
Fig. 554 This specimen was austenitized at 1205 °C (2200 °F). Yield strength was 1413 MPa (205 ksi). There appear to be large facets of quasi-cleavage, such as at A; elsewhere, the surface contains rather large dimples. Note the large void near the center, SEM, 290×

These fractographs show the effects of various austenitizing treatments on characteristics of fractures in an experimental secondary-hardening steel containing 0.3% C, 0.6% Mn, and 5.0% Mo. All specimens were austenitized for 1 h at the temperatures indicated, quenched in ice-brine, and then refrigerated for 30 min in liquid nitrogen. Plane-strain fracture-toughness specimens were then tested at room temperature as part of a program to develop high levels of toughness in steels that also maintain ultrahigh tensile strength.

These fractographs are of a fracture-toughness specimen of 0.4C-0.6Mn-5Mo secondary-hardening steel that was tested as part of a program to develop fracture toughness in high-strength steel (the same program that yielded Fig. 554, 555, 556, 557, and 558). This specimen was austenitized for 1 h at 1205 °C (2200 °F), ice-brine quenched, and refrigerated for 30 min in liquid nitrogen. Room-temperature yield strength was 1758 MPa (255 ksi). Plane-strain fracture-toughness (K_{Ic}) value was 76 MPa \sqrt{m} (69 ksi \sqrt{in})--appreciably less than the value for the lower-carbon (0.3% C) steel in Fig. 554, which was given the same heat treatment.

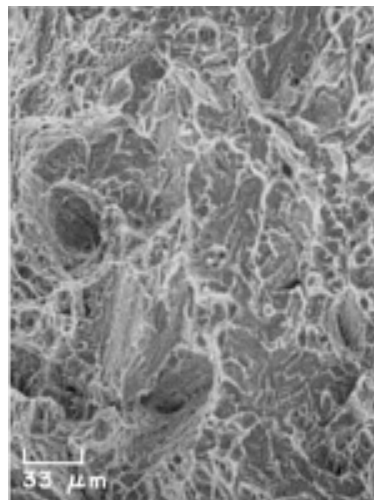
Fig. 555 This specimen was austenitized at 1095 °C (2000 °F). This fracture, like that in Fig. 554, displays quasi-cleavage facets; some of them are apparently rather deeply indented. There are also intervening regions

showing clusters of equiaxed dimples. SEM, 300×

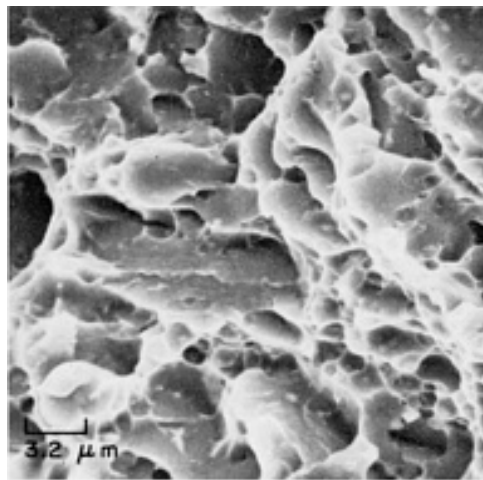
Fig. 557 The specimen was austenitized at 870 °C (1600 °F). Yield strength was 1324 MPa (192 ksi). The fracture surface exhibits a wide range of dimple sizes. The heat treatment resulted in a plane-strain fracture-toughness (K_{Ic}) value of 55 MPa \sqrt{m} (50 ksi \sqrt{in}); this contrasted with a value of 121 MPa \sqrt{m} (110 ksi \sqrt{in}) for the specimen in Fig. 554--probably because of incomplete solution of carbide particles of the lower austenitizing temperature for the specimen shown here. SEM, 3150×

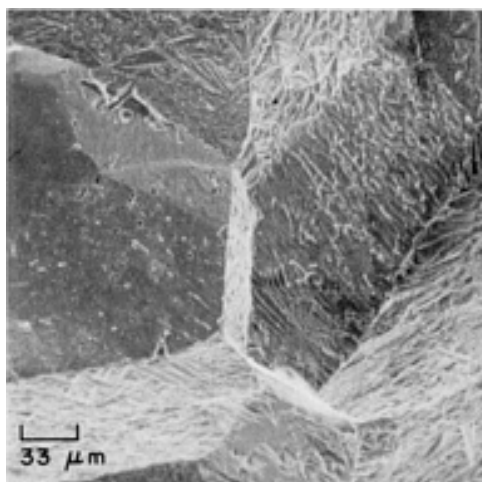
Fig. 558 The heat treatment of this specimen was altered as follows: austenitized at 1205 °C (2200 °F) for 1 h, quench to 870 °C (1600 °F) and hold for 30 min, ice-brine quench, then refrigerate in liquid nitrogen. Fracture appears to have occurred by a combination of transgranular and intergranular cleavage. The K_{Ic} value of this specimen was even lower than that for the specimen in Fig. 557; the lower value is believed to

be the result of a different distribution of carbide particles. SEM, 300×

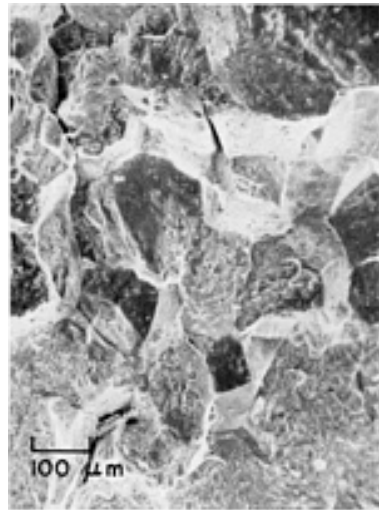
Fig. 559 An area of the fracture surface in which the fracture appears to be intergranular, with secondary cracks between the grains. The lower portion of the area may contain dimples. SEM, 100×

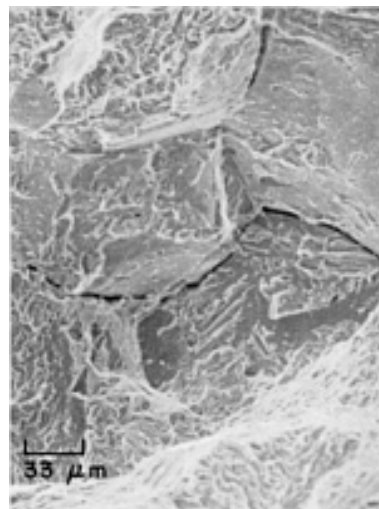
Fig. 560 Another area of the fracture surface, shown at higher magnification. This area has many characteristics of an intergranular fracture. Grain surfaces exhibit fine dimples, but no river patterns. SEM, 300×

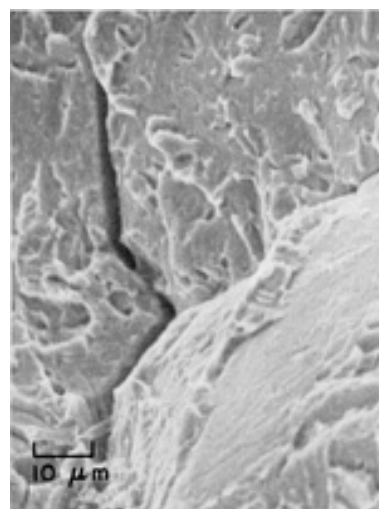
Fig. 561 A third area of the fracture surface, at still higher magnification. This area shows a secondary crack penetrating deeply into the grain boundary. Small cleavage steps are evident. SEM, 1000×

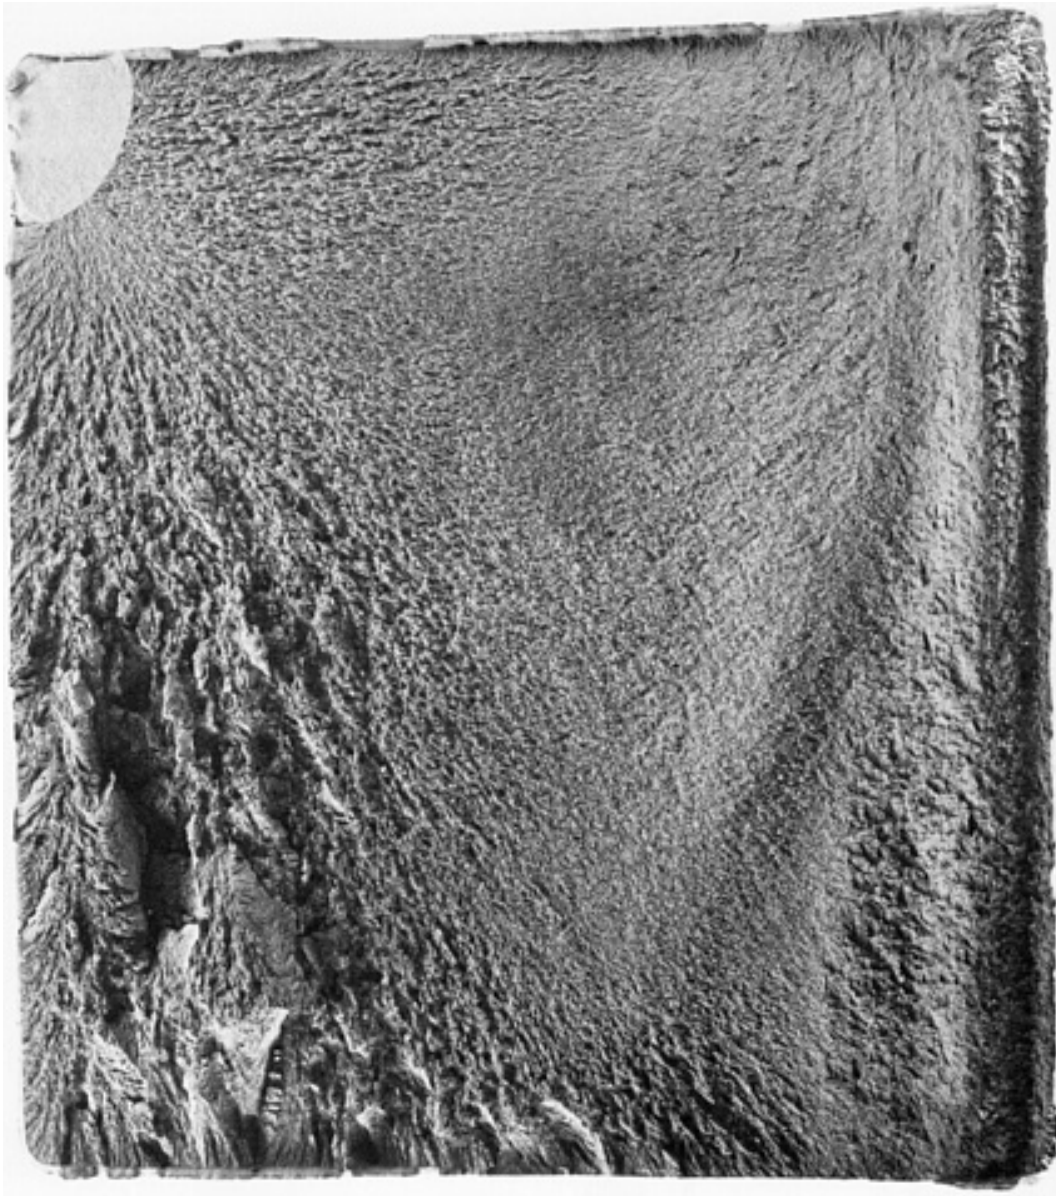
Fig. 571 Surface of a fracture in an equalizer bar, which supports the front end of a tractor, fabricated from D6B steel and heat treated to a hardness of 45 to 47 HRC. The bar was put into service for 200 h and then returned to the laboratory, where it was flexed in fatigue to fracture at 60×10^3 cycles. Note the very fine texture of the fatigue-crack zone at the upper left corner. It is concluded that because there are no beach marks beyond that small corner zone, the remainder of the fracture occurred in a catastrophic manner. Shear lips are evident along the top and right edges, and may also be present around the lower left corner. (D6B steel contains 0.45% C, 0.80% Mn, 1.00% Cr, 0.50% Ni, 1.00% Mo, and 0.10% V.) ~1.13×
