ASM HANDBOOK®

VOLUME
12

Fractography

Fractography, was published in 1987 as Volume 12 of the *ASM Handbook*. The Volume was prepared under the direction of the ASM Handbook Committee.

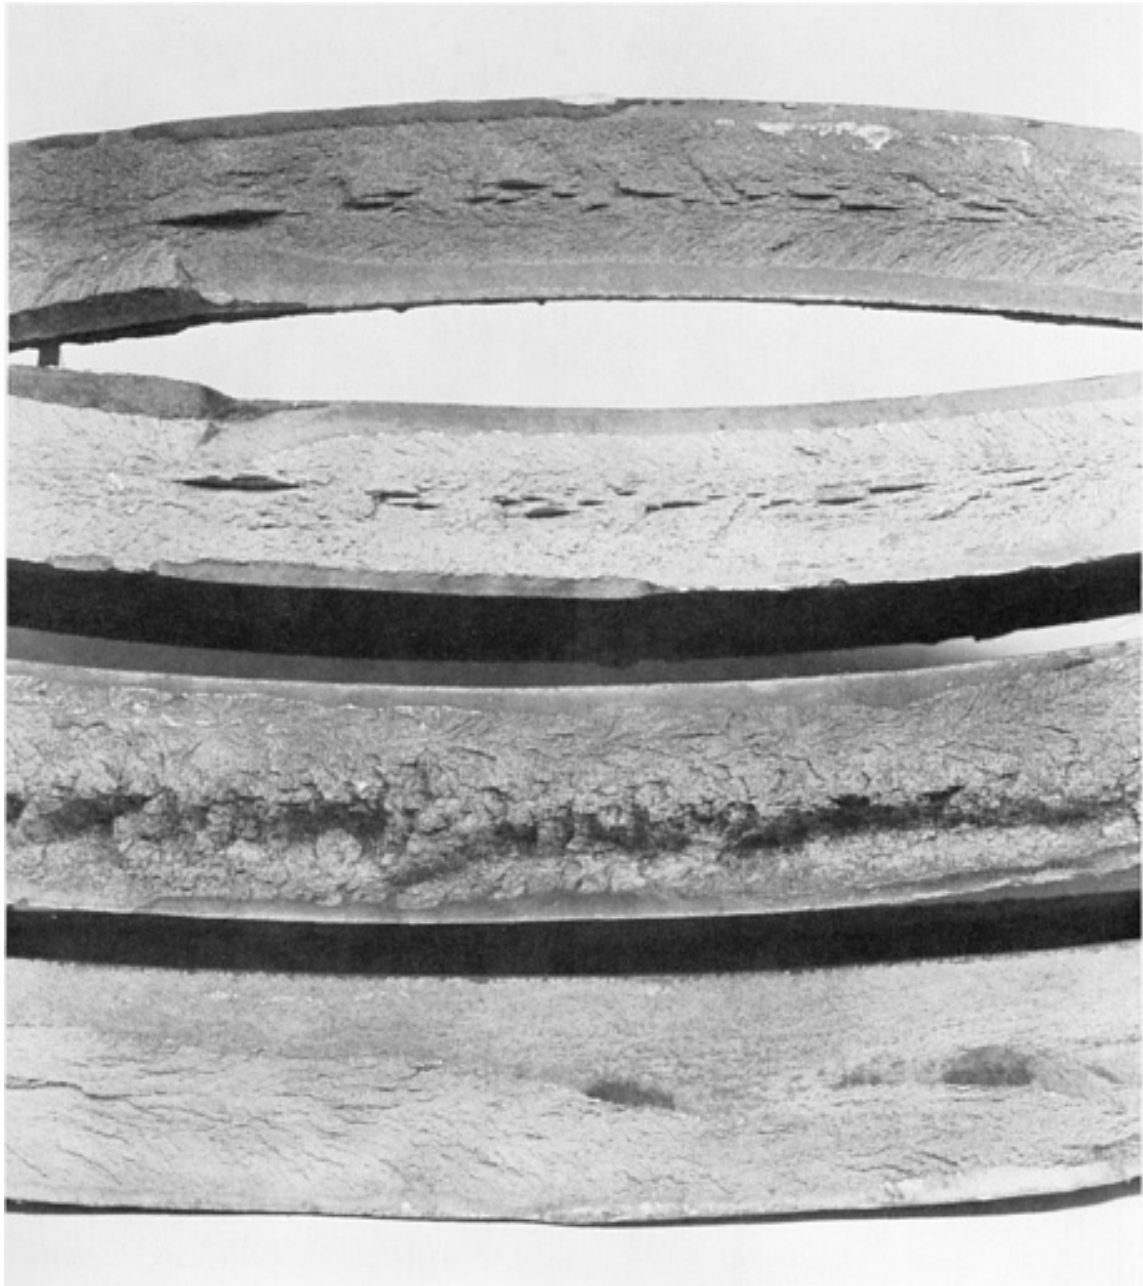
Fig. 572 Four fracture surfaces of a hemispherical accumulator head of high-strength low-alloy steel (0.15% C, 0.8% Mn, 0.6% Cr, and 0.85% Ni) that broke into several pieces during pressure testing at room temperature. Hardness ranged from 28 to 39 HRC. Fracture originated at a thin spot in the wall, where banding was also present. At top are mating surfaces of a fracture near the origin, showing chevron marks and tongues, although tongues are more typical of low-temperature cleavage of iron-base alloys than of room-temperature cleavage. The fracture surface third from the top is very coarse-grained, whereas the surface at bottom is fine-grained and silky; the difference in appearance between these two surfaces may have resulted from a difference in rate of crack propagation. Actual size

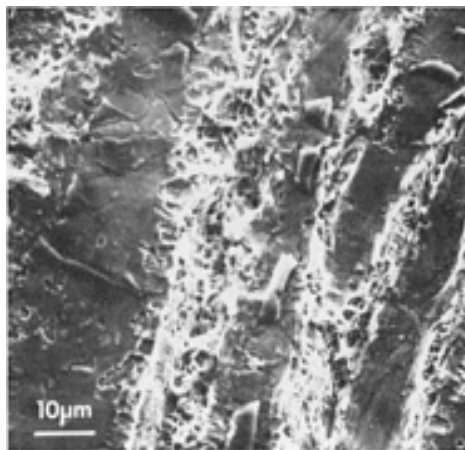
Effect of inclusions on fatigue crack propagation (FCP) in ASTM A514F. Direction of FCP is toward the top. Fig. 581: Area of fracture surface not near inclusion formations shows primarily ductile fatigue striations. Also note secondary cracking. Through-thickness (S-T orientation) FCP specimen at $\Delta K = 55 \text{ MPa } \sqrt{m}$ (50 ksi \sqrt{in}). SEM, 1020 \times . Fig. 582 and 583: Through-thickness (S-L orientation)

fractures near inclusion formations at two levels of ΔK . At the low 22-MPa \sqrt{m} (20-ksi \sqrt{in}) level (Fig. 582), fatigue damage is by striation formation in the interinclusion material of an inclusion formation. At the high 55-MPa \sqrt{m} (50-ksi \sqrt{in}) level (Fig. 583), ductile fracture (microvoid coalescence) of the interinclusion material occurs. See also Fig. 579 and 580. SEM, both at 1020 \times (A.D. Wilson, Lukens Steel Company)

Inclusions. Discontinuities in the form of inclusions, such as oxides, sulfides, and silicates, can initiate fatigue fractures in parts subjected to cyclic loading (see, for example, Fig. 579 to 583 and Fig. 588 to 598 in the "Atlas of Fractographs" in this Volume, which illustrate the effect of inclusions on the fatigue crack propagation in ASTM A533B steel). In addition, such inclusions have been identified as initiation sites of ductile fractures in aluminum alloys and steels. At relatively low strains, microvoids form at inclusions, either by fracture of the inclusion or by decohesion of the matrix/inclusion interface.

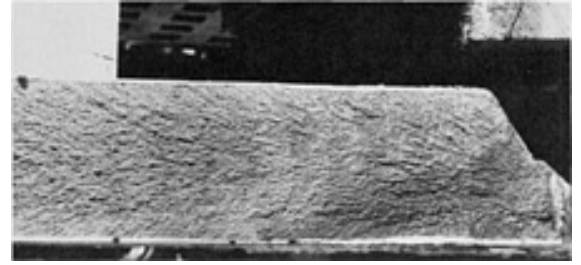
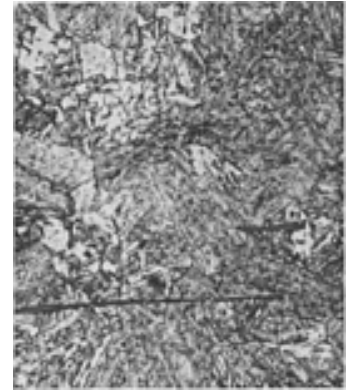
Brittle fracture of tension flange for large box-girder bridge. The flange measured 75 cm (30 in.) wide and 55 mm ($2 \frac{1}{4}$ in.) thick and was welded to a trapezoidal box girder. It was made of 55-mm ($2 \frac{1}{4}$ in.) thick ASTM A517H plate. Failure occurred catastrophically across the full width of the flange as the concrete deck of the bridge was being placed. Fracture was arrested about 100 mm (4 in.) down the web of the girder. Ambient temperature: 14 °C (58 °F). Cause of fracture was inadequate toughness in the quenched and tempered 690-MPa (100-ksi) minimum yield strength steel. At the time, toughness in A517 was assumed and was not a specification requirement as it is now. Also, the then-current specification limited maximum thickness to 50 mm (2 in.). However, thicker plate was allowed for this application. Fig. 584: Fracture surface of flange. Chevrons point to origin at right. Fig. 585: Close-up of fracture origin (right) at weld between flange and cross bracing. Fig. 586 and 587: Photomicrographs of structure of failed flange near the surface (Fig. 586) and at the center (Fig. 587) of the 55-mm ($2 \frac{1}{4}$ in.) thick plate. Both at 500 \times (C.E. Hartbower, Consultant)

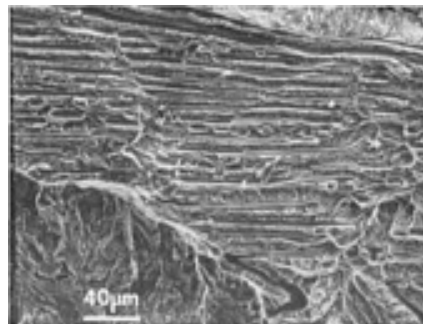
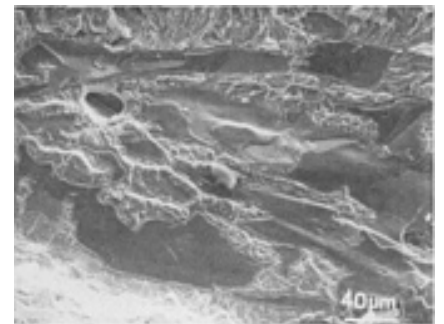
Effect of inclusions on FCP in ASTM A533B. The conventionally melted electric furnace steel was water quenched from 900 °C (1650 °F), tempered at 670 °C (1240 °F), air cooled, stress relieved at 595 °C (1100 °F), and then furnace cooled. FCP specimen tested in the through-thickness (S-T, S-L) orientations. Direction of fatigue crack propagation is toward the top. Fig. 588: Fracture surface of S-L oriented FCP test specimen. Fracture surface appearance due to inclusion formation on depressions or plateaus on the fracture surface. Figures 589, 590, and 591 show three kinds of MnS inclusions in type II MnS inclusion formations: highly elongated (Fig. 589), flattened or pancaked (Fig. 590), and small and round as a result of homogenization (Fig. 591). SEM, Fig. 589 and 590: 230×, Fig. 591: 200×. Fig. 592: Alumina (Al₂O₃) galaxies on the through-thickness fracture surface of A533B. SEM, 200×. ΔK in Fig. 589, 590, and 592 = 25 MPa \sqrt{m} (23 ksi \sqrt{in}); in Fig. 591, 58 MPa \sqrt{m} (53 ksi \sqrt{in}). See also Fig. 593, 594, 595, 596, 597, and 598. (A.D. Wilson, Lukens Steel Company)

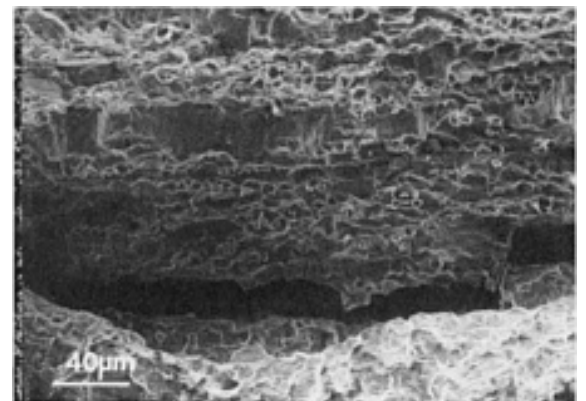
Effects of inclusions on fatigue crack propagation (FCP) in ASTM A533B. In conventional electric furnace steel, protrusions perpendicular to the direction of FCP were noted on T-S and L-S fracture surfaces. The protrusions result from inclusion formations (type II MnS and Al_2O_3) acting as crack deflectors. Figures show T-S orientation features. FCP direction is toward the top. Fig. 595: Protrusions on fracture surface. Fig. 596: Metallographic cross section reveals MnS inclusions on a protrusion. 170 \times . Fig. 597: Protrusion. SEM, 15 \times . Fig. 598: Protrusion with Al_2O_3 galaxy. SEM, 28 $^\circ$ tilt angle, 325 \times . Fig. 597 and 598 at ΔK of $40 \text{ MPa } \sqrt{m}$ ($36 \text{ ksi } \sqrt{in}$). See also Fig. 588, 589, 590, 591, 592, 593, and 594. (A.D. Wilson, Lukens Steel Company)

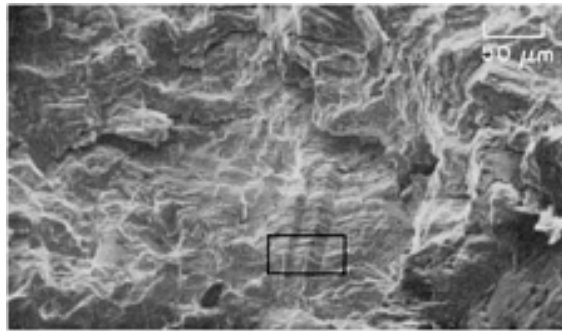
Fig. 611 Surface of fatigue-crack fracture in a specimen of AISI type 301 stainless steel that was highly stressed, breaking in 2000 cycles. Crack growth was very irregular, with many pronounced offsets. At center, twin boundaries have affected crack propagation. Area in rectangle is shown at higher magnification in Fig. 612. SEM, 200×

Fig. 612 A higher-magnification view of the area outlined by the rectangle in Fig. 611, which includes twin-boundary outlines. Several secondary cracks have formed at the roots of the fatigue striations. The striae, however, are not delineated well enough to permit a confident estimate of the spacing. SEM, 1400×

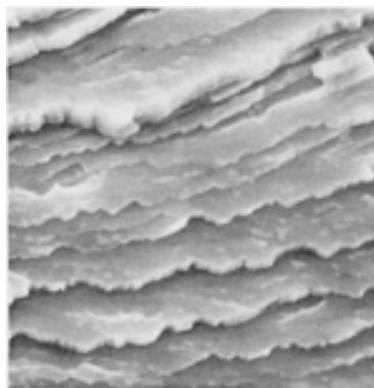
Fig. 629 Stress-corrosion cracking facets on the fracture surface of an AISI type 304 sample tested under constant load in MgCl_2 solution at 155°C (310°F). The steplike features are analogous to cleavage facets. See also Fig. 645. SEM, $3000\times$ (R. Liu, N. Narita, C. Altstetter, H. Birnbaum, and N. Pugh, University of Illinois)

Fig. 645 Hydrogen embrittlement of AISI type 304 tested under constant load in pure hydrogen gas at 100 kPa (1 atm) and 25 °C (75 °F). The two-part fractograph compares matching fracture surfaces. Note the quasi-cleavage-type facets. They generally exhibit more ductility (have a rougher surface) than classic cleavage facets. See also Fig. 629. SEM, 6000× (R. Liu, N. Narita, C. Altstetter, H. Burnbaum, and N. Pugh, University of Illinois)

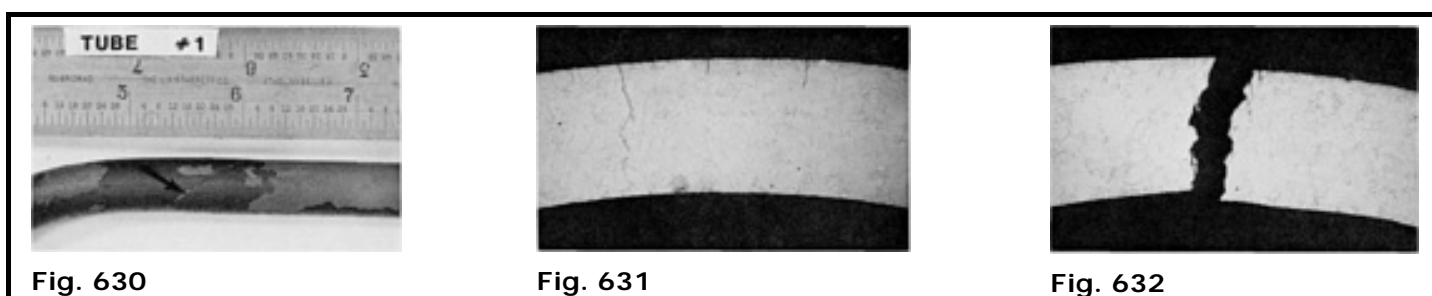
Failure of AISI type 304 tube due to chloride stress-corrosion cracking (SCC) from the outside in. The oil feed tube was used in a paper mill, where relative humidity was 100%. Cracks and evidence of corrosion were found under the coating of the painted side of the tube. No damage was noted on the other, unpainted side. Torsional stresses in service and chlorides in the paint (at a level of 6600 ppm) provided the conditions necessary for chloride SCC. Fig. 630: Crack on painted side of tube. Angle reveals influence of torsional stresses. Fig. 631: Stress-corrosion cracks extending from the outside diameter of the tube (at top) toward its inner diameter. 10% oxalic acid electrolytic etch; $28\times$. Fig. 632: Fractured tube. Branching of crack verifies that fracture occurred from the outside diameter (at top) in. 10% oxalic acid electrolytic etch; $28\times$ (Z. Flanders, Packer Engineering Associates, Inc.)

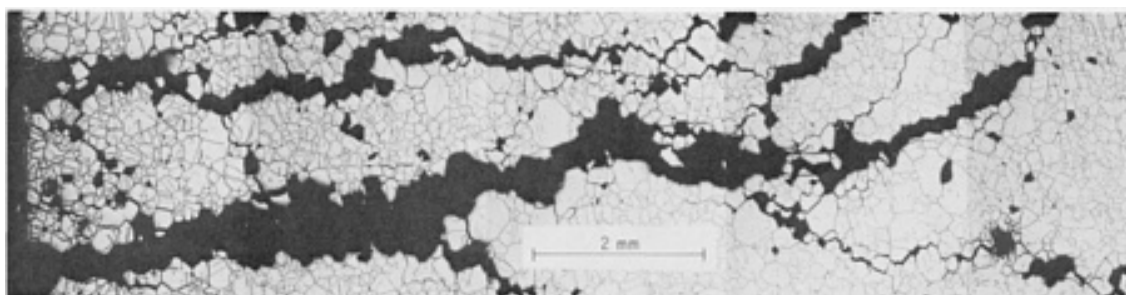
Fig. 633 Failure of AISI type 304 product gas line due to polythionic acid stress-corrosion cracking (SCC). The 205-mm (8-in.) diam Schedule 140 pipe was used in a coal-gasification pilot plant to transport product gas from the gasifier at a temperature of 430°C (800°F). The gas line failed by through-wall cracking around 270° of its circumference near a weld joining it to a 2.25Cr-0.5Mo steel tee. During plant shutdowns, the inside of the line was subjected to condensation of moisture and subsequent exposure to air. Chloride content of the condensate was 4.5 ppm. Also detected on the inside of the pipe were mixed iron and chromium sulfides, which had formed during elevated-temperature exposure to the sulfur-bearing product gas. The photomontage of the failed region of the stainless steel pipe reveals numerous intergranular, highly branched cracks originating at the inner surface (at left) of the pipe. Other metallographic work revealed that this region had been moderately sensitized due to the combined effects of welding and subsequent stress relief. Investigators concluded that polythionic acid ($\text{H}_2\text{S}_x\text{O}_6$, where $x = 3$ to 5) was produced when the condensate reacted in the presence of

oxygen with the already existing sulfidic scale on the inner diameter of the pipe. The region near the dissimilar-metal weld provides both the required sensitized microstructure and either residual or differential thermal stresses. 10% oxalic acid electrolytic etch, 15× (D.R. Diercks, Argonne National Laboratory)

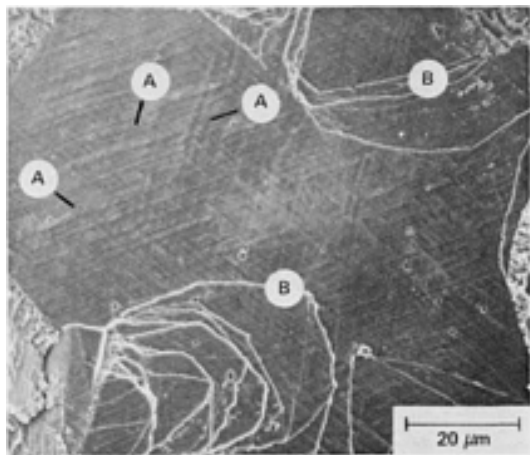
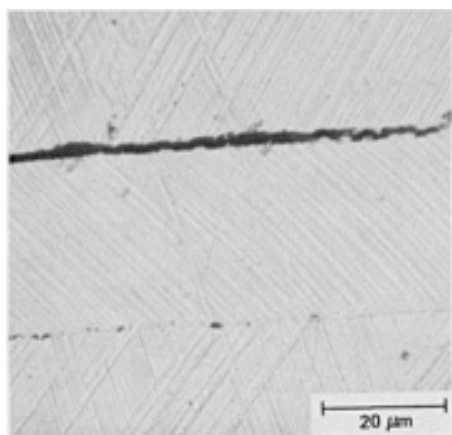
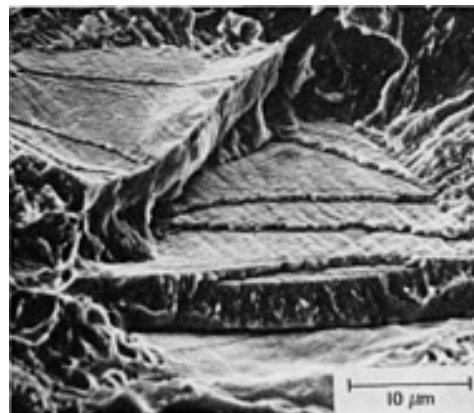
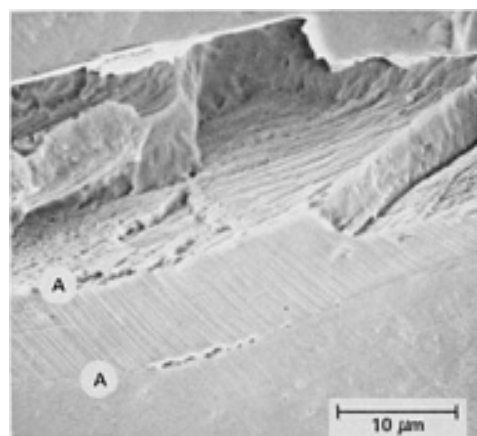
Faceted fracture in hydrogen-damaged AISI type 304L. Hydrogen damage in type 304L supersaturated with hydrogen gas is most severe at -75 to -25 °C (-105 to -15 °F). The brittle fracture surfaces exhibit predominantly facets that form by parting along coherent twin boundaries, a process similar to cleavage. Although twin parting is unusual in face-centered cubic (fcc) alloys, similar facets have been observed in hydrogen-charged Tenelon (UNS S21400) and Nitronic 40 (UNS S21900) and in stress-corrosion cracking of type 304 in MgCl_2 . Fig. 639: Ductility minimum in hydrogen-charged type 304L. Fig. 640: General view of fracture surface of sample tested at -75 °C (-105 °F). Note that facets are interconnected, are planar and flat, frequently exhibit steps 0.5 to 6.5 μm high, always have one to three sets of slip traces, and (unlike cleavage fractures) never show river patterns. Fracture plane of the facets as determined by x-ray diffraction to be $\{111\}$ plane in the fcc austenite. SEM, 170 \times . Fig. 641: Slip traces (A) and steps (B) in type 304L sample tested at -75 °C (-105 °F). SEM, 950 \times . Fig. 642: View of facet at an angle. Note steps and slip traces. Traces arise by intersection of deformation bands with coherent twin boundaries. SEM, 2000 \times . Fig. 643: Microcracking along coherent annealing twin boundaries on longitudinal section of fractured type 304L sample. Twin-boundary traces lie at an angle of 60° to 90° from the tensile axis (vertical in photomicrograph). 1000 \times . Fig. 644: Intentionally opened microcrack on polished longitudinal section. Note that features on crack face are identical to those on fracture surface facets (see Fig. 642), indicating that both facets and microcracks form by the same mechanism. SEM, 2000 \times (G.R. Caskey, Jr., Atomic Energy Division, DuPont Company)

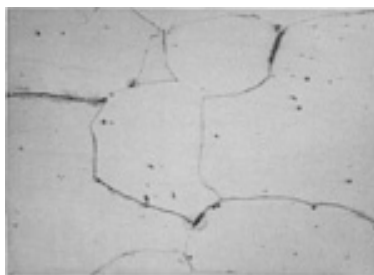
In-service failure of a paper machine suction couch roll due to intergranular stress-corrosion cracking (SCC). The centrifugally cast roll was made of ACI CF-8M (~AISI type 316) and measured 8.8 m (29 ft) long and 1.2 m (49 in.) in diameter with a 65-mm (2.5-in.) wall thickness. Cracking initiated near the outside diameter of the roll, 2.7 m (9 ft) from the driven end, and extended roughly circumferentially 320° around the roll. An overall sensitized microstructure and no evidence of corrosive attack at the lightly stressed, undriven end of the roll indicated a stress-corrosion mode as opposed to plain intergranular corrosion. The specific corrosive agent was not identified. Fig. 646: Portion of crack surface (after mechanical separation). Cracks initiated at the drilled holes near, but not directly on, the outside diameter of the shell and then propagated from hole to hole and through the wall thickness. Fig. 647: Close-up of crack face reveals intergranular nature of failure. At the

outside diameter (left) and 50 to 60% inward, the grain structure of the cast alloy is columnar. The remainder is predominantly equiaxed. Fig. 648: Evidence that cracking progressed from the outside to the inside diameter. Region of roll surface at center is completely separated, but is connected to the rest of the shell at the inside diameter. Fig. 649: Photomicrograph of structure near the inside diameter of the roll. Note intergranular cracking along sensitized, near-equiaxed grain boundaries. Ferric chloride etch, 20× (F.W. Tatar, Factory Mutual Research Corporation)

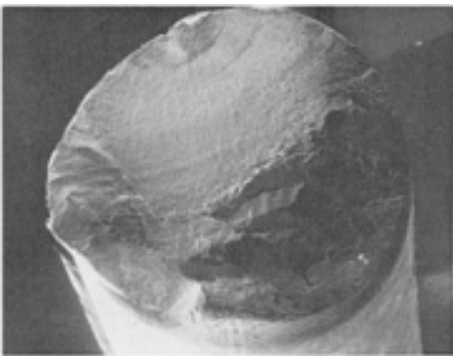
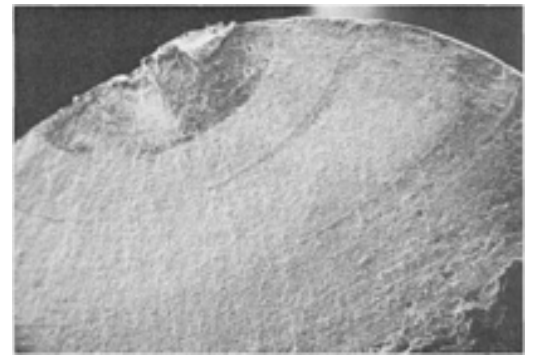
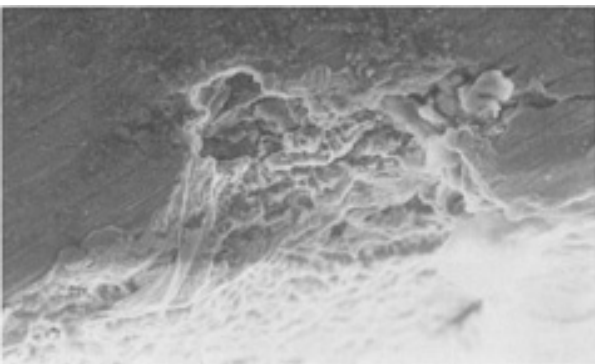
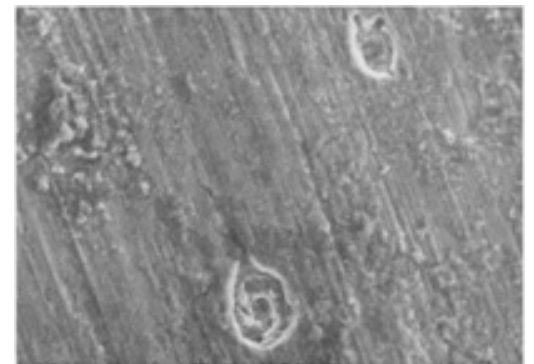
Fatigue fracture of SIS 2343 (~AISI type 316L) wire due to cracking originating at corrosion pits. The wire was used for electrodes in an electrostatic precipitator that treated the gaseous effluent from a paper mill. Fig. 651:

Fracture surface. Note beach marks. SEM, 20×. Fig. 652: Close-up of fracture origin (arrow) in Fig. 651. SEM, 50×. Fig. 653: High-magnification view of fracture origin and associated corrosion pit. Wire surface is at top, fracture surface at bottom. SEM, 620×. Fig. 654: Region on surface of wire near location of fracture, showing two corrosion pits. SEM, 1000× (C.R. Brooks, University of Tennessee)

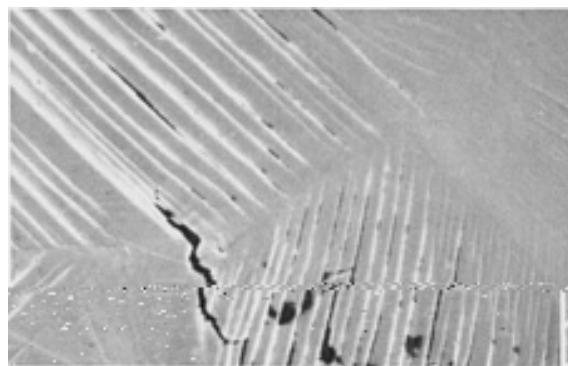
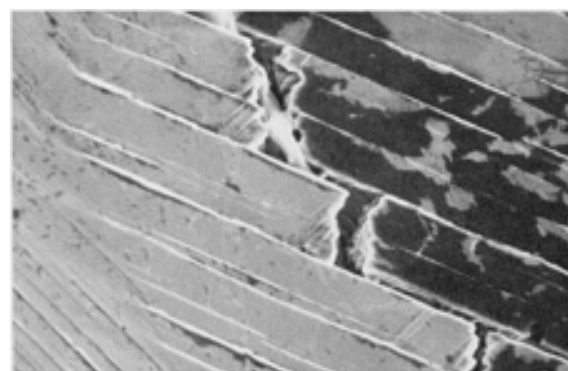
Fatigue crack nucleation at slip bands in the plate of a hip screw (compression tube and plate) surgical implant. Material and processing same as in Fig. 661, 662, and 663. Scanning electron photomicrographs are of the lateral (tension or screw-head-side) surface of plate subjected to fatigue loading. Fig. 664: Lateral surface of plate. Note slip-band activity and intrusions formed by slip bands. SEM, 187×. Fig. 665: Higher-magnification view of area on lateral surface of plate. Note microcracking at slip bands and the crack being formed at a grain-boundary triple point. SEM, 1160×. Fig. 666: Fatigue crack formed on lateral surface of plate. Growth is along slip planes. SEM, 983×. Fig. 667: Area on lateral plate surface near fracture origin. Features include slip-band cracking and crack growth along intersecting slip planes. SEM, 1400× (H.R. Shetty, Zimmer Inc.)

Fatigue crack nucleation in the plate of compression hip screw. Material and processing same as in Fig. 661, 662, and 663. This pair of scanning electron photomicrographs shows the medial (compression or bone-side) surface of the failed plate. Fig. 668: Medial surface near fracture origin. Ridges result from grain deformation. SEM, 86×. Fig. 669: Higher-magnification view of representative area in Fig. 668. Note slip-band activity and intersecting slip bands. See also Fig. 664, 665, 666, and 667. SEM, 859× (H.R. Shetty, Zimmer Inc.)

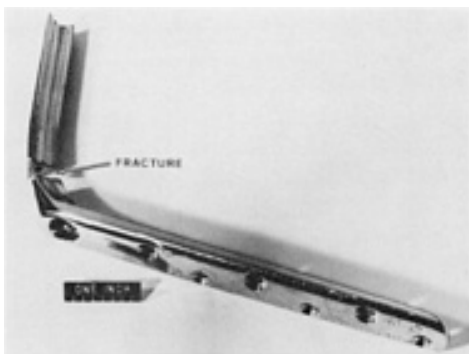
Corrosive action of body fluids masks fracture surfaces of failed AISI type 316L Jewett nail (hip implant). Corrosion of fracture faces occurred because the patient remained mobile for an extended period after the implant failed. Fig. 674: Fractured Jewett nail. Fig. 675: Fracture surfaces after removal from femur. Corrosion and possibly some erosion due to rubbing together of the mating pieces have smoothed out the once-jagged fracture surface. Corrosion of the normally passivated stainless steel results when its protective oxide layer is ruptured by such processes as deformation exceeding the elastic limit of the material (component fracture) and

the abrasive action between two metal pieces. 5× (R.J. Gray, Consultant)

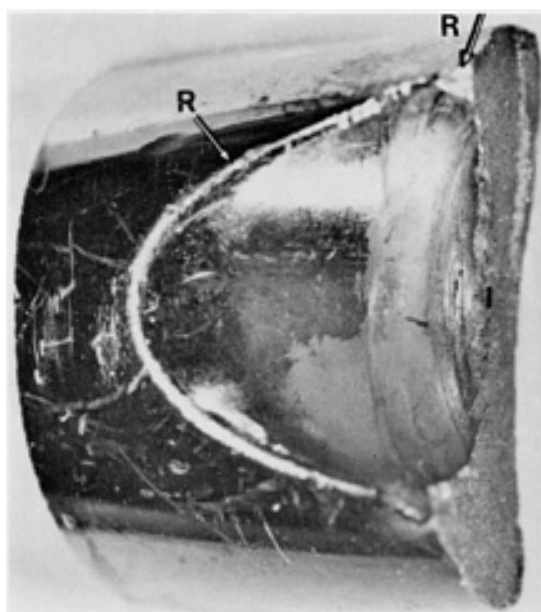
Failure of AISI type 316L Jewett nail (hip implant) due to improper installation. Fig. 680: Fractured implant after removal from body. The threaded tip of an impactor-extractor tool is inserted by the surgeon into a hole in the chamfered portion of the implant located where the side plate (left) meets the tri-finned nail (right). During installation, the threaded tip of the tool broke off. The jagged edge of the broken tool then gouged the rim of the chamfer. Even so, the operation was judged a qualified success. The implant failed 4 weeks after installation. Fig. 681: Close-up of fractured Jewett nail. Broken tip of impactor-extractor is in nail portion of implant at right. Dashed lines show cutting planes for subsequent microscopic examination. Fig. 682: Plate end of fractured impact. Fracture originates on ridge (R) of chamfer. The chamfer-fracture surface interface is indicated by I (see Fig. 684, 685, 686, and 687). Fig. 683: Close-up of area near fracture origin R in Fig. 682. Tensile stress was concentrated at groove G1, created by fractured edge of impactor-extractor tool. Fracture propagated along this groove. Also note second and third grooves. (G2 and G3) and what appears to be corrosion (areas labeled C). SEM, 50× (R.J. Gray, Consultant)

A secondary cause of the Jewett nail fracture in Fig. 680, 681, 682, and 683 may have been intergranular corrosion. Fig. 684: Close-up of chamfer-fracture surface interface (I in Fig. 682). SEM, 50×. Fig. 685: Higher-magnification view of region A on fracture face in Fig. 684. Note evidence of intergranular corrosion. In some cases, however, these "mud crack" patterns are believed to be dried body fluids that were not completely removed from the fracture surface during sample preparation (compare with Fig. 672). SEM, 500×. Fig. 686: Same as Fig. 685, but at higher magnification. SEM, 1000×. Fig. 687: Metallographic section transverse to fracture face lends support to contention that intergranular corrosion played a role in this fracture. Note how the "corrosion-etched grain size" in Fig. 686 is very similar to the etched grain size in this photomicrograph. 1000× (R.J. Gray, Consultant)

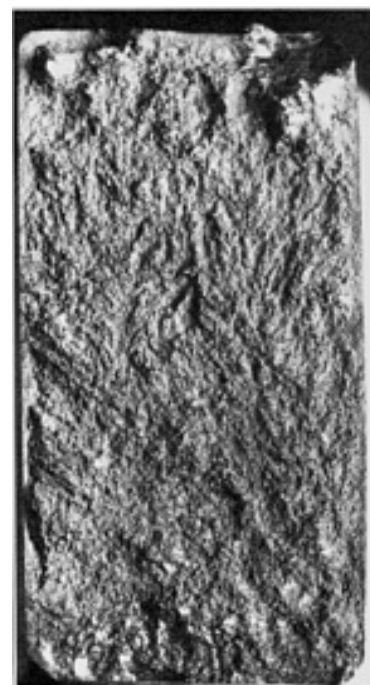
Surfaces of fractures in three AISI type 410 stainless steel links of a conveyor chain used in a food-processing operation. Heat treatment of the links had included box annealing at 995 °C (1825 °F) for 1 h, oil quenching, and tempering between 260 and 370 °C (500 and 700 °F) for 2 h. Measured hardness was 37 to 44 HRC. Service conditions included cleaning in water containing 2 ppm of chlorine at 70 °C (160 °F), cleaning in saturated steam at 120 °C (250 °F), cleaning in air at 120 °C (250 °F), and water cooling at 20 to 32 °C (68 to 90 °F). Figure 698 shows the dark, oxidized surface at a heat-treat crack; the remainder of the fracture surface is brittle and shows no shear lip. Fig. 699 shows a heat-treat crack (at top edge) and a shear lip (at bottom edge), with fast fracture between them. Figure 700 shows a very small heat-treat (right side at top edge) and portions of a shear lip (at left edge and at top edge left of crack). See also Fig. 701, 702, and 703. All at 8×

Polished and etched sections through secondary heat-treat cracks branching from the fractures in the conveyor-chain links in Fig. 698 and 700, showing the intergranular nature of the cracks. Figure 701 shows a crack in the link in Fig. 698. Note that the surfaces of this crack have oxide coatings; the short cracks branching from it were oxide induced. Figures 702 and 703 are views, at different magnifications, of a secondary crack in the link shown in Fig. 700. Again, oxide is present within the crack, as can be seen somewhat obscurely in Fig. 703. Note that this crack has branched to connect with nonmetallic inclusions. It is evident, from the presence of oxide on all crack surfaces, that both

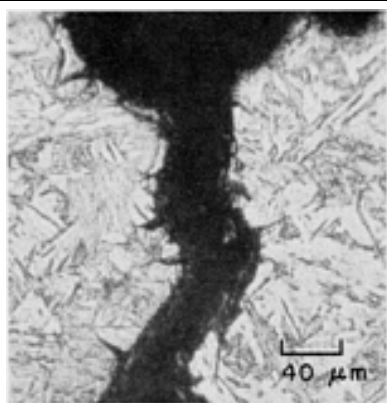
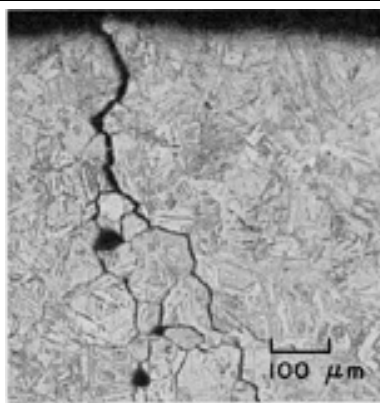
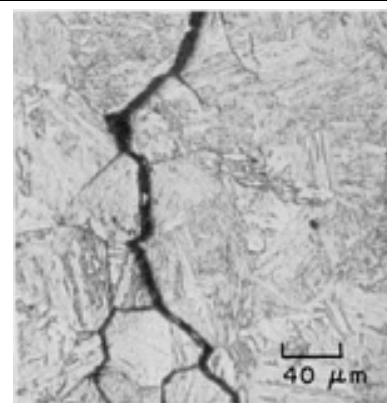
primary and secondary heat-treat cracks formed before the links were oil quenched from the annealing temperature. All etched in super picral. Fig. 701 and 703: 250×. Fig. 702: 100×

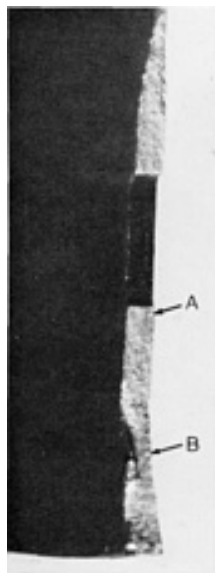
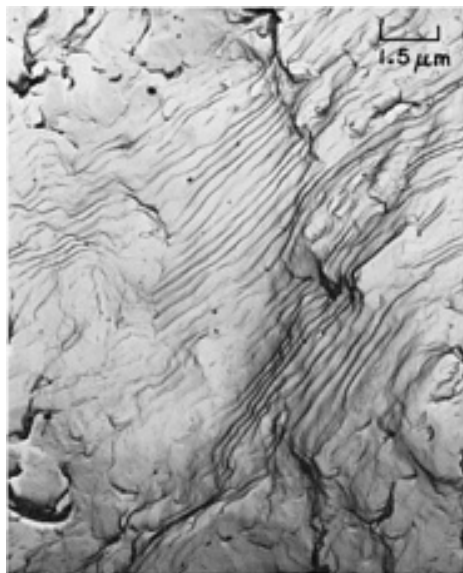
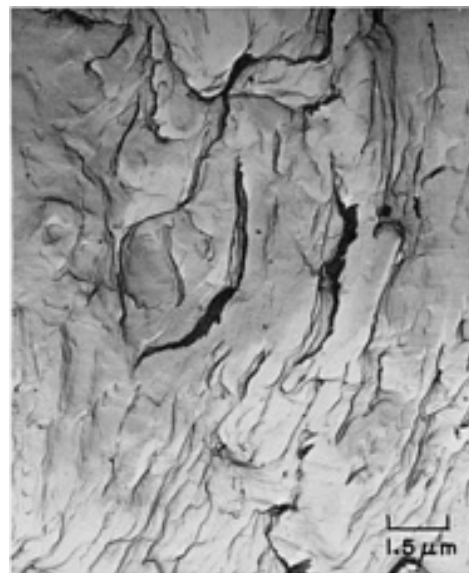
Figure 704 shows the surface of a high-cycle fracture in a $140 \times 25 \times 1.3$ mm ($5 \frac{1}{2} \times 1 \times 0.050$ in.) notched specimen of AISI type 431 stainless steel oil quenched from 1040 °C (1900 °F) and tempered at 275 °C (525 °F) to a tensile strength of 1241 to 1379 MPa (180 to 200 ksi). The notch consisted of a center hole 0.25 mm (0.01 in.) in radius and 5 mm (0.2 in.) long. The specimen was subjected to tensile stress that was cycled from 154.4 to 772 MPa (22.4 to 112 ksi) at 1000 cycles/min, and fracture occurred after 5700 cycles. Figures 705 and 706 are TEM p-c replicas of two areas at A in Fig. 704, immediately below the notch. In Fig. 705, fatigue striations are well developed, and suggestions of partly formed dimples are present at a few locations. In Fig. 706, fatigue striations are much less regular than in Fig. 705; again, there are suggestions of partly formed dimples. See also Fig. 707, 708, and 709. Fig. 704: 4.5×. Fig. 705 and 706: 6500×

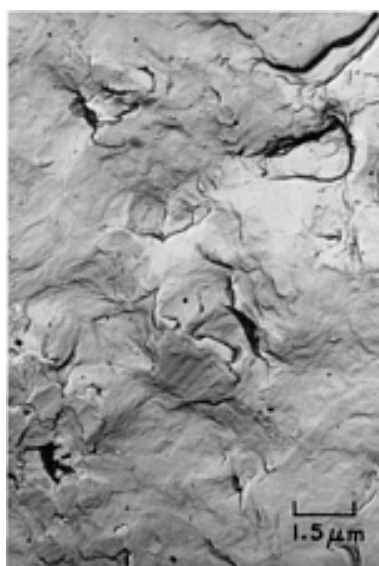
Fig. 707 TEM p-c replica of a third area at A in Fig. 704. This area exhibits faint but quite recognizable fatigue striations with spacings similar to those in Fig. 705. 6500×

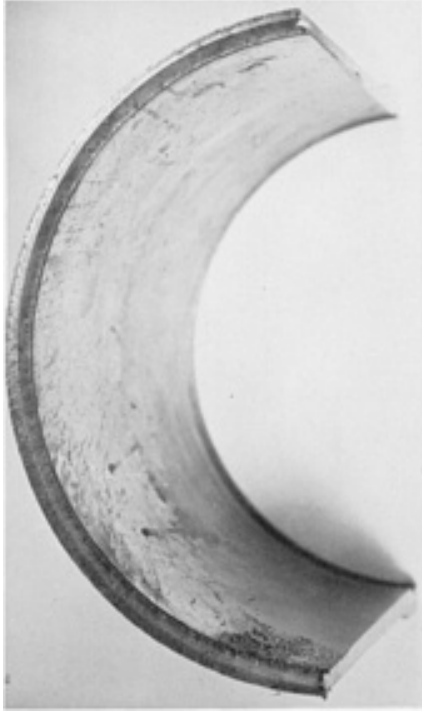
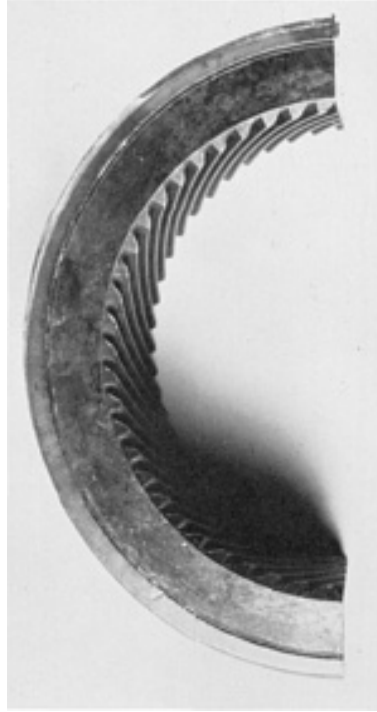
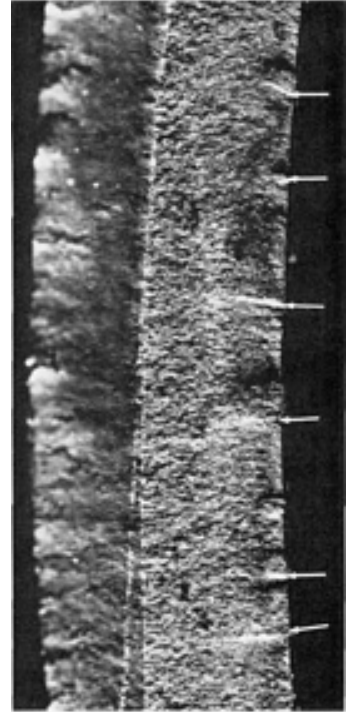
Figures 710 and 711 show the mating segments of a fractured AISI type 501 stainless steel torque cylinder from the hub socket of an aircraft propeller. Cracking originated at an internal fillet at a shoulder between the smooth bore (Fig. 710) and the internal spline (Fig. 711). Figures 712 shows clearly the inner fatigue zone and the outer zone of final tensile-shear fracture. The ratchet marks visible in Fig. 710 (at the bore) are shown more clearly in Fig. 712, a view that reveals many crack nuclei (at arrows). The fatigue cracks that propagated from these nuclei ultimately merged to form a common front. See Fig. 713, 714, 715, and 716 for TEM views of other regions of this fracture surface. Fig. 710 and 711: 0.8 \times . Fig. 712: 10 \times

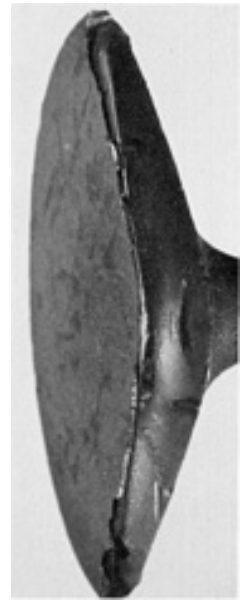
Surfaces of fatigue fractures in three automotive intake valves forged of Silcrome-1 steel (0.45% C, 3.25% Si, and 8.5% Cr) and heat treated. Figure 717 shows a transverse fracture in the stem of a valve with a hardness of 37 HRC. The stem rocked within the valve retainers, initiating many fatigue cracks around the periphery of the stem; these cracks later joined to form two main crack fronts. Very well-defined beach marks are visible in the fatigue zone at right. Figure 718 shows a transverse fracture in the stem of a valve with a hardness of 38 HRC. The stem rotated in the valve retainers, which initiated many fatigue cracks around the periphery of the stem; these cracks penetrated nearly a third of the way to the center of the stem before uniting into a single circumferential crack front. Figure 719 shows a fracture in the head of a valve with a hardness of 37 HRC. The fatigue-crack origin is at right, at the head-stem juncture. Note the peeled surface layer. Fig. 717 and 718: 10×. Fig. 719: 2×

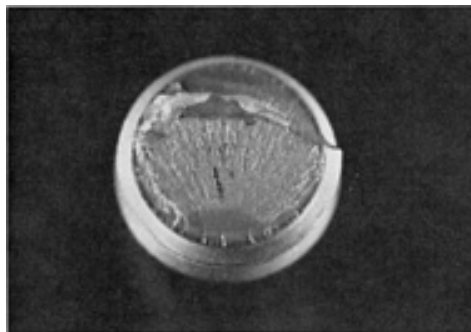
Fig. 726 Low-cycle fatigue fracture in threaded specimen of 13-8 PH stainless steel (tensile strength): 1634 MPa, or 237 ksi; 47% reduction of area) tested in tension-tension ($R = 0.1$) with maximum loading at 60% of tensile strength. Fracture, at 16,000 cycles, began at lower edge of crescent-shaped area at bottom. 6×

Fig. 727 SEM view of the fracture surface in Fig. 726, taken at the rounded lip at the bottom edge of the crescent-shaped area. Even this close to the crack origin, there are no fatigue striations. The irregular surface displays ridges formed by a shear process. 4000×

Fig. 728 Another SEM view of the fracture surface in Fig. 726, taken in the region of final fast fracture. Fatigue fracture has given way to dimpled rupture. Two pockets, one at the left and one at the right, contain features that resemble localized quasi-cleavage. 4000×

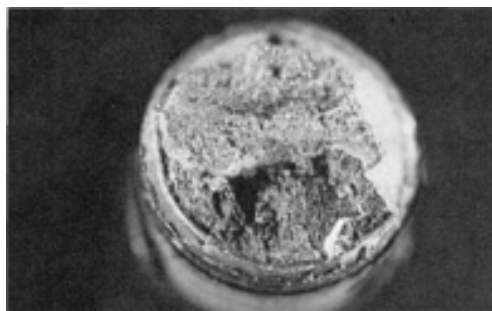
Fig. 735 Stress-corrosion cracking fracture in threaded specimen of 13-8 PH stainless steel (same properties as in Fig. 726) loaded to 75% of tensile strength in a 3.5% NaCl solution. See also Fig. 736. 6×

Fig. 736 SEM view of crack origin area of fracture surface in Fig. 735, showing corrosion products that probably are oxides. Secondary cracks may or may not extend into the metal below. See also Fig. 737 and 738. 1000×

Fig. 738 Another higher-magnification view of the crack-origin area of the SCC fracture surface shown in Fig. 735, displaying a coating of a hydroxide corrosion product containing many fine secondary cracks. Compare with the area shown in Fig. 737. SEM, 4000×

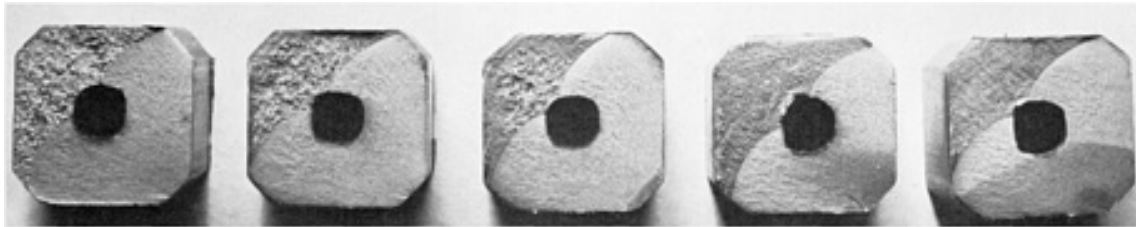
Fig. 759 Five fatigue-fracture surfaces that were produced in reversed bending in pneumatic testing machine. The material is AISI W1 tool steel. The lighter areas of the fracture surfaces are the fatigue zones--all of which were initiated at the lower right corners. Note the lack of beach marks, which indicates that during each test the load amplitude and environment were uniform. The dark regions at the upper left corners are the regions of final fast fracture. 1.5×

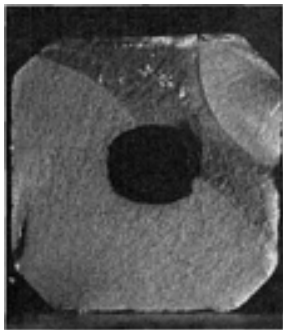
Fig. 760

Four fatigue-fracture surfaces that were produced in bending in the laboratory with the use of assorted notches to simulate service conditions; the material is AISI W1 tool steel. The specimen in Fig. 760, which was tested without a notch and fractured after 432,000 cycles at 365 MPa (53 ksi), shows two cracks origins at opposite corners where bending was maximum. The specimen in Fig. 761 had a single notch at top and broke after 20,500 cycles at 434 MPa (63 ksi); note the small shear lip around the region of fast fracture at bottom. The specimen in Fig. 762 was notched at two corners that were along an axis not in the plane of bending and broke after 50,000 cycles at 338 MPa (49 ksi); the two resulting fatigue cracks therefore had somewhat distorted shapes. The specimen in Fig. 763 was notched at four sites--two in the bending plane and two in a plane 60° from it--and broke after 10,260 cycles at 434 MPa (63 ksi). The four notches produced fatigue zones, which formed two major crack fronts that nearly penetrated the section. All at 2×

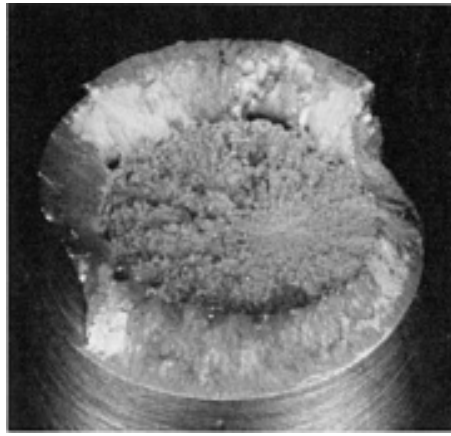
Fig. 774 Tension-overload fracture in an unnotched specimen of AISI H11 tool steel heat treated to a tensile strength of 2041 MPa (296 ksi) and 48% reduction of area. Note radial features between fibrous origin (just right of center) and shear lip. See also Fig. 775 and 776 for higher-magnification views of this fracture. 9×

Fig. 775 Another view of the fracture surface in Fig. 774, taken in the vicinity of the fracture origin, showing an unusually uneven array of dimpled facets with a scattering of large voids. See Fig. 776 for a higher-magnification view of the area in the rectangle. SEM, 1000×

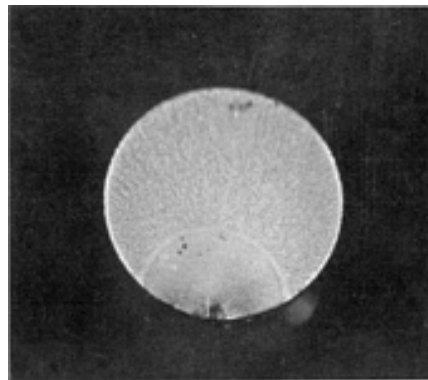
Fig. 786 High-cycle fatigue fracture in AISI H11 tool steel heat treated to a tensile strength of 2041 MPa (296 ksi) and 48% reduction of area, which broke after 775,000 cycles of tension-tension ($R = 0.1$) under a maximum load of 30% of tensile strength. The fatigue-crack origin is at the outer edge of the crescent-shaped region at bottom. See also Fig. 787 and 788 for higher-magnification views of this fracture. 6×

Fig. 787 An area within the crescent-shaped (fatigue) region of the fracture surface in Fig. 786. The surface contains many pockmarks, which resemble dimples. There are no suggestions of fatigue striations. See Fig. 788 for an enlargement of the area in the rectangle. SEM, 1000×

Fig. 789 Fracture caused by hydrogen embrittlement in threaded specimen of AISI H11 tool steel (same heat treatment and tensile strength as in Fig. 786). Hydrogen impregnation was by plating. Fracture occurred before the full sustained load could be applied and progressed around the circumference of the specimen. See also Fig. 790 and 791. 6×

Fig. 794 Fracture caused by stress-corrosion cracking in a threaded specimen of AISI H11 tool steel (same heat treatment and tensile strength as in Fig. 786) at a sustained loading of 75% tensile strength in a 3.5% NaCl environment at room temperature. Appreciable corrosion is evident. See also Fig. 795, 796, and 797. 6×

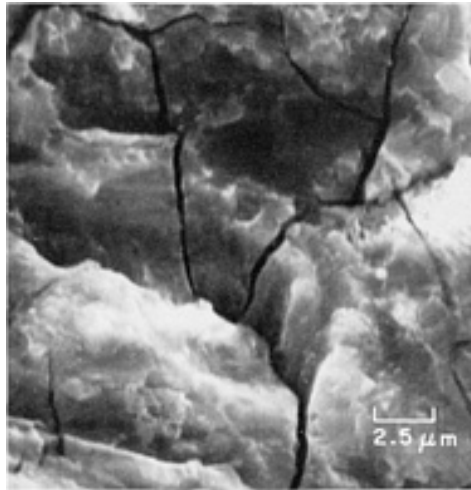
Fig. 797 High-magnification view of a region of the fracture in Fig. 794 not shown in Fig. 795, displaying grain-boundary facets and some corrosion. Some of the deep secondary cracks may be transgranular. SEM, 4000×

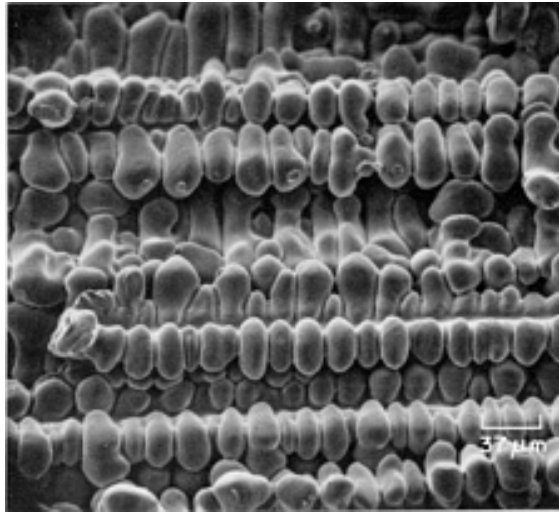
Fig. 803 Surface of tensile-test fracture in a cast specimen of 18% Ni, grade 300, maraging steel, showing a region where the fracture intersected a shrinkage cavity and exposed dendrites whose growth during solidification was arrested by a lack of molten metal within the cavity. In this view, the primary dendrite arms are oriented horizontally. See also Fig. 804 and 805. SEM, 270×

Fig. 804 Lower-magnification view of the exposed dendrites in the shrinkage cavity in the cast specimen of 18% Ni, grade 300, maraging steel in Fig. 803, showing dendrites that formed at different orientations. Had this casting been properly risered, the channels between the dendrite arms would have been filled, forming continuous metal. See also Fig. 805, which shows the area in the rectangle at higher magnification. SEM, 130×

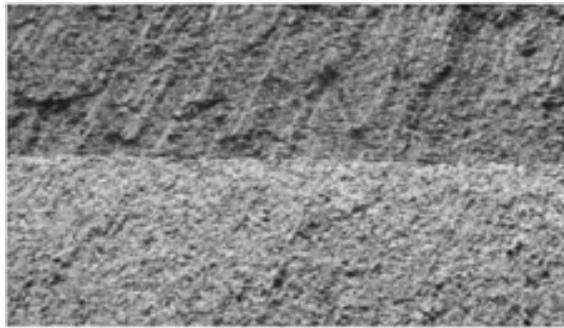
Fig. 806 Fracture surface of a fracture-toughness specimen of 18% Ni, grade 300, maraging steel; the heat treatment of this specimen was not reported. This view shows entry of the fatigue crack from bottom, and sharp onset of final fast fracture at center. See also Fig. 807 and 808; compare with Fig. 809. SEM, 26×

Fig. 807 SEM view, at higher magnification, of the fracture surface shown in Fig. 806, with the fatigue-crack surface at bottom and the fast-fracture surface at top. Note the secondary cracks and lack of clear fatigue striations in the fatigue area. See also Fig. 808. 300×

Fig. 808 Same fracture surface in 18% Ni, grade 300, maraging steel as in Fig. 806 and 807, shown here at still higher magnification. At bottom, fatigue has produced numerous secondary cracks. Note the stretched zone at center, at the transition from fatigue to final fast fracture. SEM, 1350×

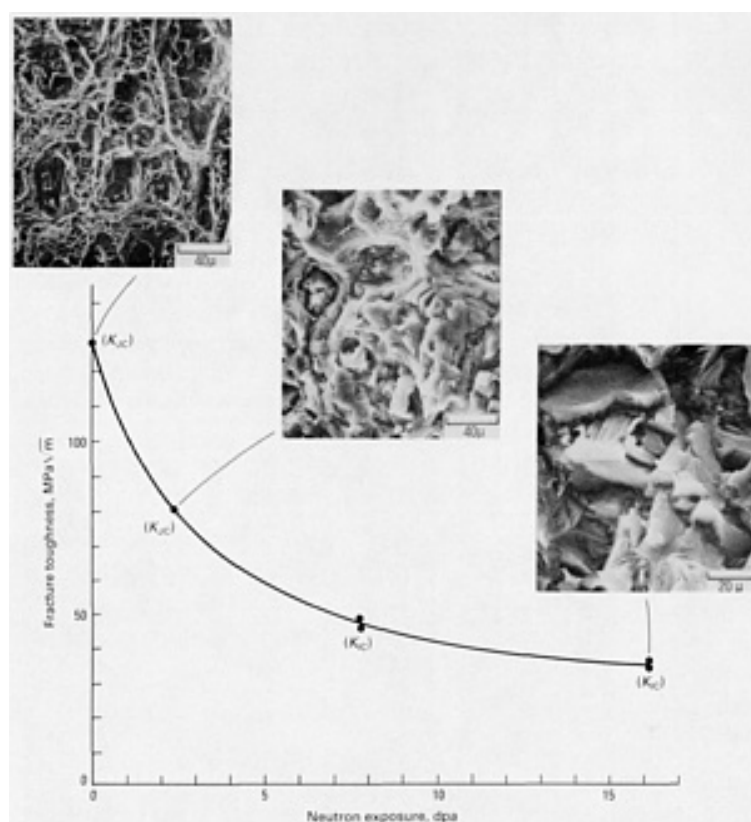
Fig. 823 Effect of neutron irradiation on fracture mode and fracture toughness of the iron-nickel-base superalloy A-286 (UNS S66286). The plot of fracture toughness versus neutron exposure charts the degradation of K_{IC} with increased irradiation. Note the fracture-mode transition from microvoid coalescence at no exposure to channel fracture in the highly irradiated condition. At the high exposure level, all dislocation activity was localized in a planar slip band, and cracking eventually initiated and propagated along the resultant dislocation channels, causing fracture toughness to fall off. (J.E. Nolan, Westinghouse Hanford Company)

- (e) Total includes two sulfur dot maps obtained by energy-dispersive x-ray spectroscopy (Fig. 825 and 827).
- (f) Total includes a graph of fracture toughness versus neutron irradiation that contains three superimposed electron fractographs (Fig. 823), a graph charting fatigue crack growth rate versus the stress intensity factor range that contains four superimposed electron fractographs (Fig. 846), and a schematic illustrating the selective area polishing technique (Fig. 847).
- (g) Total includes a tin distribution map obtained by energy-dispersive x-ray spectroscopy (Fig. 916).
- (h) Miscellaneous metals and alloys include tungsten, iridium, magnesium-base, iron-base, molybdenum-base, and tantalum-base materials.
- (i) Total includes two sulfur dot maps obtained by energy-dispersive x-ray spectroscopy (Fig. 1290 and 1292).

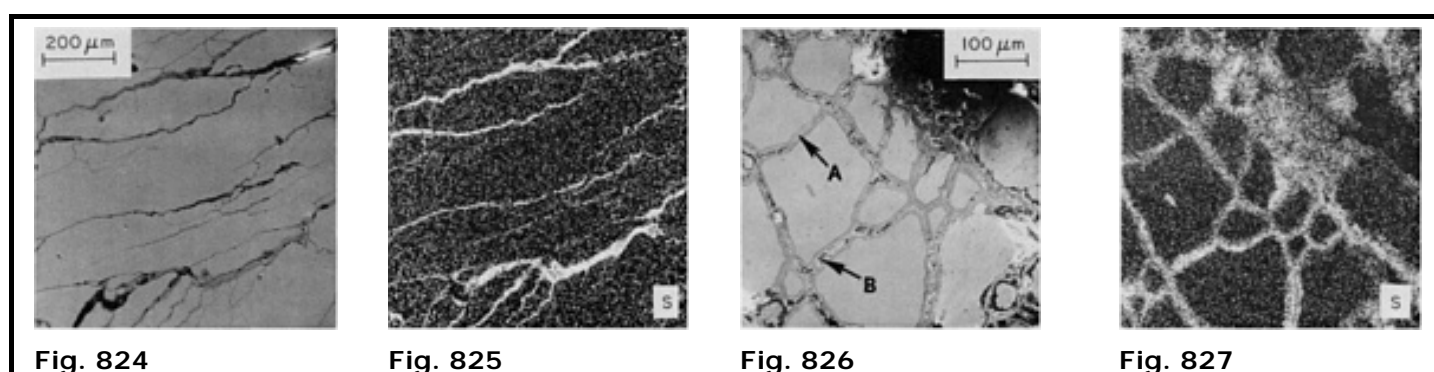
Failure due to sulfidation of a coupling for a hot-gas sampling line used in a coal-gasification pilot plant. The coupling was made of the iron-nickel-base superalloy RA-330 (UNS N08330), joined using Inconel alloy 182 filler metal (AWS A5.11, class ENiCrFe-3). It failed after 8500 h of service at a temperature of 870 to 980 °C (1600 to 1800 °F) in gas having this typical composition (in vol%): 56.9% H₂O, 16.9% H₂, 16.2% CO₂, 8.0% CO, 1.9% CH₄, and 0.1% H₂S. Higher H₂S levels may have been present on occasion. Sulfidation at the surface of the filler metal (~65% Ni) led to formation of the Ni₃S₂-Ni eutectic, which melts at 635 °C (1175 °F), well below the operating temperature of the coupling. This liquid phase penetrated the interdendritic regions of the weld metal and then the grain boundaries of the base metal. Fig. 824: Backscattered electron image of ENiCrFe-3 weld metal

showing severe interdendritic attack. SEM, 65×. Fig. 825: Sulfur map of field in Fig. 824 reveals high level of the element in interdendritic regions. Technique used was energy-dispersive x-ray spectroscopy (EDS). 65×. Fig. 826: Backscattered electron image of superalloy base metal adjacent to filler metal shows intergranular attack by $\text{Ni}_3\text{S}_2\text{-Ni}$ (at B), most of which transformed to more stable chromium sulfide (at A). SEM, 130×. Fig. 827: Sulfur map of field in Fig. 826 reveals high levels of the element in grain boundaries. 130× (D.R. Diercks, Argonne National Laboratory)

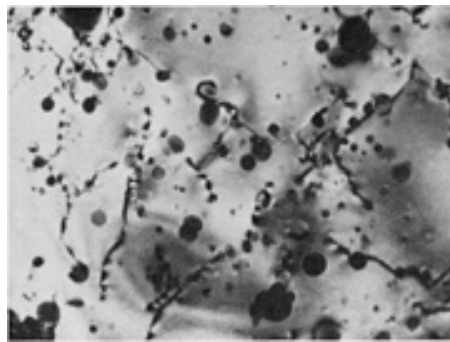
Fig. 852 "Departure side pinning" during creep of Inconel alloy MA754. The mechanically alloyed nickel-base superalloy is stabilized by yttria (0.8% Y_2O_3). Samples were tested in creep to 2% strain at 760 °C (1400 °F) and 221 MPa (32 ksi) and then cooled on load. TEM examination revealed that dislocations were still associated with Y_2O_3 particles--the departure side pinning phenomenon. Etched in 60% ethanol, 30% *n*-butanol, 10% perchloric acid (70%). TEM thin foil, 76,800× (J.K. Tien, V.C. Nardonne, and D. Matejczyk, Columbia University).

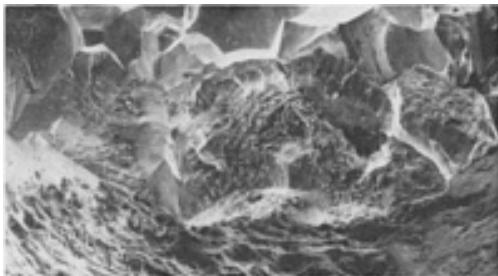
Fatigue fracture of Udimet 720 tested in a salt environment at 705 °C (1300 °F). Sample heat treatment and salt composition same as in Fig. 861. Test conditions: 827 MPa \pm 69 MPa (120 ksi \pm 10 ksi), 5000 cycles to failure. Fig. 863: Fracture surface shows intergranular origin at grain-boundary triple point (near bottom) with subsequent transgranular propagation. Because origin is near the surface, corrosion may have had an effect on fracture initiation. River patterns in transgranular portion of fracture reveal crack path. SEM, 23 \times . Fig. 864: Higher-magnification view of fatigue fracture origin in Fig. 863. SEM, 82 \times (E.A. Schwarzkopf, J. Stefani, and J.K. Tien, Columbia University)

conditions same as in Fig. 863 and 864. Cycles to failure: 66,000, compared with 5000 for the sample tested in a salt environment (Fig. 863 and 864). Fracture surface shows multiple transgranular fatigue origins near edge of sample. River patterns reveal initiation sites at specimen surface and grain boundaries perpendicular to the stress axis. SEM, 40× (E.A. Schwarzkopf, J. Stefani, and J.K. Tien, Columbia University)

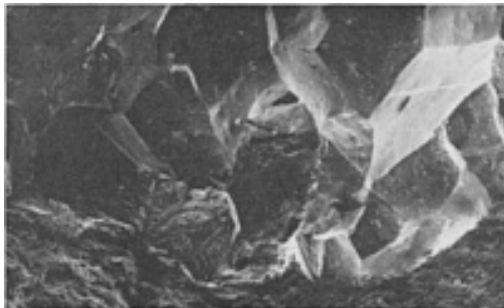
Fig. 866 Creep fracture of Udimet 720 tested in a salt environment at 705 °C (1300 °F). Sample heat treatment and salt composition same as in Fig. 861. Test stress: 896 MPa (130 ksi). Fractograph shows salt-coated sample surface and intergranular stress-rupture surface. Note salt corrosion of grain boundaries that intersect the sample surface. SEM, 40× (E.A. Schwarzkopf, J. Stefani, and J.K. Tien, Columbia University)
