ASM HANDBOOK®

VOLUME
12

Fractography

Fractography, was published in 1987 as Volume 12 of the *ASM Handbook*. The Volume was prepared under the direction of the ASM Handbook Committee.

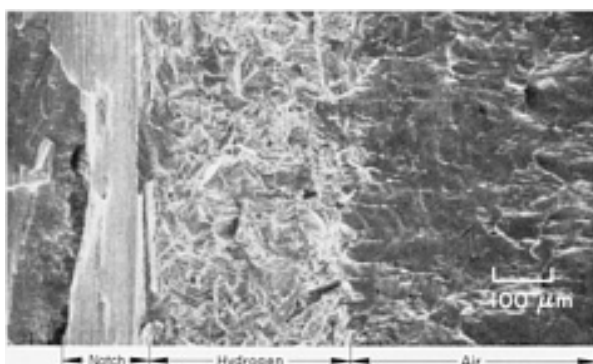
Fig. 867 Surface of a fracture in a bend-test specimen of Nickel 201 containing 0.02% C, 0.35% Mn, 0.01% S, 0.35% Si, 0.25% Cu, 0.04% Fe, remainder Ni. After the material had been annealed, a specimen 19 mm ($\frac{3}{4}$ in.) wide by 3.17 mm (0.13 in.) thick was prepared, a notch was machined in the side of the specimen, and a fatigue crack was produced in the root of the notch. The specimen was then loaded in three-point bending (77-mm, or 3-in., support span) to give a fixed displacement rate of 0.0015 μm/s. The test was performed at room temperature in a stainless steel chamber equipped for testing in vacuum, in hydrogen, or in air. During the first portion of the test, the chamber was filled with hydrogen, partway through the test, the hydrogen was replaced with air. In this view, the notch at the left, and just to the right of the root of the notch is a very shallow fatigue crack. The central region (light) is the portion of the fracture that was obtained in hydrogen, and the darker region of the right is the portion that was subsequently produced in air. See Fig. 868, 869, 870, and 871 for higher-magnification views of the portions produced in hydrogen and in air, and of the transition between them. SEM, 100×

Fig. 868 View of an area of the fracture surface in Fig. 867 that shows the transition from fracture in hydrogen (left) to subsequent fracture in air (right). Much of the fracture in hydrogen shows transgranular cleavage. In the portion produced in air, flow occurred after the crack front has passed. SEM, 540×

Fig. 869 View of the fracture surface in Fig. 867, showing a region from the portion of the fracture that was produced in air. Visible are suggestions of dimples, but these features have been largely obscured by the effects of the secondary flow that occurred in this very ductile metal following passage of the crack front. SEM, 2000×

Fig. 870 View of the fracture surface in Fig. 867, showing a region from the portion of the fracture that was produced in hydrogen. As in the left portion of Fig. 868, the fracture here is mainly by transgranular cleavage. Scattered regions of intergranular were reported, but are not visible here. See also Fig. 871. SEM, 500×

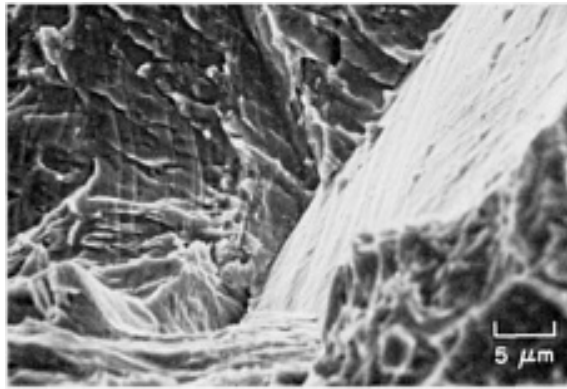
Fig. 871 Higher-magnification view of the area in the rectangle in Fig. 870, showing the ledgelike character of the cleavage facets. In contrast, a suggestion of dimpled rupture is visible a bottom right. Note the small tongues on the bright facet at right. SEM, 2000×

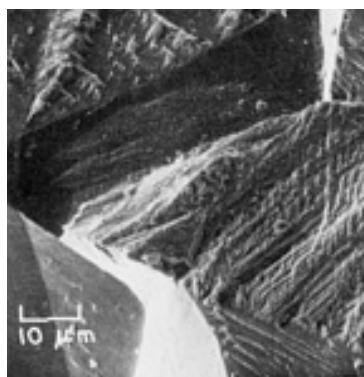
Fig. 873 A portion of the same fracture surface as that in Fig. 872, but at higher magnification, showing facets that contain cleavage river patterns (bottom right) and pyramid-shaped tongues (top left). SEM, 1000×

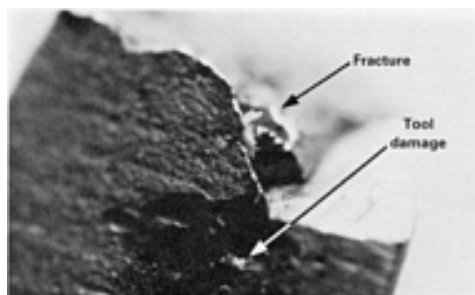
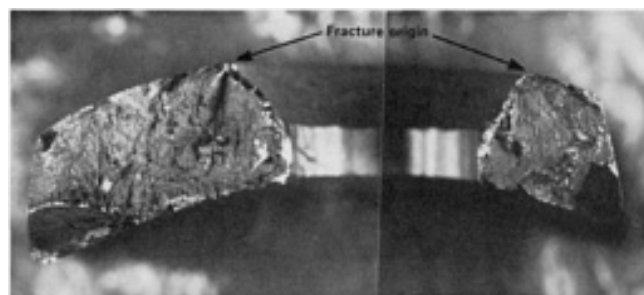
Fatigue fracture of a cast Vitallium (Co-30Cr-7Mo) surgical implant (side plate of Jewett nail) due to improper insertion. A tool used by the surgeon to contour the plate prior to its insertion into the patient also accidentally damaged the surface of the implant, introducing microcracks that led to fracture. Fig. 881: Tool damage on surface of implant near fracture surface. 3×. Fig. 882: The Jewett nail broke across a screw hole. Radial marks on the fracture surface (shown here) reveal the fatigue crack origin near the top of the hole. 10× (C.R. Brooks and A. Choudhury, University of Tennessee)

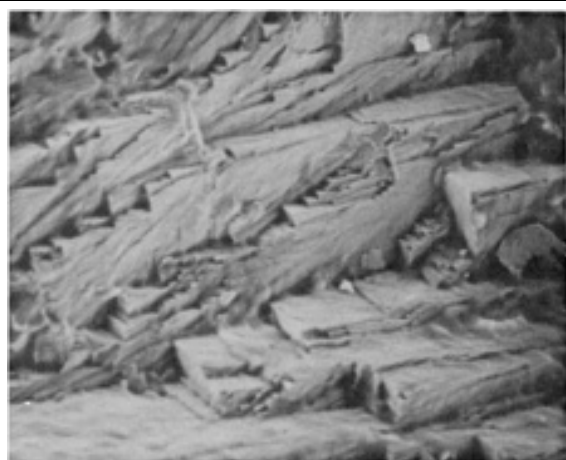
Fig. 883

Fatigue fracture of cast ASTM F75 alloy (Co-28Cr-6Mo). Material was solution treated prior to testing on a cantilever-beam machine. Fig. 883: "Stair step" fracture surface indicative of stage I fatigue. SEM, 515×. Fig. 884: Photomicrograph reveals stage I fatigue cracking. FeCl₃ electrolytic etch, 200× (R. Abrams, Howmedica, Division of Pfizer Hospital Products Group, Inc.)

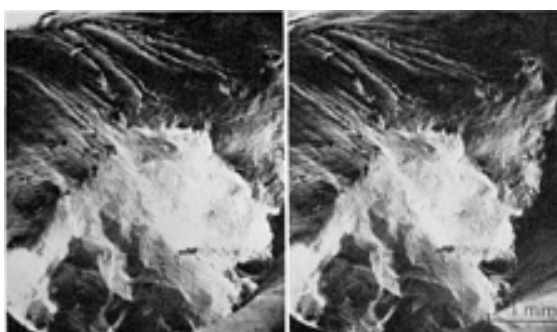
Fig. 891 Fracture at 525 °C (977 °F), 10.3 MPa (1.5 ksi). 12.5×

The specimen in Fig. 891 was tested at 525 °C (977 °F) and 10.3 MPa (1.5 ksi) and attained a steady-state strain rate 5.0×10^{-7} /min, fracturing in 300 h, 6 min; its fracture surface has larger and smoother facets than those in Fig. 889 and 890. At top in this view is a region that fractured by transgranular rupture accompanied by plastic flow. The specimen in Fig. 892, 893, and 894 was tested at 540 °C (1004 °F) and

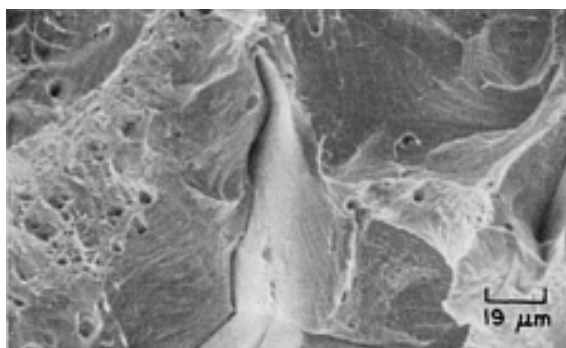
Fig. 907 Higher-magnification view of the area in the rectangle in Fig. 906, revealing a fine structure of dimples, which resulted from microvoid coalescence, on the separated-grain facets. The regions of intergranular fracture here may have been caused by increased coarsening of the spinodal microstructure at the grain boundaries. SEM, 525×

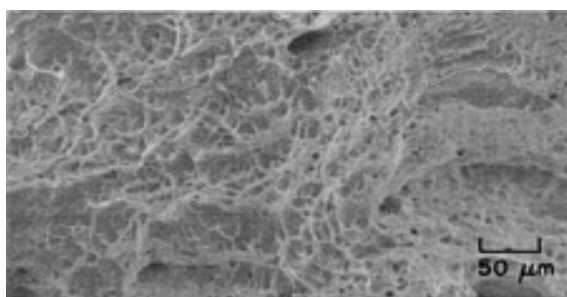
Fig. 908 Tensile-overload fracture in a fracture-toughness test specimen of the same 64Cu-27Ni-9Fe alloy as in Fig. 906, but here spinodal decomposition occurred during heat treatment at 775 °C (1425 °F) for 100 h. Only dimpled transgranular facets are visible (no intergranular facets); this may be due to a coarser spinodal structure resulting from the longer heat treatment. SEM, 200×

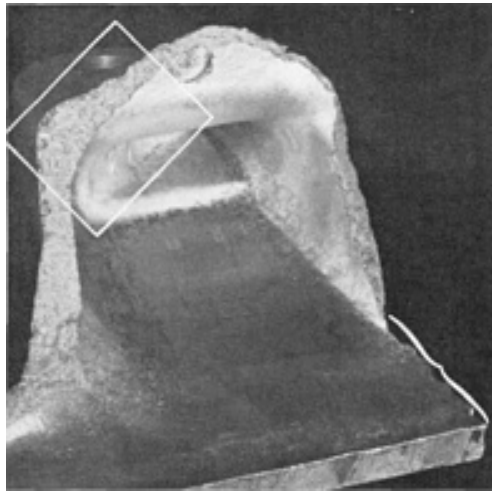
Fig. 921 A portion of a fractured carrier tray and sand cast of an aluminum alloy intended to be 356.0-T6. Chemical analysis revealed that the copper and zinc contents were of an order of magnitude above the specified limits. The silicon content was approximately as dictated by the specification. The hardness measured 82 HB--appreciably above the 70 HB expected. Tensile strength was 179 to 193 MPa (26 to 28 ksi)--slightly below the specified minimum of 207 MPa (30 ksi). See Fig. 922 for the area in the rectangle and Fig. 923 for bracketed area at a magnification of 3 \times . Actual size

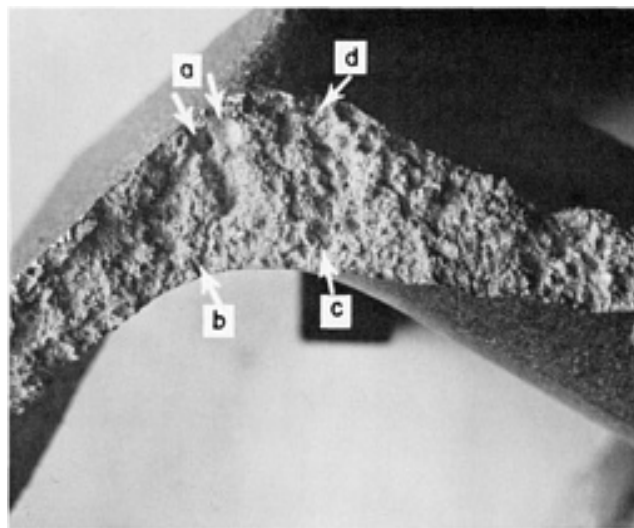
Fig. 922 Fracture surface of the shoulder of the sand-cast carrier tray shown in the rectangle in Fig. 921. The appearance of this surface suggests that fracture occurred in a brittle manner. The two arrows at "a" indicate two large gas cavities. The arrows at "b," "c," and "d" identify sites that were examined with a scanning electron microscope. (SEM fractographs of these sites are shown in Fig. 924 and Fig. 925.) Note the absence of shear lips on the edges of this fracture surface, indicating a general lack of ductility. 3 \times

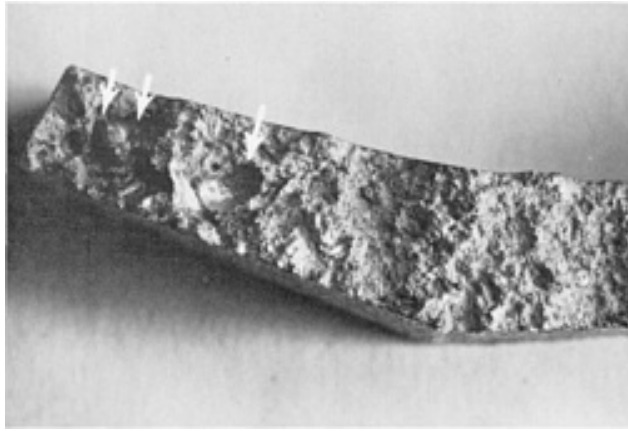
Fig. 923 This fracture surface is from the bracketed edge of the sand-cast carrier tray in Fig. 921. Like the surface shown in Fig. 922, the one here exhibits the characteristics of brittle fracture, there being no sign of a shear lip at any of these edges. Again, there is evidence of porosity; the arrows point to quite large gas cavities. The cavities could have been caused by a reaction between the liquid metal and organic binders in the sand mold, or could have resulted from entrapped air being carried into the mold by undue turbulence in pouring the casting. 3×

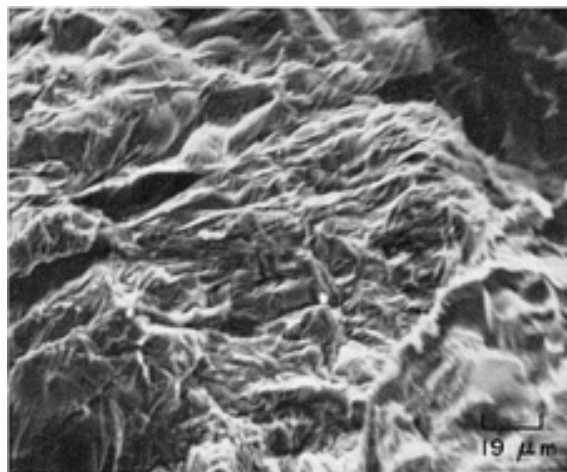
Fig. 928 Enlarged view of a part of the fracture surface area in Fig. 927. Some features vaguely resemble fatigue striations, but it is doubtful that they were caused by fatigue inasmuch as they do not seem to have been formed in an orderly sequence (and there are no beach marks in Fig. 922 and 923). Instead, the surface is very tumbled, with no suggestion of fatigue patches, and many regions bear whiskerlike features resembling some form of cleavage step. Lacking a significant amount of dimples, this surface can be rated as a brittle fracture. SEM, 520 \times

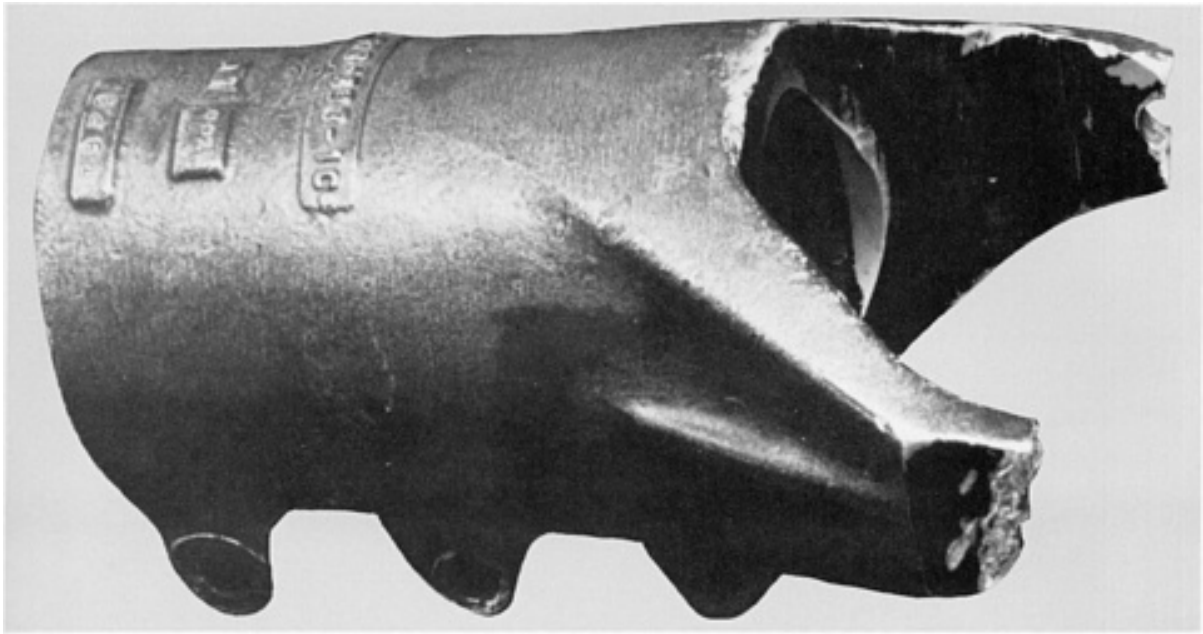
Fig. 929 A broken extension-housing yoke, part of a helicopter tail-rotor drive assembly, that fractured by fatigue in service. The fracture occurred through the left and right lugs at the points of attachment to the tail boom. The yoke was cast from aluminum alloy 356.0 and heat treated to the T6 temper. Chemical analysis showed that the composition of the yoke conformed to specifications, except for silicon, which was 0.05% below the required minimum. Hardness measurements ranged from 48 to 52 HRB (or about 81 to 85 HB), which was above the required minimum. Details of the fractures are shown in Fig. 930, 931, 932, 933, 934, 935, 936, 937, and 938. Actual size

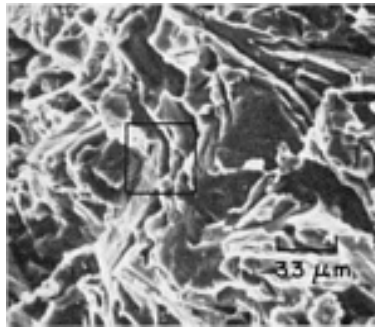
Fig. 941 A cellular region that was found to be characteristic of the fracture surface in Fig. 938. Although some features faintly suggest dimples, the higher-magnification view in Fig. 942 reveals no dimples. SEM, 300×

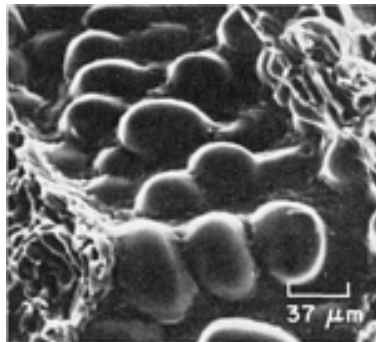
Fig. 952 View of fracture surface in Fig. 949, 950, and 951, displaying a shrinkage cavity. Cavity is somewhat like those in Fig. 940, but with a much coarser dendrite cell structure. SEM, 270×

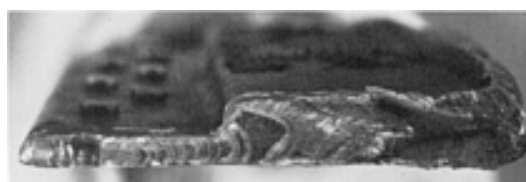
Fig. 975 View of the fracture surface in Fig. 974. The rivet hole intersected by the fracture is abnormal, consisting of two overlapping holes (see Fig. 976). Beach marks, which are clearly visible, indicate that the fatigue crack began at the double-drilled rivet hole. 1.13×

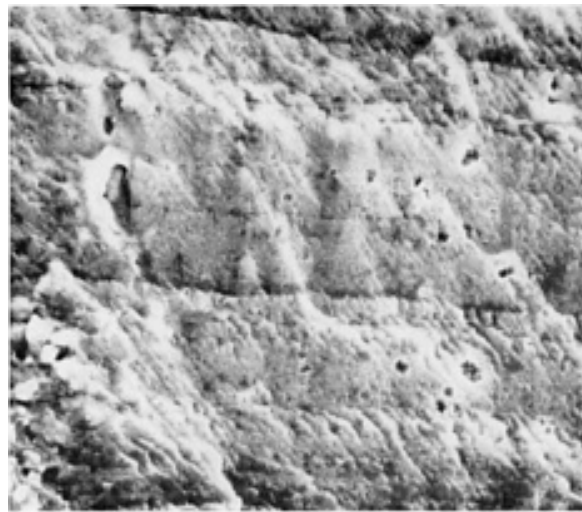
Fig. 980 Fatigue fracture of an aluminum alloy 2014-T6 heat-treated forging. Details of the heat-treatment procedure were not available. Some machining was carried out on the forging prior to heat treatment. The aircraft structural component cracked in service. The horizontal lines on the fracture surface are grain boundaries. Fatigue striations are also visible, traversing the fracture face at roughly 60°. Note the absence of discontinuities at their intersections with the grain boundaries. SEM, 1800× (E. Neub, University of Toronto)

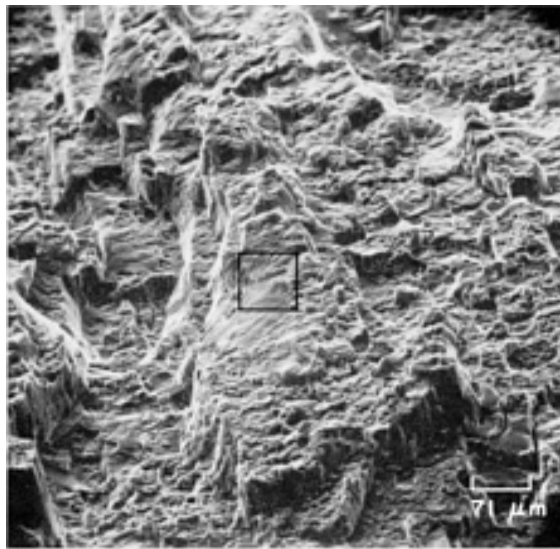
Fig. 982 A different area of the fracture surface shown in Fig. 981. This also exhibits vertical faces that are tear ridges. The surface is covered with voids, but at this low magnification it is not possible to decide whether or not they are dimples. The smooth central area outlined by the rectangle is shown enlarged in Fig. 983. SEM, 140×

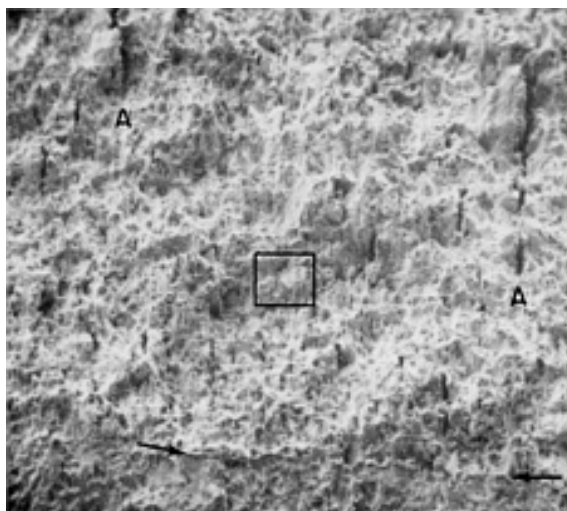
Fig. 1005 Fracture surface of a fracture-toughness test specimen of aluminum alloy 7075-T6, showing the zone of transition from the fatigue-precrack region (below arrows) to the tension-overload plane-strain fracture region (above arrows). Specimen was aged 24 h at 120 °C (250 °F); tensile strength was 593 MPa (86 ksi), and uniform elongation was 13%. Note the appreciable number of vertical delaminations (as at A's), which probably are grain-boundary separations, caused by the transverse tensile stress in the plane-strain region. Area in rectangle is shown enlarged in Fig. 1006. SEM (gold shadowed), 50×

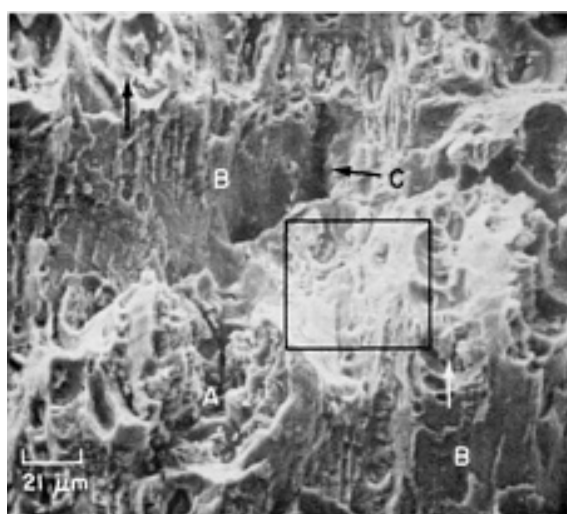
Fig. 1006 Area outlined by the rectangle in Fig. 1005, as seen at ten times the magnification there. It is apparent that the matrix contained many second-phase particles that have undergone brittle fracture (arrows). The surface is quite complex, with some regions that appear to show clusters of minute dimples (A) and other regions that strongly resemble intergranular fracture (B's). At C is one of the numerous vertical fissures visible in Fig. 1005, presumably elongated during tension overload. See Fig. 1007 for a higher-magnification view of area in rectangle here. SEM (gold shadowed), 480×

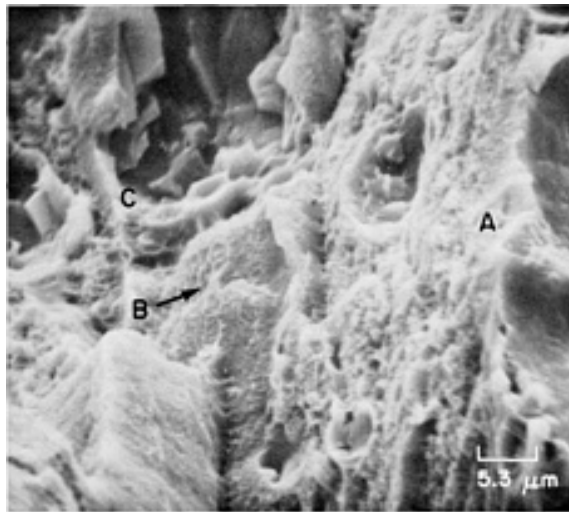
Fig. 1007 Higher-magnification view of the area in the rectangle in Fig. 1006. At A is a region of extremely fine dimples, which are slightly out of focus. At B, there appear to be grain-boundary facets bearing small, very shallow dimples. At C are fragments of a number of second-phase inclusions, many of which have separated from their original pockets in the matrix. SEM (gold shadowed), 1900×

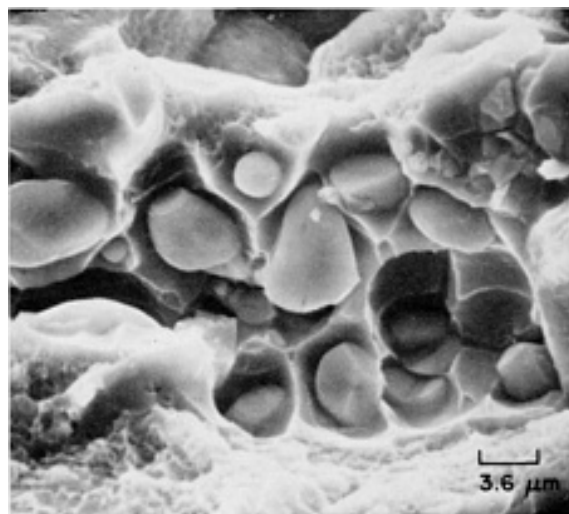
Fig. 1008 Tension-overload fracture in the short-transverse plane of a specimen of aluminum alloy 7075-T6. At top and bottom are regions of quite small dimples. In the central portion of this view are large pockets in which the cleaved facets of intermetallic inclusions are visible. These inclusions, which are rich in iron and silicon, are only slightly bonded to the walls of the pockets. SEM, 2800×

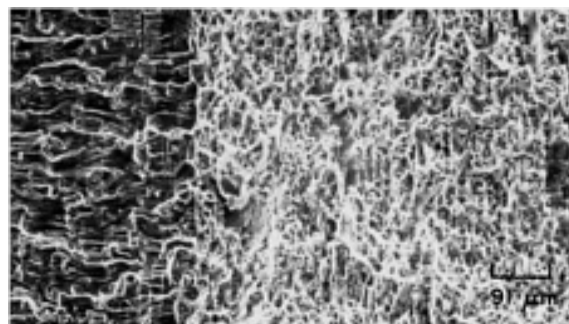
Fig. 1009 Specimen of aluminum alloy 7075-T6 broken in a slow-bend fracture-toughness test in air. Dark area, at left, is the fatigue-precrack surface, which shows no fatigue striae. At right is the tension-overload fracture surface; here, the surface appears dimpled, although this is uncertain at only 110 \times . See also Fig. 1010. SEM, 110 \times

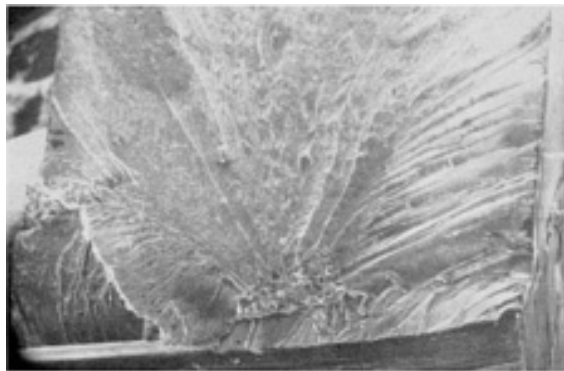
Fig. 1042 Fatigue fracture in a notched plate specimen of aluminum alloy 7075-T6 subjected to cyclic stresses in air. (Notch is at bottom; sides of plate, at far left and right). It is apparent that the fracture consists of at least three cracks that formed on various planes and temporarily grew independently. SEM, 26×

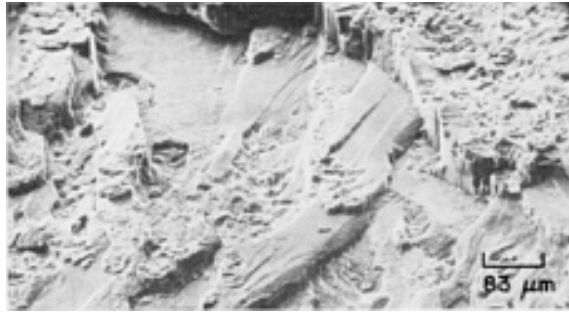
Fig. 1054 Surface of a corrosion-fatigue fracture in a specimen of aluminum alloy 7075-T6 that was tested in a 3.5% NaCl solution. Shown here are portions of two grains that exhibit brittle striations; the difference in appearance of their striations is caused by the difference in grain orientation. The vertical dividing line is the boundary between the grains. SEM, 1150×

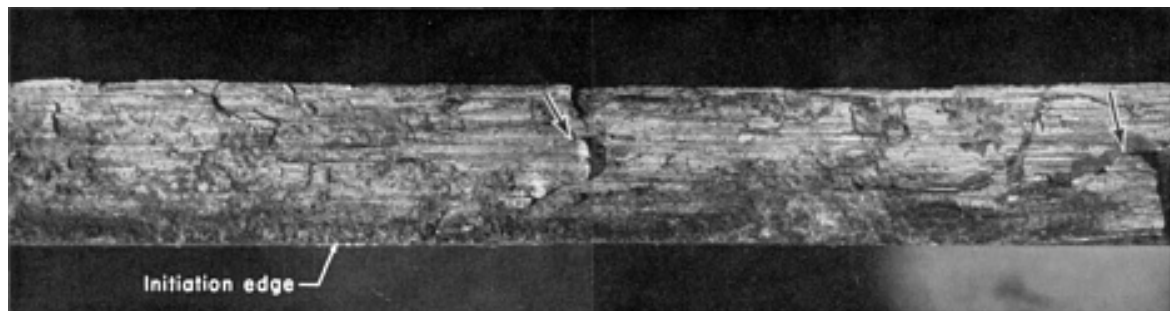
Fig. 1060 Surface of a fracture in an aircraft lower-bulkhead cap fabricated from an extrusion of aluminum alloy 7075-T6. The cap was cut open to expose the fracture for inspection, and evidence of corrosion was found along the edge at which fracture was initiated (bottom edge in this view). Secondary cracks had produced "leaves" (at arrows) in the fracture surface. See also Fig. 1061, 1062, 1063, 1064, 1065, 1066, 1067, 1068, and 1069. 8×

Fig. 1061 A portion of the painted external surface of the fractured aircraft lower-bulkhead cap in Fig. 1060, showing a profile of the fracture surface (at top) and voids in the paint film. Subcracks are evident immediately below and parallel with the fracture surface. Compare with Fig. 1062. 8 ×

Fig. 1062 Another portion of the painted external surface of the cap in Fig. 1060. Fracture surface, shown in profile at top, contains a "leaf"; compare this view of the "leaf" with that in Fig. 1060, which is normal to the fracture surface. As in Fig. 1061, paint voids are evident. 8 ×

Polished and etched sections through two portions of the fractured bulkhead cap in Fig. 1060, showing "leaves" in the fracture surface (in profile, at top). Note the elongated grains, which are parallel with the fracture surface. Note also that both the primary and secondary cracks are intergranular. Intergranular corrosion has nearly separated several of the "leaves" from the fracture surface. Stress-corrosion cracking was favored by imposition of tensile stresses in installation and by exposure to a marine atmosphere in service. Both etched in Keller's reagent. 100×

Fig. 1066 TEM p-c replica of an area of the fracture surface in Fig. 1060 near the edge at which fracture was initiated, showing corrosion debris on a very flat intergranular surface. The original separated-grain facets have been corroded away. 3000×

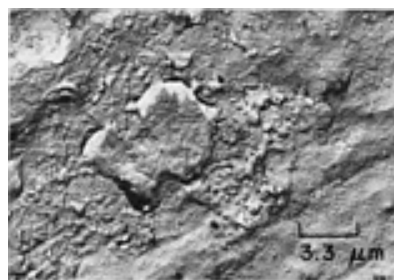
Fig. 1067 TEM p-c replica taken from another area of the fracture surface in Fig. 1060 near the edge at which fracture was initiated. This area, like the one in Fig. 1066, shows that cracking was intergranular and was accomplished by severe corrosion. 3000×

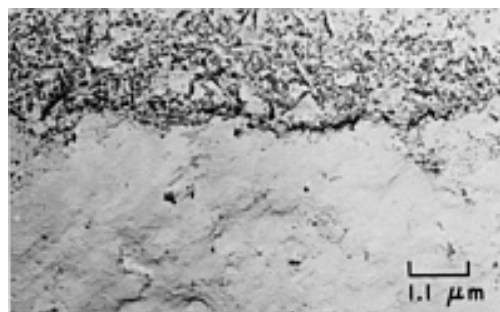
Fig. 1072

TEM p-c replicas of two areas of the surface of a fracture in a forged aluminum alloy 7075-T6 support for a cargo-door cylinder. The fracture, which originated at a cold shut, formed at an attachment hole that extended above and below the cold shut. These TEM replicas reveal that the fracture surface is flat and encrusted with oxide particles. Fig. 1072: 6500×. Fig. 1073: 9300×

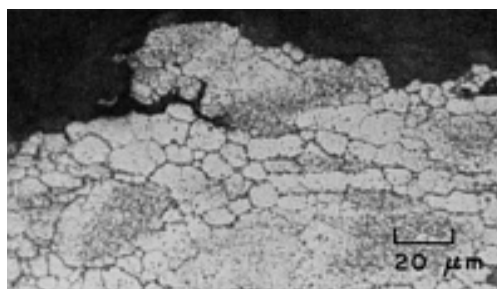
Fig. 1075 Polished and etched section through the light region at arrow "d" in Fig. 1076. At top in this view is the profile of the fracture surface. Note that the fracture usually followed grain boundaries. Cracks branching from the fracture surface are also evident. Etched in Keller's reagent, 500×

Fig. 1076 Surface of the fracture in the bogie beam shown in Fig. 1074. Three stress-corrosion cracks caused the final fast fracture, which was a tearing type of rupture. The intergranular attack characteristic of stress corrosion is shown in Fig. 1075. The three stress-corrosion cracks are the light areas marked by arrows "b," "c," and "d." The crack surfaces appear flat, but contain many small steps. Some of these steps were found to have been pulled away from the fracture surface in a leaf fashion, indicating overlapping or branching cracks. At arrow "e" is a pronounced step, which hides a portion of area "b." ~0.4×

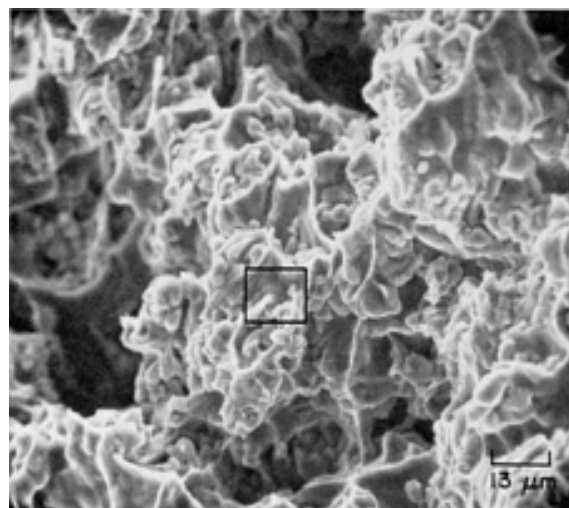
Fig. 1084 Higher magnification view of the area in the rectangle in Fig. 1083, showing more clearly the details

of the fracture surface. It should be noted that the grain size of this specimen is approximately 7 μm . Note also that a majority of the dimples contain one or more particles--probably particles of the CuAl_2 phase of the eutectic. See Fig. 1085 for a higher-magnification view of area in rectangle here. SEM, 770 \times

Fig. 1086 Tensile-overload fracture in a specimen of 67Al-33Cu alloy that was cast, extruded, and tested the same as the specimen in Fig. 1083. In this specimen, the grain size is only 2 μm . It appears that both the large dimples and the CuAl_2 particles here are smaller than those in Fig. 1084. SEM, 670 \times

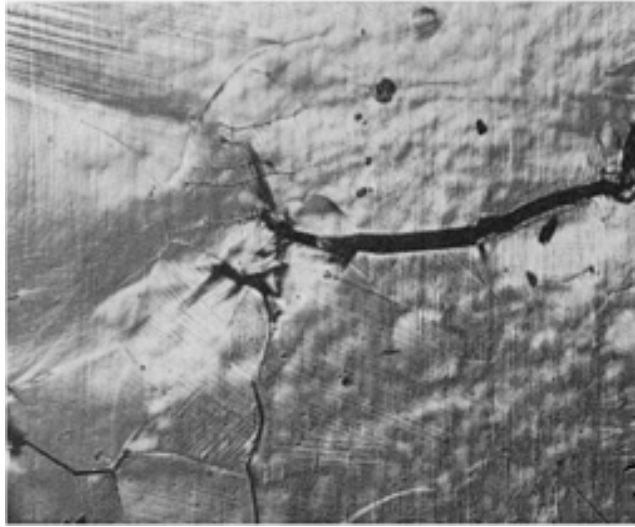
Fig. 1087 Deformation at the tip of a fatigue crack in Al-5.6Zn-1.9Mg. The experimental alloy was heavily cold worked, solution treated for 1.5 h at 465 °C (870 °F) in flowing argon, aged for 24 h at 120 °C (250 °F) to develop peak hardness, and then tested in fatigue. Sample electropolished in a mixture of perchloric acid, ethanol, butyl cellusolve, and water and observed under phase-contrast illumination. SEM, 200× (R.E. Ricker, University of Notre Dame, and D.J. Duquette, Rensselaer Polytechnic Institute)

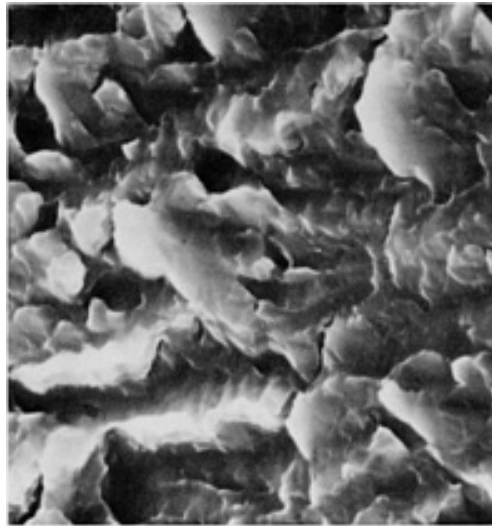
Fig. 1088 Transgranular corrosion-fatigue crack propagation in a solution-treated and peak-aged Al-5.6Zn-1.9Mg sample tested in humid nitrogen gas. Compare with Fig. 1091 and 1092. SEM, 5000× (R.E. Ricker, University of Notre Dame, and D.J. Duquette, Rensselaer Polytechnic Institute)

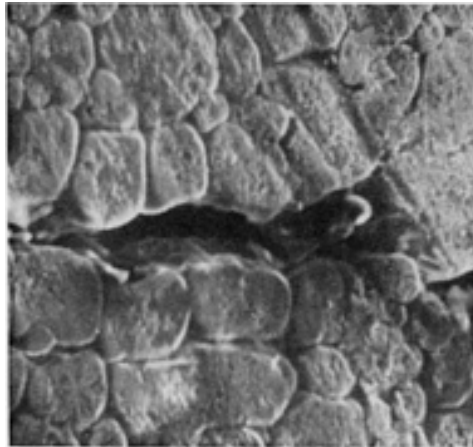
Fig. 1096 Fracture along prior powder particle boundaries in cold-rolled Al-4.2Mg-2.1Li. The experimental P/M alloy was solution treated for 1 h at 510 °C (950 °F), water quenched, naturally aged, and then cold rolled to a 4% thickness reduction in one pass. The cracks at particle boundaries reflect the low ductility typical of aluminum-lithium alloys. SEM, 375× (R.E. Ricker, University of Notre Dame, and D.J. Duquette, Rensselaer Polytechnic Institute)

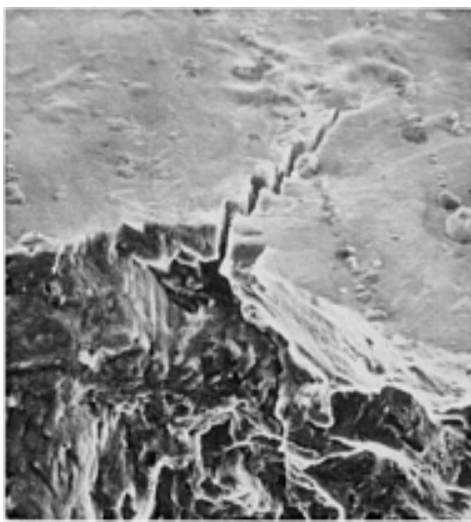
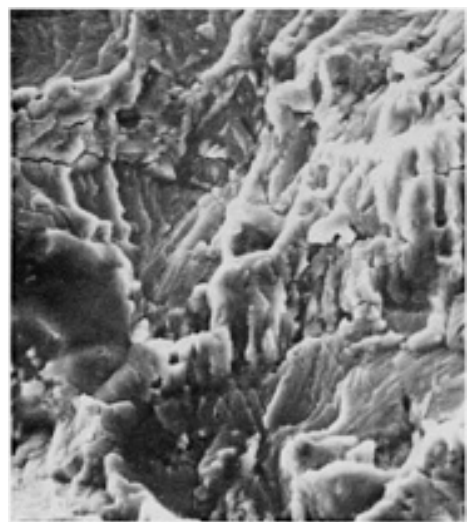
Corrosion-fatigue crack initiation and propagation in a solution-treated and peak-aged Al-4.2Mg-2.1Li P/M alloy tested in deaerated high-purity water. Fig. 1097: View of external surface (top) and fracture surface (bottom). SEM, 500×. Fig. 1098: Higher-magnification view of fracture surface. SEM, 1000× (R.E. Ricker, University of Notre Dame, and D.J. Duquette, Rensselaer Polytechnic Institute)

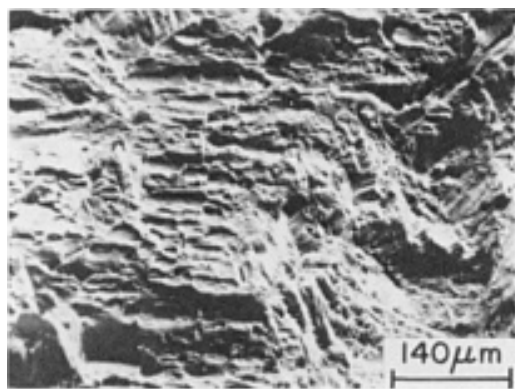
Fatigue crack growth fracture topography in a Ti-6Al-2Sn-4Zr-2Mo-0.1Si (Ti-6242, UNS R54620) forging, $\alpha + \beta$ processed prior to β heat treatment and aging. Compact tension specimen tested in air at 25 °C (75 °F). As crack growth rate (da/dN) and stress-intensity factor (ΔK) increased, the fracture surface changed from one characterized by large transgranular facets to one exhibiting intergranular facets and dimples. Crack growth direction is from left to right. Fig. 1103, 1104 and 1105: Fracture surface at low ΔK ($<25 \text{ MPa } \sqrt{m}$, or $23 \text{ ksi } \sqrt{in}$) and da/dN of $0.005 \text{ } \mu\text{m/cycle}$. Note large transgranular facets in Fig. 1103 and 1104. Intermixed with the facets were regions of pronounced secondary cracking (Fig. 1105). SEM; 60 \times , 125 \times , and 2900 \times . Fig. 1106: At intermediate ΔK (25 to $38 \text{ MPa } \sqrt{m}$, or $23 \text{ to } 35 \text{ ksi } \sqrt{in}$) and a da/dN of $0.1 \text{ } \mu\text{m/cycle}$, the amount of faceting decreased, being replaced by more ductile modes of fracture. SEM, 12 \times . Fig. 1107 and 1108: At high ΔK ($>38 \text{ MPa } \sqrt{m}$, or $35 \text{ ksi } \sqrt{in}$) and da/dN of $0.5 \text{ } \mu\text{m/cycle}$, the fracture surface was characterized by striations, microvoids, and dimples. SEM, 12 \times and 1250 \times . Fig. 1109 and 1110: Final separation occurred along prior- β grain boundaries (Fig. 1109, $da/dN = 20 \text{ } \mu\text{m/cycle}$), with the intergranular fracture surface exhibiting dimples (Fig. 1110, fast fracture region). SEM, 150 \times and 3500 \times (J.A. Ruppen and A.J. McEvily, University of Connecticut)

Same material as in Fig. 1103, 1104, 1105, 1106, 1107, 1108, 1109, and 1110, but tested in air at 540 °C (1000 °F). Crack growth direction is from right to left. Fig. 1111: At $da/dN = 0.018 \mu\text{m}/\text{cycle}$, the fracture surface was 100% faceted. The macroscopically smoother surface (compare with Fig. 1103) reflects the effect of oxidation. SEM, 150×. Fig. 1112: High-magnification view of a facet reveals parallel markings that indicate the underlying α -platelet microstructure and highlight the tendency for crack propagation to occur perpendicular to the α platelets. One of many small, parallel cracks is noted at A. SEM, 1500× (J.A. Ruppen and A.J. McEvily, University of Connecticut)

Same material as in Fig. 1103, 1104, 1105, 1106, 1107, 1108, 1109, 1110, 1111, and 1112, but tested in vacuum at room and elevated temperatures. Fracture surfaces were more ductile appearing, and striation formation was suppressed (compare with samples tested in air). Fig. 1113: At 25 °C (75 °F) and $da/dN = 0.0051 \mu\text{m}/\text{cycle}$, both the degree of faceting and the irregularity of the fracture surface were reduced (compare with Fig. 1104). Crack growth direction is from left to right. SEM, 1500×. Fig. 1114: At 540 °C (1000 °F) and $da/dN = 0.0051 \mu\text{m}/\text{cycle}$, the amount of faceting increased but not to the extent observed in samples tested in air (Fig. 1111). Crack growth direction is from right to left. SEM, 840× (J.A. Ruppen and A.J. McEvily, University of Connecticut)

Fatigue crack growth fracture topography in a Ti-6Al-2Sn-4Zr-2Mo-0.1Si (Ti-6242, UNS R53620) forging, β processed prior to $\alpha + \beta$ heat treatment and aging. (Contrast with the $\alpha + \beta$ forging in Fig. 1103, 1104, 1105, 1106, 1107, 1108, 1109, 1110, 1111, 1112, 1113, and 1114.) Compact tension specimen tested in air at room and elevated temperatures. Crack growth direction is from left to right in room-temperature fractographs, and from right to left in elevated-temperature fractographs. Fig. 1115 and 1116: At low da/dN ($0.025 \mu\text{m}/\text{cycle}$) and at 25 and 540 °C (75 and 1000 °F), respectively, the β forging exhibited a less irregular fracture surface consisting of smaller facets (compare with Fig. 1103 and 1111). Features in this microstructure-sensitive regime are related to the prior- β grain size of the β forging and the colony size of the $\alpha + \beta$ forging. SEM, 150 \times . Fig. 1117 and 1118: At higher da/dN ($2.5 \mu\text{m}/\text{cycle}$) and at 25 and 540 °C (75 and 1000 °F), respectively, fracture modes were the same in both β and $\alpha + \beta$ forged material, but the β forging exhibited elongated dimples corresponding to the underlying α/β platelet microstructure (Fig. 1117) and more secondary cracking at elevated temperature (Fig. 1118). SEM, 350 \times and 150 \times (J.A. Ruppen and A.J. McEvily, University of Connecticut)

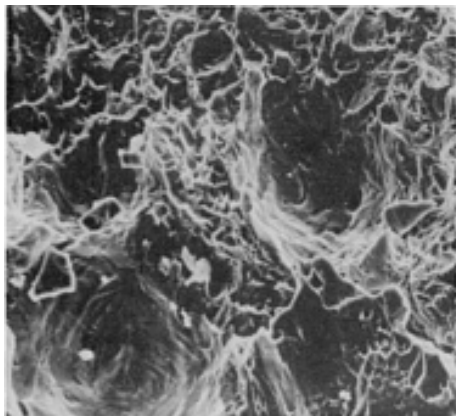
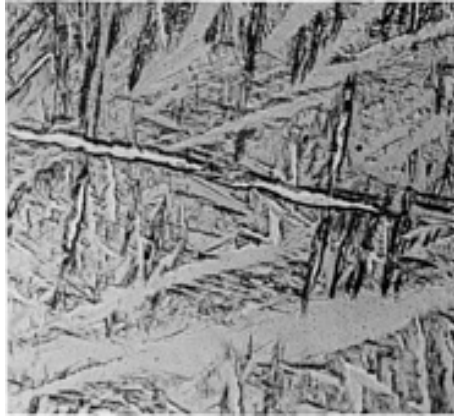
Ductile fracture of laser beam welded Ti-6Al-2Nb-1Ta-1Mo (Ti-6211, UNS R56210). A plate measuring 13 mm (0.5 in.) thick was welded using beam power of 8 kW, speed of 28 mm/s (65 in./min), and heat input of 0.29 kJ/mm (7.4 kJ/in.). Fig. 1122: Fracture surface of the dynamic tear test specimen indicates 100% ductile rupture via microvoid coalescence. Mechanical properties of the weld were excellent, even though some porosity is evident. SEM, 500 \times . Fig. 1123: Microstructure of the titanium alloy base plate features the basketweave appearance of Widmanstätten α . Primary α and β phase are also present. Hardness: 32 to 40 HRC. Keller's etch, 1000 \times . Fig. 1124: Microstructure of the fusion zone features needlelike martensitic α surrounded by some β phase, and the boundaries of the elongated β grains present prior to cooling. Hardness: 32 to 38 HRC. Keller's etch, 500 \times (E.A. Metzbower and D.W. Moon, Naval Research Laboratory)

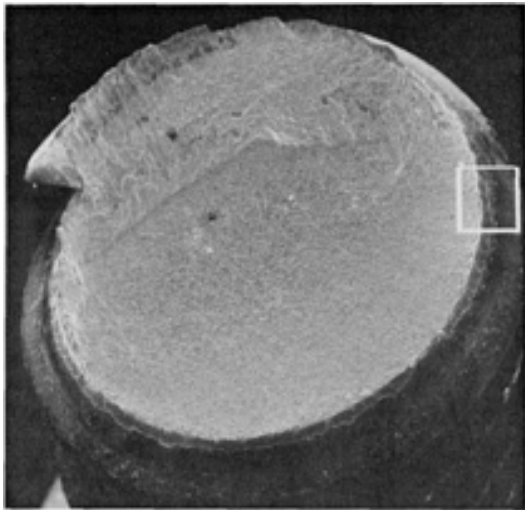
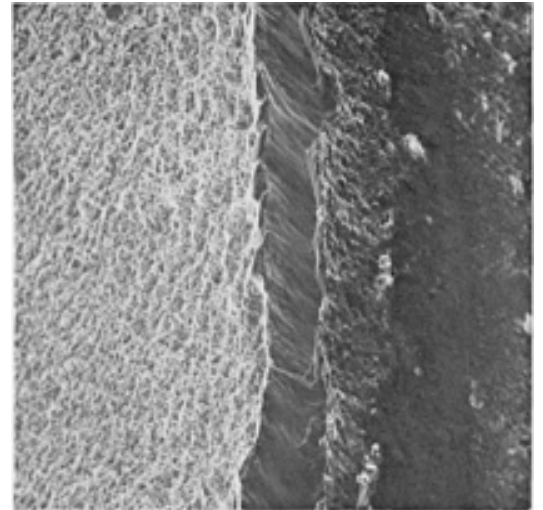
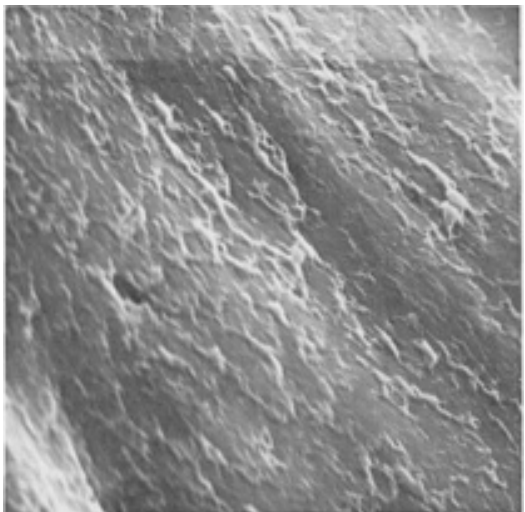
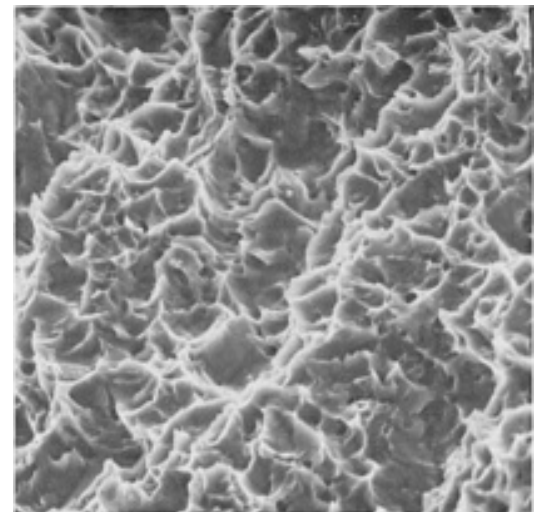
Fracture of Ti-6Al-4V (UNS R56400) threaded fasteners during installation due to the presence of high-

angle shear bands at thread roots. The nut (collar) of the aerospace fastener is designed to break in two when a specific installation torque is reached. The joint is then created by the remaining, tightened half of the collar and its mating threaded pin. In this case, however, the titanium alloy pins from a single manufacturer had been breaking before their collars "torqued off." Comparisons were made with pins produced by other manufacturers that did not fail during installation. The only significant differences observed were in the extent of shear-band formation and the orientation of shear bands near the roots of the rolled threads, both of which can be controlled by altering the tool-workpiece geometry. Shear-band formation was more extensive in the failed pins, and the bands are oriented at a higher angle to the pin axis. (More details are given in Fig. 1129, 1130, 1131, 1132.) Fig. 1125: Typical fracture surface of failed pin. Fracture was flat and propagated across the pin through a single thread root. SEM, 10 \times . Fig. 1126: Boxed area in Fig. 1125. Note the relatively featureless shear band on the circumference of the fracture surface. It is at a 45 $^{\circ}$ angle to the pin axis. SEM, 100 \times . Fig. 1127: Small, partially formed dimples on the shear-band portion of the fracture surface. SEM, 5000 \times . Fig. 1128: Balance of fracture surface away from the shear band was typical of dimpled rupture in Ti-6Al-4V. The equiaxed shape of the dimples indicate that a tensile stress was operative. SEM, 1000 \times (G. Hopple, Lockheed Missiles & Space Company, Inc.)

Shear-band formation in Ti-6Al-4V threaded fasteners that fractured during installation (see Fig. 1125, 1126, 1127, 1128). Shear bands form in thread roots of fasteners during the cold thread rolling process. In Ti-6Al-4V, they readily form during the highly localized plastic deformation that accompanies mechanical working at temperatures below 705 $^{\circ}\text{C}$ (1300 $^{\circ}\text{F}$). The role of shear-band orientation in fracture resistance is significant: A tensile stress is needed to initiate shear band fracture, and the higher the angle of the shear band to the pin axis, the greater the tensile component of the uniaxial stress applied to the fastener during installation. A suitably high tensile stress is required regardless of the extent of shear-band formation. Fig. 1129 and 1130: Void initiation and coalescence, respectively, in a shear band at a thread root adjacent to the

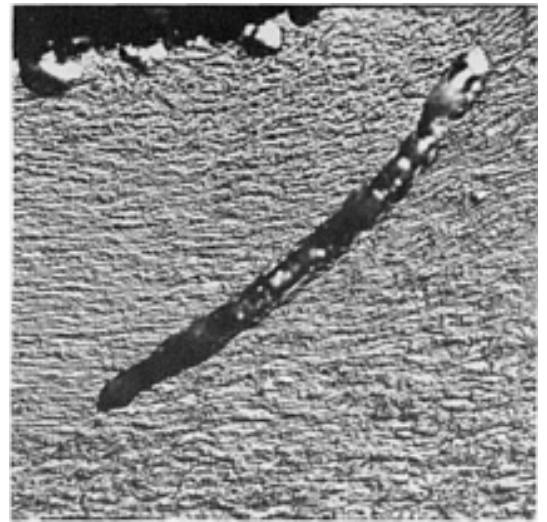
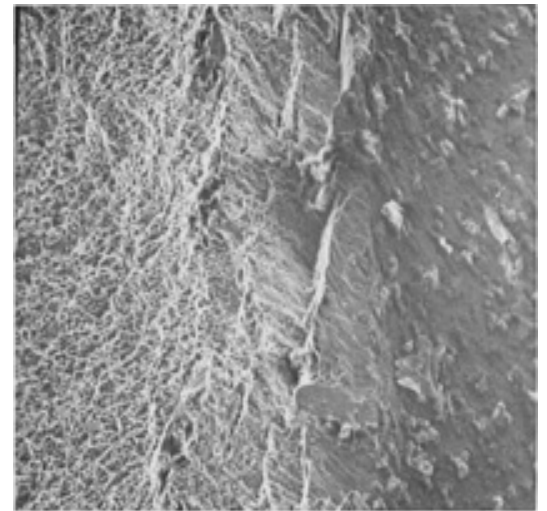
fracture. Rounded voids lend support to contention that tensile stress initiated fracture. Duplex etch, Kroll's solution and $\text{H}_2\text{O}_2\text{-KOH}$. Differential interference contrast microscopy, 500 \times . Fig. 1131 and 1132: Comparison of shear-band orientation in tensile-tested Ti-6Al-4V fasteners made by producer of failed pins (Fig. 1131) and a producer of pins that did not fail during installation (Fig. 1132). Shear-band angles are higher--40° to 50° versus 20° to 30°--in the former. SEM, 200 \times (G. Hopple, Lockheed Missiles & Space Company, Inc.)

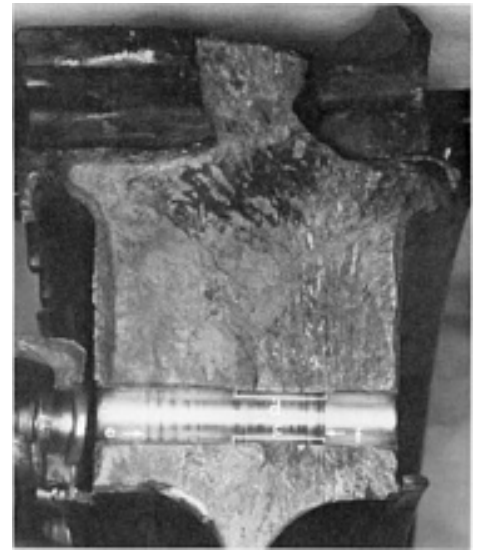
Figure 1133 shows two portions of a fractured titanium alloy Ti-6Al-4V second-stage compressor disk from a jet engine. Of the three radial fractures, the one at upper right, which passes through the bolthole marked "a," was found to be the primary fracture, exhibiting several fatigue-crack origins adjacent to the hole. The two other fractures showed no sign of fatigue. Figure 1134 shows a surface of the fracture through the bolthole at arrow "a" in Fig. 1133. Several fatigue cracks originated at locations within brackets "c" and "d." Deep tool marks in the bore of the hole are visible between arrows "e" and "f"; a section through the hole marked "b" in Fig. 1133 showed no such deep tool marks. Average tensile properties of two specimens cut from the disk were 1007 MPa (146 ksi) tensile strength, 17.5% elongation, and 39% reduction of area. See also Fig. 1135, 1136, 1137, 1138, 1139, and 1140. Fig. 1133: 0.2 \times . Fig. 1134: 0.9 \times

Fig. 1135 Enlarged view of the fatigue-crack regions (indicated by brackets) at the edges of the bolthole in Fig. 1134. The cracks grew in both directions from the hole. 3 \times

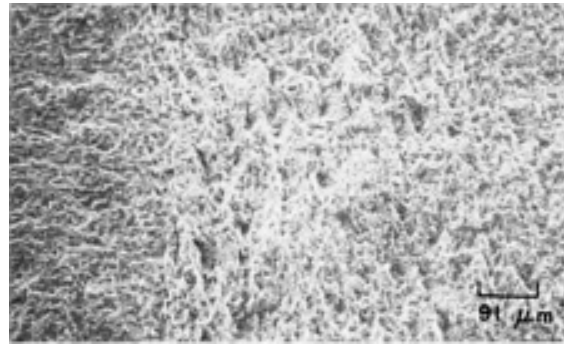
Fig. 1141 Fracture surface of a ductile fracture-toughness specimen of titanium alloy Ti-6Al-4V that was solution treated for 40 min at 830 °C (1525 °F), water quenched, aged at 510 °C (950 °F), then loaded in three-point bending (in air). See also Fig. 1142, 1143, 1144, and 1145. SEM, 110×

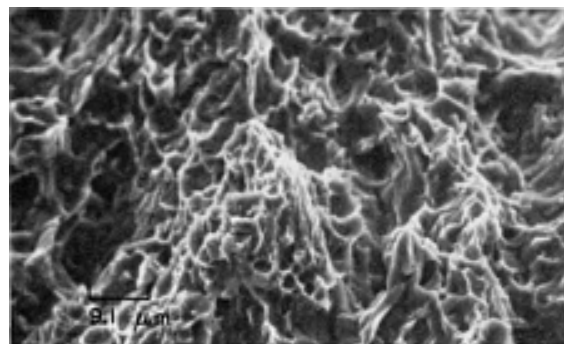
Fig. 1142 Higher-magnification view of the fracture surface in Fig. 1141, typical of fractures produced in this alloy in air after various solution treatments. Entire surface shows dimpled fracture of fine, equiaxed α phase that ruptured in ductile shear. SEM, 1100×

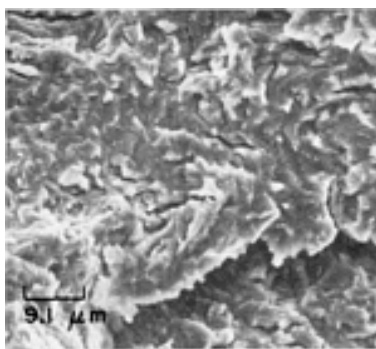
Fig. 1144 Higher-magnification view of the fracture surface shown in Fig. 1143. The embrittlement of this specimen by hydrogen was slight (about 12%). Fracture was by a mixture of shear rupture and transgranular cleavage. See also Fig. 1145. SEM, 1100×

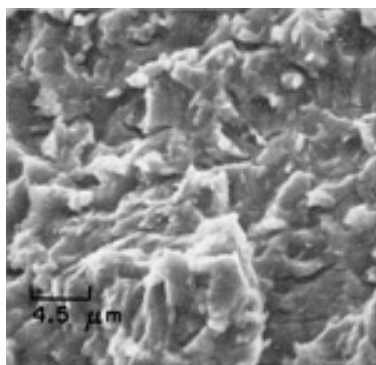
Fig. 1145 Same fracture surface as in Fig. 1143 and 1144, but shown at even greater magnification. Many small secondary cracks are present among moderate-sized dimples. SEM, 2200×

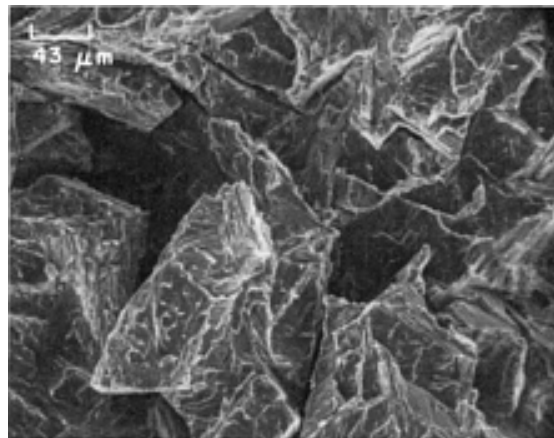
Fig. 1148 Higher-magnification view of the fracture surface in Fig. 1146, showing an area different from that in Fig. 1147. As in Fig. 1146, the very angular secondary cracking is noteworthy and is believed to have been

influenced by interfaces between β phase and acicular α phase. Note the fine parallel steps on the angular facets at bottom right. SEM, 230 \times

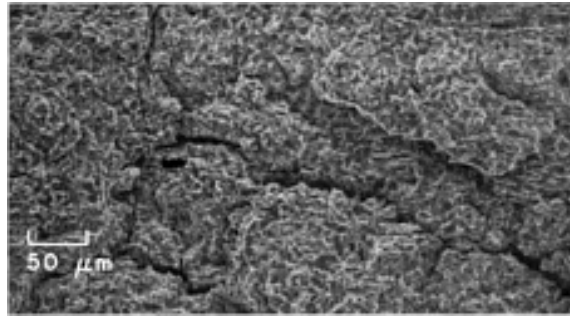
Fig. 1152 Fracture surface of a fracture-toughness specimen same as in Fig. 1150, except this specimen received a 24-h soak at 955 °C (1750 °F) before undergoing the stabilizing treatment. (Stabilizing consisted of furnace cooling to 704 °C (1300 °F) from the heat-treating temperature, holding 1 h, furnace cooling to 593 °C (1100 °F), holding 1 h and air cooling. This treatment was used to secure a large grain size to increase the susceptibility of the alloy to slow-strain-rate embrittlement in hydrogen.) (Structure is continuous β phase with dispersed α phase.) A gross network of secondary intergranular cracks is evident, providing steps that separate different levels of the main crack advance. See also Fig. 1153. SEM, 200×

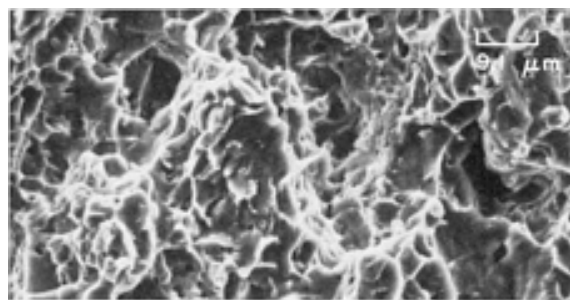
Fig. 1157 Portion of the tensile-overload fracture region of the fracture surface in Fig. 1156, as seen at ten times the magnification there. (Structure is continuous α phase with dispersed β phase.) This displays a rather uniform size of equiaxed dimples, shows essentially no inclusions, and contains no indication of secondary cracking; in summary, this is a thoroughly ductile fracture. SEM, 1100 \times

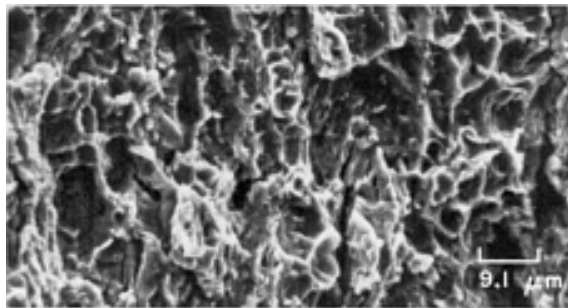
Fig. 1159 View of the region of tensile-overload fracture in Fig. 1158, at ten times the magnification there. (Structure is continuous α phase with dispersed β phase.) In spite of the effects of hydrogen, this region is quite similar in appearance to the tensile-overload region of the air-tested specimen in Fig. 1157. However, note that here there are many fine, parallel secondary cracks scattered throughout the dimpled surface. SEM, 1100 \times

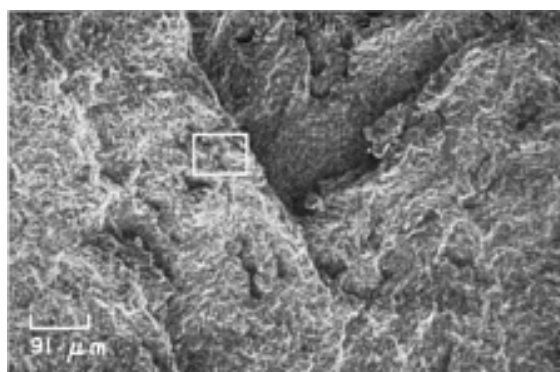
Fig. 1160 Same as Fig. 1158, except that before being fracture-toughness tested in hydrogen, this specimen was heat treated at 705 °C (1300 °F) for 2 h and air cooled. (Structure is continuous α phase with dispersed β phase.) In contrast to the fracture surface shown in Fig. 1158, no dimples are evident here. This surface exhibits giant steps. See also Fig. 1161. SEM, 110 \times

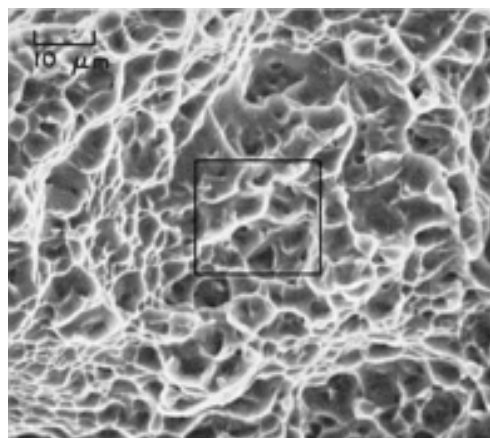
Fig. 1163 View of the fibrous central zone of the fracture surface in Fig. 1162, showing the equiaxed dimples expected in this region. The dimples are relatively uniform in size, with none being extremely large. A few inclusions are evident. See Fig. 1164 for an enlarged view of the area in the rectangle. SEM, 1000×

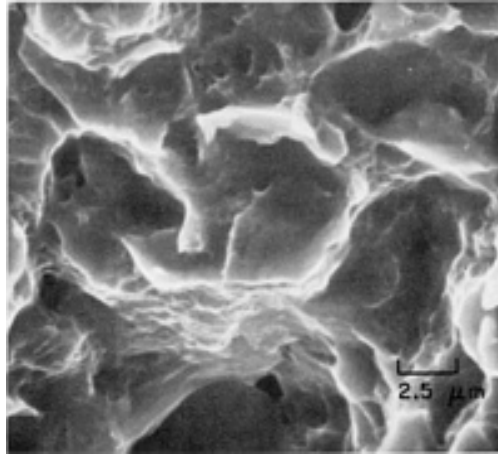
Fig. 1173 Another view of the fracture surface in Fig. 1171, this one showing an area in the rapid-fracture region beyond the fatigue beach mark. Fine tear dimples are distinctly evident on the walls of the larger dimples. No fissures or secondary cracks are visible here. SEM, 4000×
