ASM HANDBOOK®

VOLUME
12

Fractography

Fractography, was published in 1987 as Volume 12 of the *ASM Handbook*. The Volume was prepared under the direction of the ASM Handbook Committee.

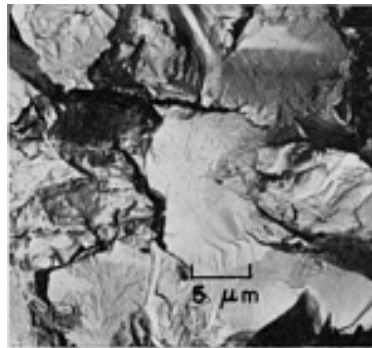
Fig. 1174 Fracture resulting from stress-corrosion cracking in a specimen of titanium alloy Ti-6Al-4V that was stressed in methanol. The crack path is transgranular (by cleavage). See also Fig. 1175. TEM p-c replica, 2000×

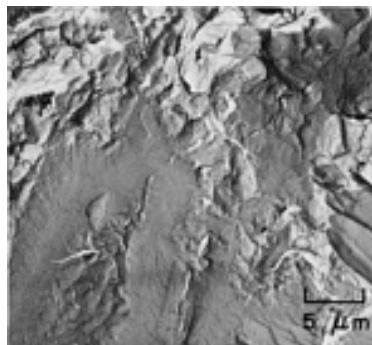
Fig. 1175 A companion fractograph to that in Fig. 1174, from the same specimen of titanium alloy Ti-6Al-4V, but showing an area farther from the fracture origin. Visible are what appear to be a few small dimples. TEM p-c replica, 2000×

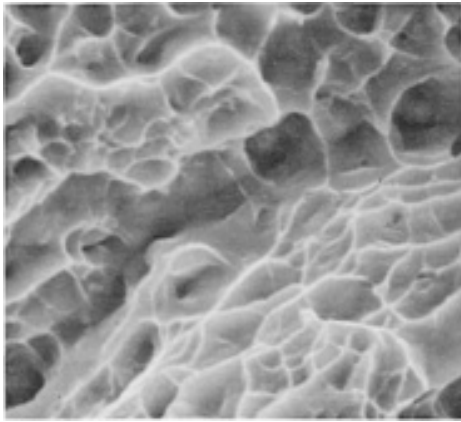
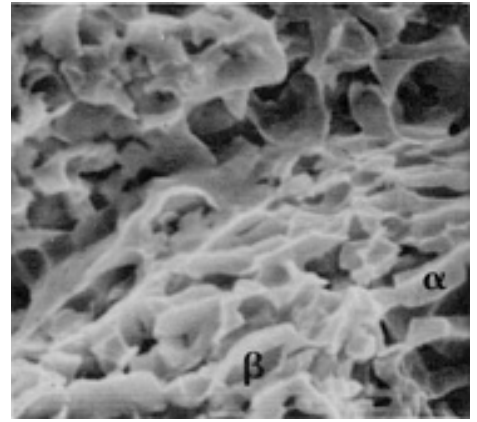
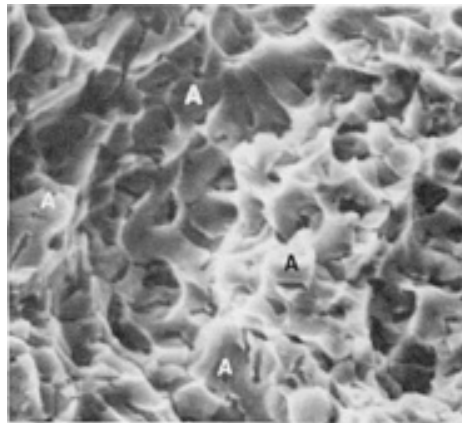
Tensile fractures at $-196\text{ }^{\circ}\text{C}$ ($-320\text{ }^{\circ}\text{F}$) in Ti-3.9Mn. Volume fraction β : 0.38. Beta particle spacing: $2.1\text{ }\mu\text{m}$. Interbeta spacing: $4.5\text{ }\mu\text{m}$. Processing and heat treatment same as in Fig. 1189 and 1190. Etchant (when used) same as in Fig. 1183, 1184, and 1185. Fig. 1186 and 1187: Unetched and etched, respectively, fracture surface of tensile specimen with prior strain at room temperature of 0.140. True strain of subzero fracture: 0.253. Material machined using coolant during final stages of specimen preparation. Compared with Fig. 1184 and 1185, average dimple size is smaller and there is comparatively less thinning of β at shear regions. SEM, $3000\times$. Fig. 1188. Etched fracture surface of specimen machined without coolant. True strain at fracture: 0.144. Cooling during machining substantially increases fracture strain. Fractograph is of region near origin, which was close to specimen surface. Note wavy nature of fracture propagation and large number of β particles at a dimple boundaries (A). Dark regions are β particles. SEM, $1600\times$ (H. Margolin and R.V. Vijayaraghavan, Polytechnic Institute of New York)

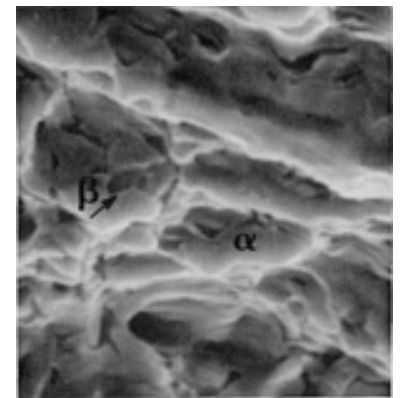
Tensile fracture at room temperature in Ti-3.9Mn, an α - β alloy with a β volume fraction of 0.38, β particle size of $2.1\text{ }\mu\text{m}$, and interbeta spacing of $44.25\text{ }\mu\text{m}$. Processing same as in Fig. 1183, 1184, and 1185. Heat treatment: anneal 24 h at $700\text{ }^{\circ}\text{C}$ ($1290\text{ }^{\circ}\text{F}$), water quench. True strain at fracture was 0.68. Note particles

inside voids. Fig. 1189: Unetched fracture surface. SEM, 3800 \times . Fig. 1190: Etched fracture surface. Etchant same as in Fig. 1183, 1184, and 1185. SEM, 3000 \times (H. Margolin and R.V. Vijayaraghavan, Polytechnic Institute of New York)

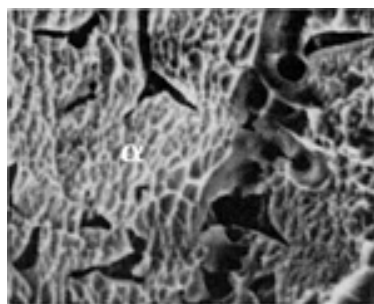
Fig. 1191 Tensile fracture at -196 °C (-320 °F) in Ti-1.8Mn, an α - β alloy with a β volume fraction of 0.17. Beta particle size: 6.30 μ m. Interbeta spacing: 30.8 μ m. Material processed as in Fig. 1183, 1184, and 1185. Heat Treatment: 30 days at 780 °C (1435 °F); furnace cool over 3 days to 700 °C (1290 °F); 24 h at 700 °C (1290 °F); water quench. Fracture surface etched as in Fig. 1183, 1184, and 1185. Note shear dimples in α and β (finer dimples in α). True strain to fracture: 0.90 (0.93 at room temperature). SEM, 1250 \times (H. Margolin and R.V. Vijayaraghavan, Polytechnic Institute of New York)

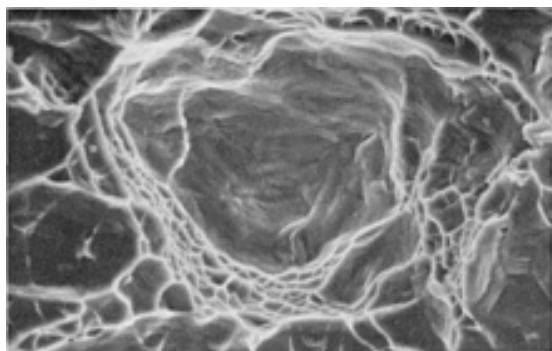
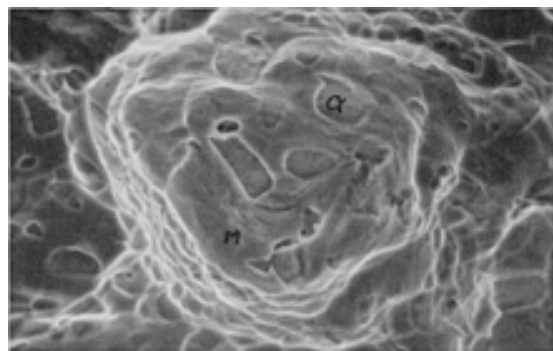
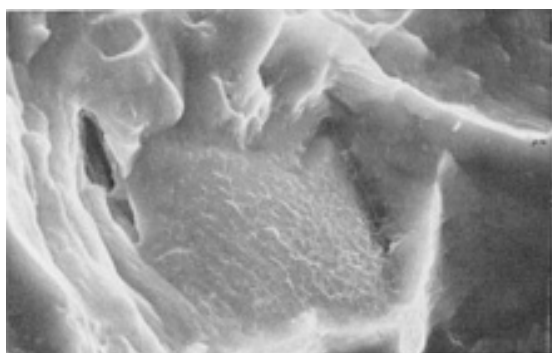
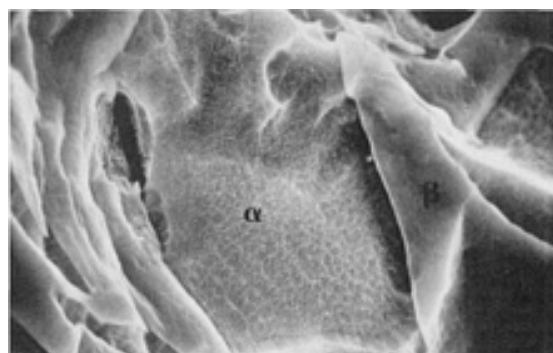
Tensile fractures at room temperature in Ti-5Mo-4.5Al-1.5Cr. The α - β alloy was processed as in Fig. 1183, 1184, and 1185. Etchant (when used) same in Fig. 1183, 1184, and 1185. Fig. 1192 and 1193: Unetched and etched, respectively, fracture surfaces of alloy having α particles in a martensite matrix. Volume fraction α : 0.30. Alpha particle size: 9.0 μ m. Interalpha spacing: 20.0 μ m. Fracture was ductile. Note shear at the boundary of the large void and particles inside the void. SEM, 570 \times and 620 \times . Fig. 1194 and 1195: Unetched and etched, respectively, fracture surfaces of alloy having α particles in a retained β matrix. (Tilt slightly different in etched Fig. 1195.) Alpha particle size: 11.6 μ m. Interalpha spacing: 8.6 μ m. Note large void at α - β interface close to shear. SEM, 3250 \times (H. Margolin and R.V. Vijayaraghavan, Polytechnic Institute of New York)

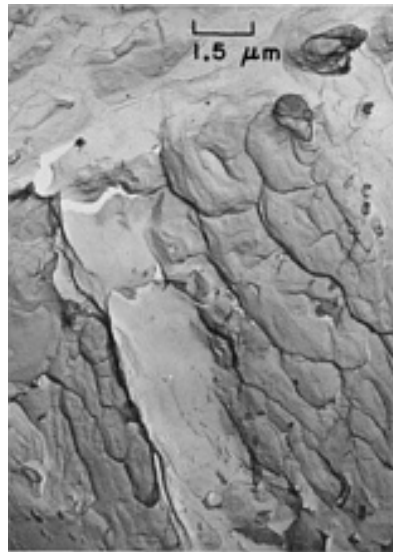
Fig. 1200 TEM p-c replica of an area at C in Fig. 1196, in the region of final fast fracture. This area exhibits rather flat, elongated dimples. The region at left center in this view appears to have been stretched. 6500×

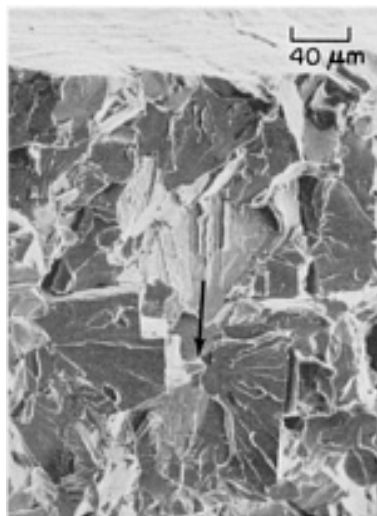
Fig. 1201 Surface of a slow-bending fracture produced at $-160\text{ }^{\circ}\text{C}$ ($-256\text{ }^{\circ}\text{F}$) in Fe-3.9Ni alloy deoxidized with aluminum and titanium, which was forged at $1260\text{ }^{\circ}\text{C}$ ($2300\text{ }^{\circ}\text{F}$), hot rolled at $1040\text{ }^{\circ}\text{C}$ ($1905\text{ }^{\circ}\text{F}$), annealed at about $1000\text{ }^{\circ}\text{C}$ ($1830\text{ }^{\circ}\text{F}$), and air cooled. Root of specimen notch is at top. Fracture was by cleavage that began at cracked Ti(C,N) particles (as at arrow). See also Fig. 1202. SEM, 250×

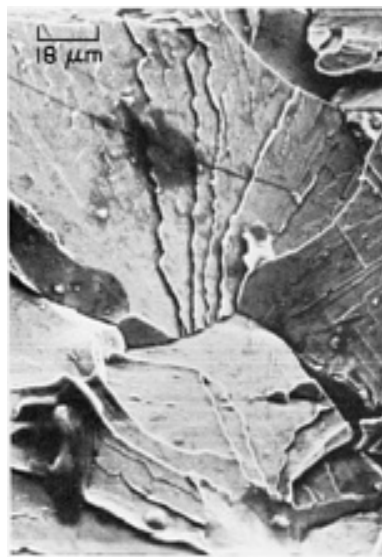
Fig. 1203 Surface of a slow-bending fracture that was produced at -130 °C (-200 °F) in an Fe-0.3Ni alloy that had been melted, deoxidized, forged, rolled, and heat treated exactly the same as the higher-nickel alloy shown in Fig. 1201 and 1202. See also Fig. 1204, 1205, and 1206. SEM, 550 \times

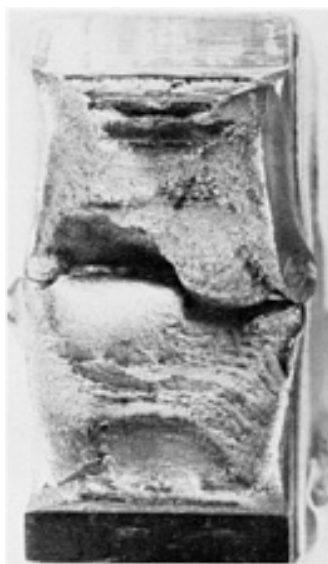
Fig. 1213 Both fracture surfaces of a specimen aged at 750 °C (1380 °F) 2 h and air cooled. Impact energy was about 203 J (150 ft · lb); deformation is similar to that in Fig. 1211. See also Fig. 1214. 4.8× (Figures 1207, 1208, 1209, 1210, 1211, 1212, 1213, 1214, 1215, 1216, 1217, and 1218 present six related pairs of light and SEM fractograph of specimens of an Fe-12Ni-0.5Ti alloy intended for use at cryogenic temperatures. The series shows the effect on Charpy impact energy at -196 °C (-321 °F), and on fracture-surface characteristics, of the temperature of aging after austenitizing at 900 °C (1650 °F) for 2 h and air cooling.)

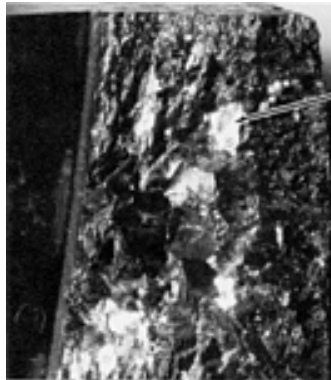
Fig. 1225 Surface of a "rock candy" fracture in a notched as-cast specimen of Alnico alloy broken by impact at room temperature, showing large, shiny facets. The brittle nature of this specimen is reflected in its unnotched tensile strength of only 34 MPa (5 ksi). See also Fig. 1226, 1227, 1228, 1229, 1230, and 1231. 5.5×

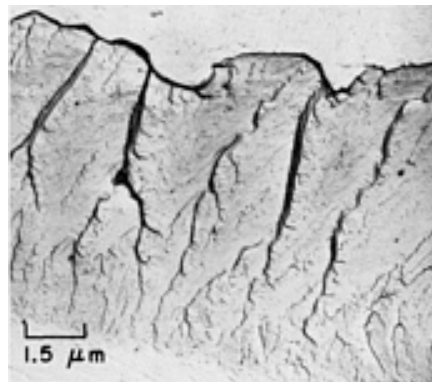
Fig. 1226 TEM p-c replica of an area of the facet at the arrow in Fig. 1225, showing features resulting from transgranular cleavage. Pronounced cleavage steps in central region indicate that fracture progressed from bottom to top. The margins of this central region are believed to have formed at grain boundaries; the cause of the marked irregularity of the margin at top is not known. 6500×

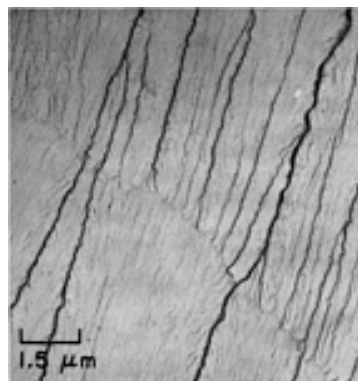
Fig. 1227 TEM p-c replica at a second area of the facet at the arrow in Fig. 1225, showing features resulting

from transgranular cleavage and cleavage steps that cross a tilt boundary extending from lower right to upper left. The approximate direction of crack propagation was from lower left to upper right. 6500×

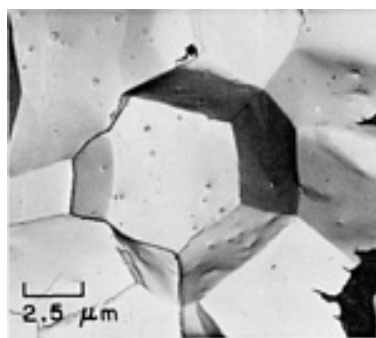
Fig. 1234 A very clean intergranular fracture in sintered tungsten that was broken by impact. Note the several very flat separated-grain facets; small sintering pores can be seen in several of the facets. TEM p-c replica, 4000×

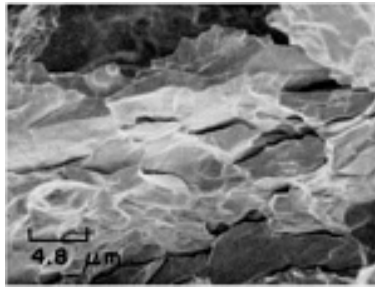
Fig. 1239 Surface of a brittle, intergranular fracture, produced by bending, in an iridium sheet (rolled to a thickness of 0.076 mm, or 0.0003 in.) that had been annealed for 2 h at 1200 °C (2190 °F) in vacuum. Note the deep secondary cracks between the elongated grains. 2100 \times

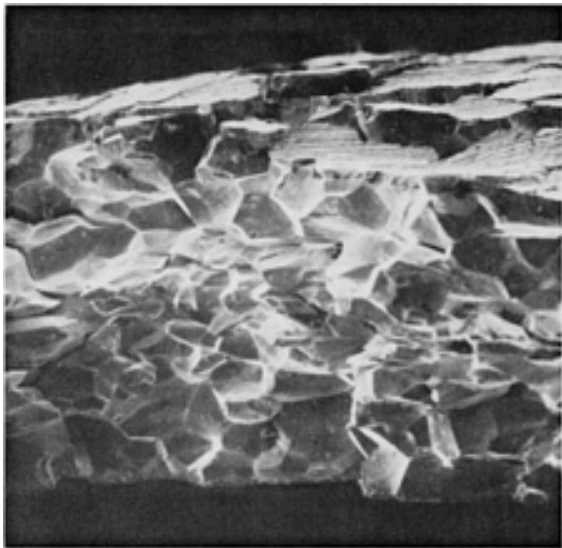
Fig. 1240

Intergranular fracture at elevated temperatures in DOP-26, a thorium-doped Ir-0.3W alloy. A high-rate biaxial punch test was used to fracture a disk specimen measuring 52 mm (2 in.) in diameter and 0.635 mm

(0.025 in.) thick. The intrinsic brittleness of iridium makes it unique among face-centered cubic metals. This ordinarily application-limiting property has been taken advantage of here to provide striking examples of exclusively intergranular fracture. Fig. 1240: Fracture surface of disk aged 18 h at 1500 °C (2730 °F) and then biaxially tested at 1440 °C (2625 °F). SEM, 115×. Fig. 1241: Another section of the fracture in Fig. 1240. SEM, 185×. Fig. 1242: Surface cracking in an iridium alloy disk annealed for 1 h at 1500 °C (2730 °F) and then biaxially tested at 1000 °C (1830 °F). SEM, 60×. Fig. 1243: High-magnification view of large crack near center of disk in Fig. 1242. SEM, 1000× (T.G. George, Los Alamos National Laboratory)

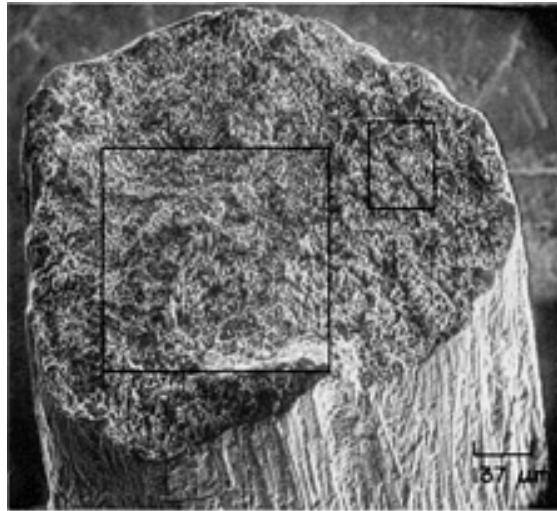
Fig. 1250 Surface of a fracture in a longitudinal tensile-test specimen of a carbon (graphite)-magnesium composite having a tensile strength of 640 MPa (93 ksi). The approximate makeup of the composite was 40% graphite fibers and 60% magnesium matrix (99.5% pure), by volume. See Fig. 1251 and 1252 for higher-magnification views of the areas outlined by the large and small rectangles, respectively. See also Fig. 1254. SEM, 75×

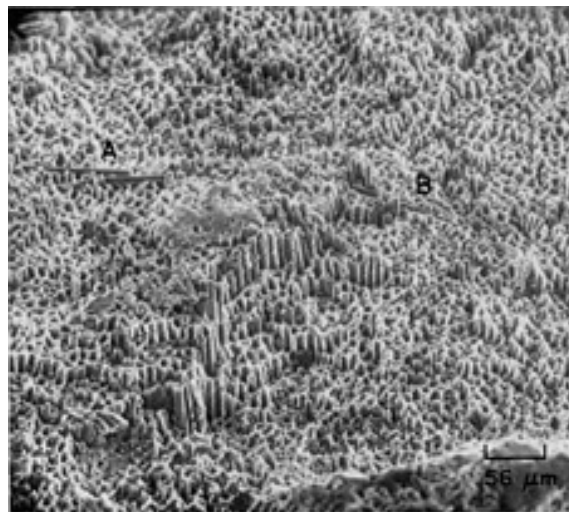
Fig. 1251 Higher-magnification view of the area in the larger rectangle in Fig. 1250. At A are two transversely oriented features that appear to be graphite fibers that either are lying loose on the surface or were inadvertently misaligned during manufacture. The feature at B is probably a ridge. Much of the surface exhibits broken fibers, the ends of which are roughly in the same plane as the fracture in the surrounding matrix, but at center are exposed fibers with the appearance of "palisades." SEM, 180×

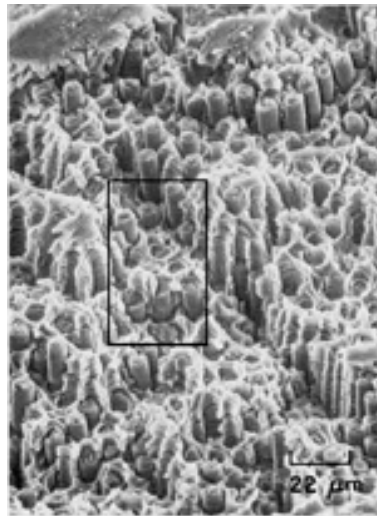
Fig. 1252 Higher-magnification view of the area in the smaller rectangle in Fig. 1250, showing "palisades," some of which are the reverse of those in Fig. 1251 in that the fibers have broken at the bottom of the "palisades," exposing the sides of the holes in the matrix. See Fig. 1253 for an enlarged view of the area in the rectangle. SEM, 450×

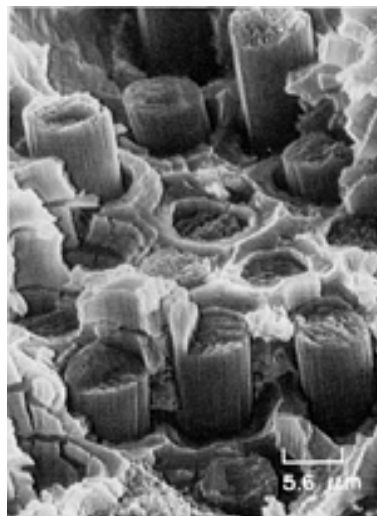
Fig. 1253 Enlargement of the area in the rectangle in Fig. 1252, showing that the magnesium matrix fractured in a brittle manner; note the many transverse fissures in the sides of the holes. Note also that the surfaces of the holes in the matrix reflect faithfully the fluted contours of the graphite fibers. SEM, 1800×

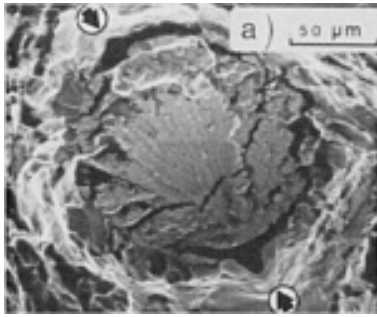
Fig. 1256

Fig. 1257

Tensile fracture at room temperature in a unidirectionally solidified composite consisting of 45 vol% NS-55 tungsten fibers in an AISI 1010 carbon steel matrix. Fiber diameter: 110 μm . Composite was fabricated by diffusion bonding alternating layers of metal foils and aligned fiber arrays for 30 min at 69 MPa and 760 °C (1400 °F). Tensile strength was considerably less than that predicted by the rule of mixtures. Compare with Fig. 1255. Fig. 1256: Typical fracture surface reveals adequate fiber-matrix diffusion bonding with the ductile matrix deformed around the fiber. The unbonded regions (arrows) are at points where the macroscopic pressure direction during bonding was tangent to the fiber circumference. The fiber failed in a brittle transgranular mode. However, each fiber had a 15- to 20- μm -thick annular feature at its periphery consisting of numerous secondary fractures propagating along the boundaries of the elongated grains. The river pattern in the core of the fiber indicates that these secondary cracks originated inside the peripheral ring. Subsequent analyses revealed that the annular fracture surface feature corresponded exactly with an iron diffusion front. Cause of the lower-than-expected tensile strength of the composite was fiber embrittlement due to contamination by elemental iron. SEM, 300 \times . Fig. 1257: Lower-magnification view of fracture surface in Fig. 1256 better shows annular rings on fiber surfaces. Major (transverse) fiber fractures originated at the circumference of the smooth interior core region. Note the inadvertent omission of a foil layer between two fiber layers. SEM, 150 \times (C. Kim, Naval Research Laboratory)

Longitudinal cracking in the annular portion of the tungsten fiber fracture surface in Fig. 1256 and 1257 is revealed in these mating-surface fractographs (one is an inverted image). The transverse fracture proceeded toward the upper left of the fiber, and the intergranular longitudinal cracks propagated radially inward. The good matchups between the traces of the longitudinal cracks on the mating fracture surfaces indicate they nucleated independent of and prior to the transverse fracture. SEM, 2025 \times (C. Kim, Naval Research Laboratory)

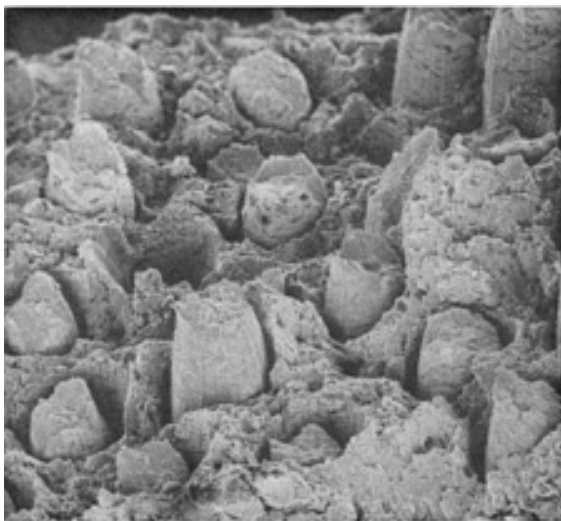
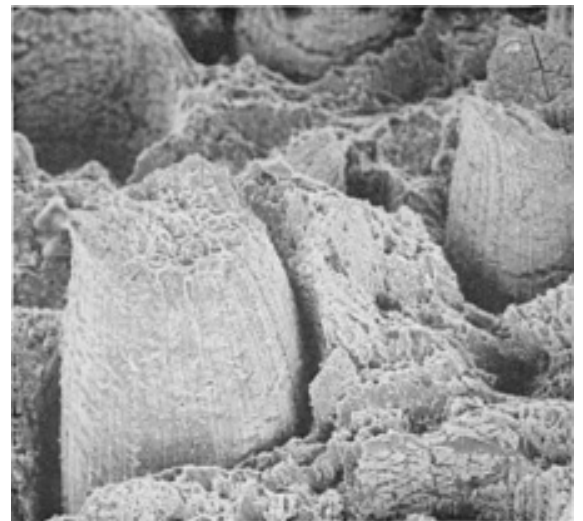
Fig. 1269

Fig. 1270

Fracture of metal-matrix composite low-cycle fatigue specimen. Material: Fe-24Cr-4Al-1Y matrix reinforced with W-1ThO₂ fibers, 0.2 mm (8 mil) in diameter. The composite was fabricated by applying a matrix alloy powder "cloth" to a fiber mat via use of a plasticizer. A monotape was then made by hot pressing at 1095 °C (2000 °F). Several monotapes were hot pressed together to form a panel, from which fatigue specimens were machined. The composite failed after 200 cycles at 760 °C (1400 °F). Cup-and-cone fiber fractures indicate a ductile failure mode. SEM, 100× and 250× (D.W. Petrasek, NASA Lewis Research Center)

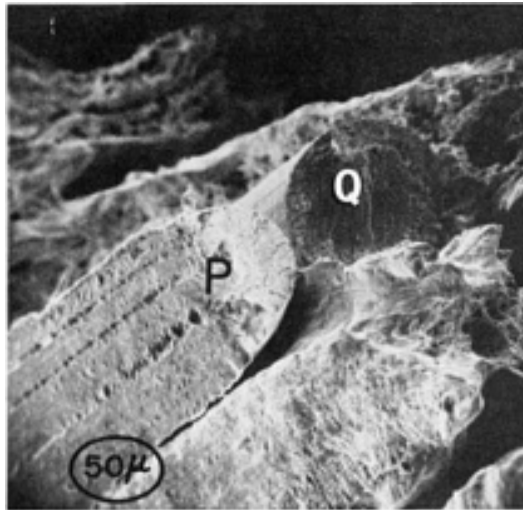
Fig. 1271 Surface of a tension-overload fracture in a composite consisting of tungsten fibers in a silver matrix. The tungsten fiber marked P has undergone a ductile fracture with necking, whereas fiber Q has suffered a sharp, flat, transverse cleavage fracture. See also Fig. 1272. SEM, 320×

Fig. 1272 Higher-magnification view of an area of tungsten fiber P in Fig. 1271. Deformation during fracture has thinned the walls of the dimples to sharp edges, which shows the highly ductile nature of the fracture. Note the uniformity in height of the walls. Compare with Fig. 1262. SEM, 10,000×

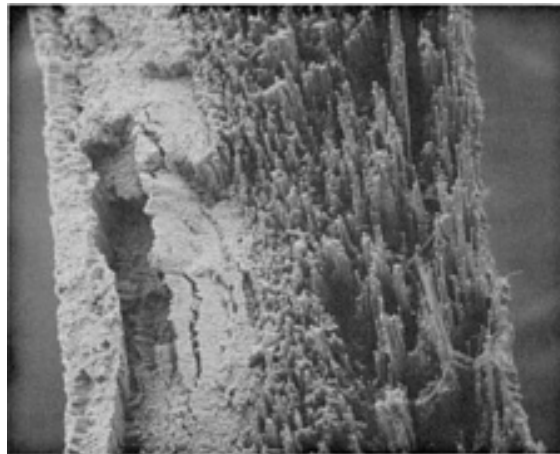
Fig. 1301 A different view and higher magnification of the carbon/epoxy flexural specimen shown in Fig. 1300. Once again, the difference between the compressive (left) and the tensile (right) sides of the fracture surface is dramatic. SEM (same conditions as in Fig. 1294), 50× (The composite specimens shown in Fig. 1296, 1297, 1298, 1299, 1300, 1301, 1302, 1303, 1304, 1305, 1306, 1307, 1308, 1309, and 1310 all consisted of *circa* 1978 Thornel 300 fibers in Narmco 5208 epoxy resin. The composites were all fabricated by lay-up of prepreg tape and were autoclave cured 175 °C (350 °F) according to the manufacturer's recommendations. Specimens were then end-tabbed and cut in accordance with the ASTM D3039. The 0° and 90° tensile specimens were tested in accordance with ASTM D3039, and the 0° flexural three-point-bend specimens were tested in accordance with ASTM D790. The composites were dried before testing in the same manner as the epoxy specimens described in Fig. 1294 and 1295. "Dry" specimens were tested as-dried and had essentially 0 wt% moisture. "Room" moisture specimens had about 0.6 wt% moisture, having been placed after drying in a

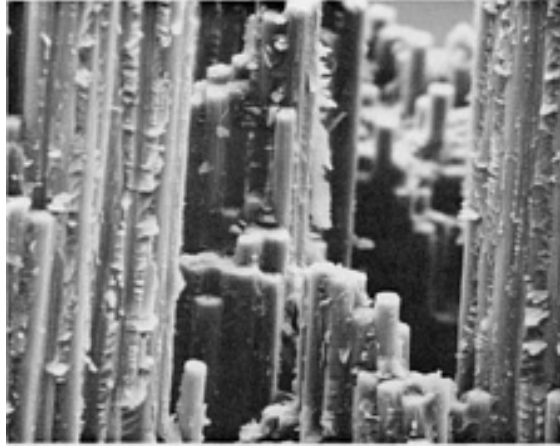
Fig. 1304 Fracture surface of a longitudinal (0°) carbon/epoxy specimen failed in tension. The specimen was tested in the dry condition (see below for explanation) at 25 °C (77 °F). The fibers are broken at many different levels; the fiber breaks are perpendicular to the fiber (and load) direction. There is substantial epoxy adhering to the fiber surfaces, indicating that the interfacial bond strength is fairly high. SEM (same conditions as in Fig. 1294), 500× (The composite specimens shown in Fig. 1296, 1297, 1298, 1299, 1300, 1301, 1302, 1303, 1304, 1305, 1306, 1307, 1308, 1309, and 1310 all consisted of *circa* 1978 Thornel 300 fibers in Narmco 5208 epoxy resin. The composites were all fabricated by lay-up of prepreg tape and were autoclave cured 175 °C (350 °F) according to the manufacturer's recommendations. Specimens were then end-tabbed and cut in accordance with the ASTM D3039. The 0° and 90° tensile specimens were tested in accordance with ASTM D3039, and the 0° flexural three-point-bend specimens were tested in accordance with ASTM D790. The composites were dried before testing in the same manner as the epoxy specimens described in Fig. 1294 and 1295. "Dry" specimens were tested as-dried and had essentially 0 wt% moisture. "Room" moisture specimens had about 0.6 wt% moisture, having been placed after drying in a chamber at 60 °C (140 °F) and 60% relative humidity for at least 2 months and then placed in a drawer in the laboratory for several months before testing. "Wet" specimens had about 1.5 to 2.0 wt% moisture, having been placed for several months in an environmental chamber at 60 °C (140 °F) and 100% relative humidity. The composites were tested at moisture conditions designed not to alter their conditioning, and at the temperatures noted.) (L. Clements, San Jose State University, and P.R. Lee, United Technologies)

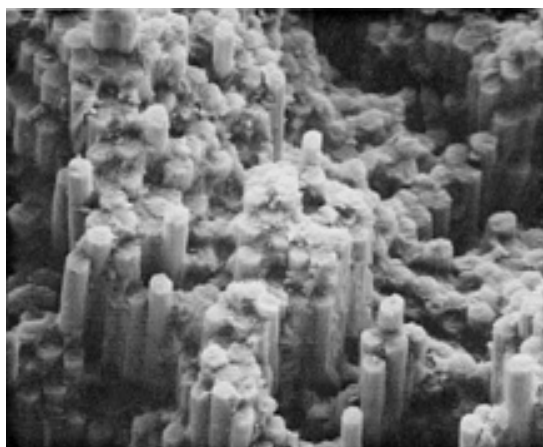
Fig. 1305 Same carbon/epoxy specimen as shown in Fig. 1304, but showing a somewhat less typical fracture area. Although the fibers still protrude at varying levels, the overall appearance is more flat than in Fig. 1304. There are also some holes where fairly short fibers have pulled out. SEM (same conditions as in Fig. 1294), 500 \times (The composite specimens shown in Fig. 1296, 1297, 1298, 1299, 1300, 1301, 1302, 1303, 1304, 1305, 1306, 1307, 1308, 1309, and 1310 all consisted of *circa* 1978 Thornel 300 fibers in Narmco 5208 epoxy resin. The composites were all fabricated by lay-up of prepreg tape and were autoclave cured 175 $^{\circ}$ C (350 $^{\circ}$ F) according to the manufacturer's recommendations. Specimens were then end-tabbed and cut in accordance with the ASTM D3039. The 0 $^{\circ}$ and 90 $^{\circ}$ tensile specimens were tested in accordance with ASTM D3039, and the 0 $^{\circ}$ flexural three-point-bend specimens were tested in accordance with ASTM D790. The composites were dried before testing in the same manner as the epoxy specimens described in Fig. 1294 and 1295. "Dry" specimens were tested as-dried and had essentially 0 wt% moisture. "Room" moisture specimens had about 0.6 wt% moisture, having been placed after drying in a chamber at 60 $^{\circ}$ C (140 $^{\circ}$ F) and 60% relative humidity for at least 2 months and then placed in a drawer in the laboratory for several months before testing. "Wet" specimens had about 1.5 to 2.0 wt% moisture, having been placed for several months in an environmental chamber at 60 $^{\circ}$ C (140 $^{\circ}$ F) and 100% relative humidity. The composites were tested at moisture conditions designed not to alter their conditioning, and at the temperatures noted.) (L. Clements, San Jose State University and P.R. Lee, United Technologies)

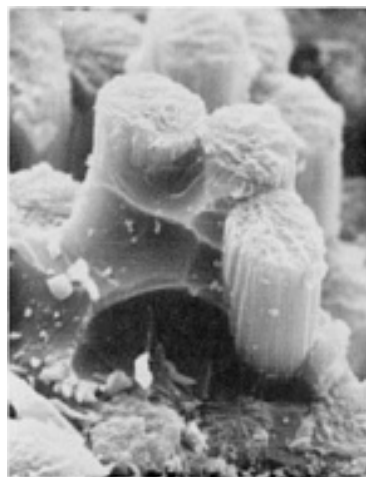
Fig. 1308 Fracture surface of a longitudinal (0°) carbon/epoxy specimen that failed in tension. Specimen was tested at 25 °C (77 °F) in the dry condition. This fractograph shows typical tensile failure of the epoxy resin in a local resin-rich region. This results when fibers break and produce overload tensile failure in the resin. SEM (same conditions as in Fig. 1294), 2000 \times (The composite specimens shown in Fig. 1296, 1297, 1298, 1299, 1300, 1301, 1302, 1303, 1304, 1305, 1306, 1307, 1308, 1309, and 1310 all consisted of *circa* 1978 Thornel 300 fibers in Narmco 5208 epoxy resin. The composites were all fabricated by lay-up of prepreg tape and were autoclave cured 175 °C (350 °F) according to the manufacturer's recommendations. Specimens were then end-tabbed and cut in accordance with the ASTM D3039. The 0° and 90° tensile specimens were tested in

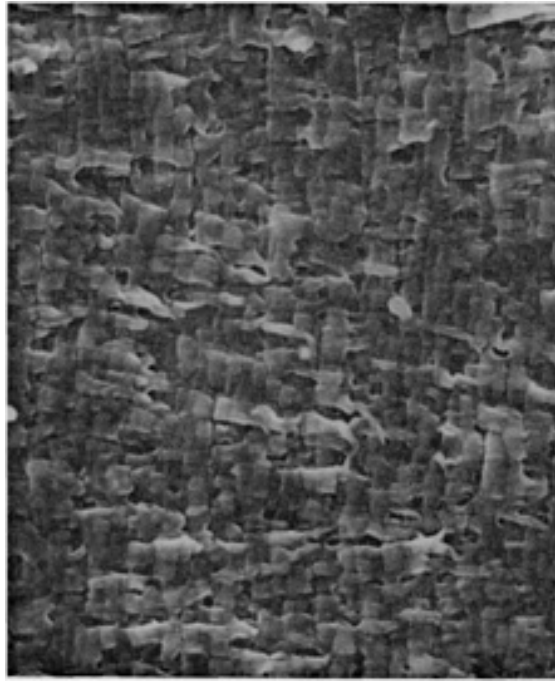
Fig. 1323 Fatigue striations in medium-density polyethylene. Crack growth direction is left to right. Loading conditions: $\sigma_{\min}/\sigma_{\max} = R = 0.5$, where $\sigma_{\max} = 0.3 \sigma_{\text{yield}}$ and $\sigma_{\text{yield}} = 22.6 \text{ MPa (3.278 ksi)}$; frequency = 0.5 Hz. SEM, 200 \times (A.S. Moet, Case Western Reserve University)

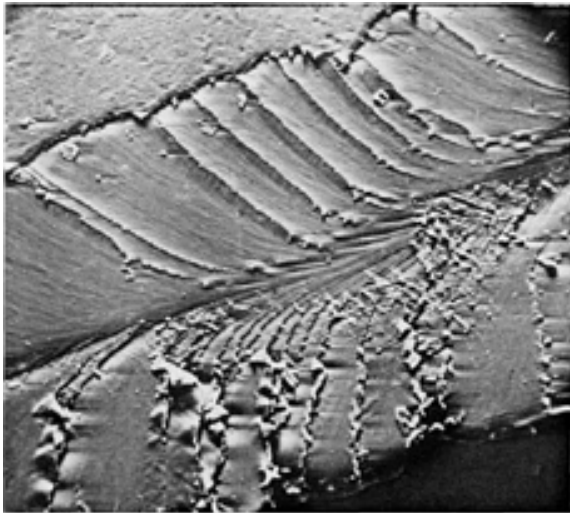
Fig. 1324

Chevronlike features on fracture surface of polyimide recorder belt point to origin of failure. The 75- μm (3-mil) thick belt was used on Spacelab I. Cause of failure was traced to a design deficiency. SEM, 120 \times and 240 \times (R.J. Schwinghamer, NASA Marshall Space Flight Center)

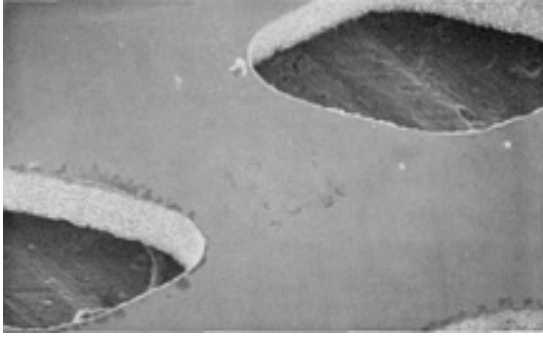
Fig. 1326

Effect of exposure to the atomic oxygen environment found in low earth orbit (LEO) on a silver solar cell interconnect. The pure silver foil, 40 μm (1.5 mil) thick, was exposed to the LEO environment for 40 h at 100 °C (210 °F) in the spacecraft velocity direction. The sample was flown on Space Shuttle flight 8. The original surface of the interconnect (Fig. 1326) was converted to an oxide of silver (Fig. 1327). Both reflectivity and electrical conductivity decreased as a result. SEM, 3800 \times (R.J. Schwinghamer, NASA Marshall Space Flight Center)

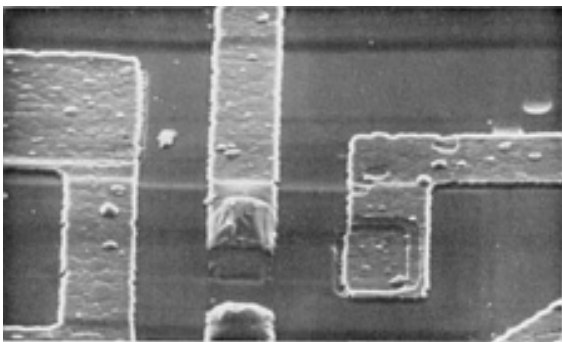
Fig. 1328

Integrated circuit (IC) defects. Material: pure aluminum vacuum deposited on Si/SiO₂. Fig. 1328: Oxide flaws under the metallized layer on this IC produced a thin oxide layer that promoted voltage "punchthrough" and failure (center). SEM, 800 \times . Fig. 1329: Shown here is a base emitter for input transistors. The cracklike defect at center was caused by electrical discharge across the junction. SEM, 3360 \times (R.J. Schwinghamer, NASA Marshall Space Flight Center)

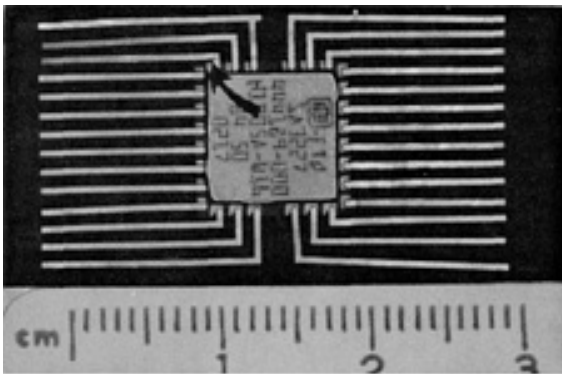
Fig. 1330

Fatigue failure of L-shaped electronic flat pack leads due to cyclic, eccentric loading during ultrasonic cleaning. The 0.13-mm (5-mil) thick Alloy 42 (42Ni-58Fe) leads were nickel electroplated, soldered (Cu-Ag alloy) to tungsten, and then gold plated. Fig. 1330: A 28-lead electronic flat pack. Cracking was predominantly observed in the smallest L-shaped leads (arrow). 2.5 \times . Fig. 1331: Cracks in L-shaped leads were found in the solder and near the edge of the solder in both top and bottom fillets (arrows). See also Fig. 1332, 1333, and 1334. SEM, 300 \times (T. O'Donnell, P. Tung, A. Shumka, R. Ruiz, and J. Okuno, California Institute of Technology)

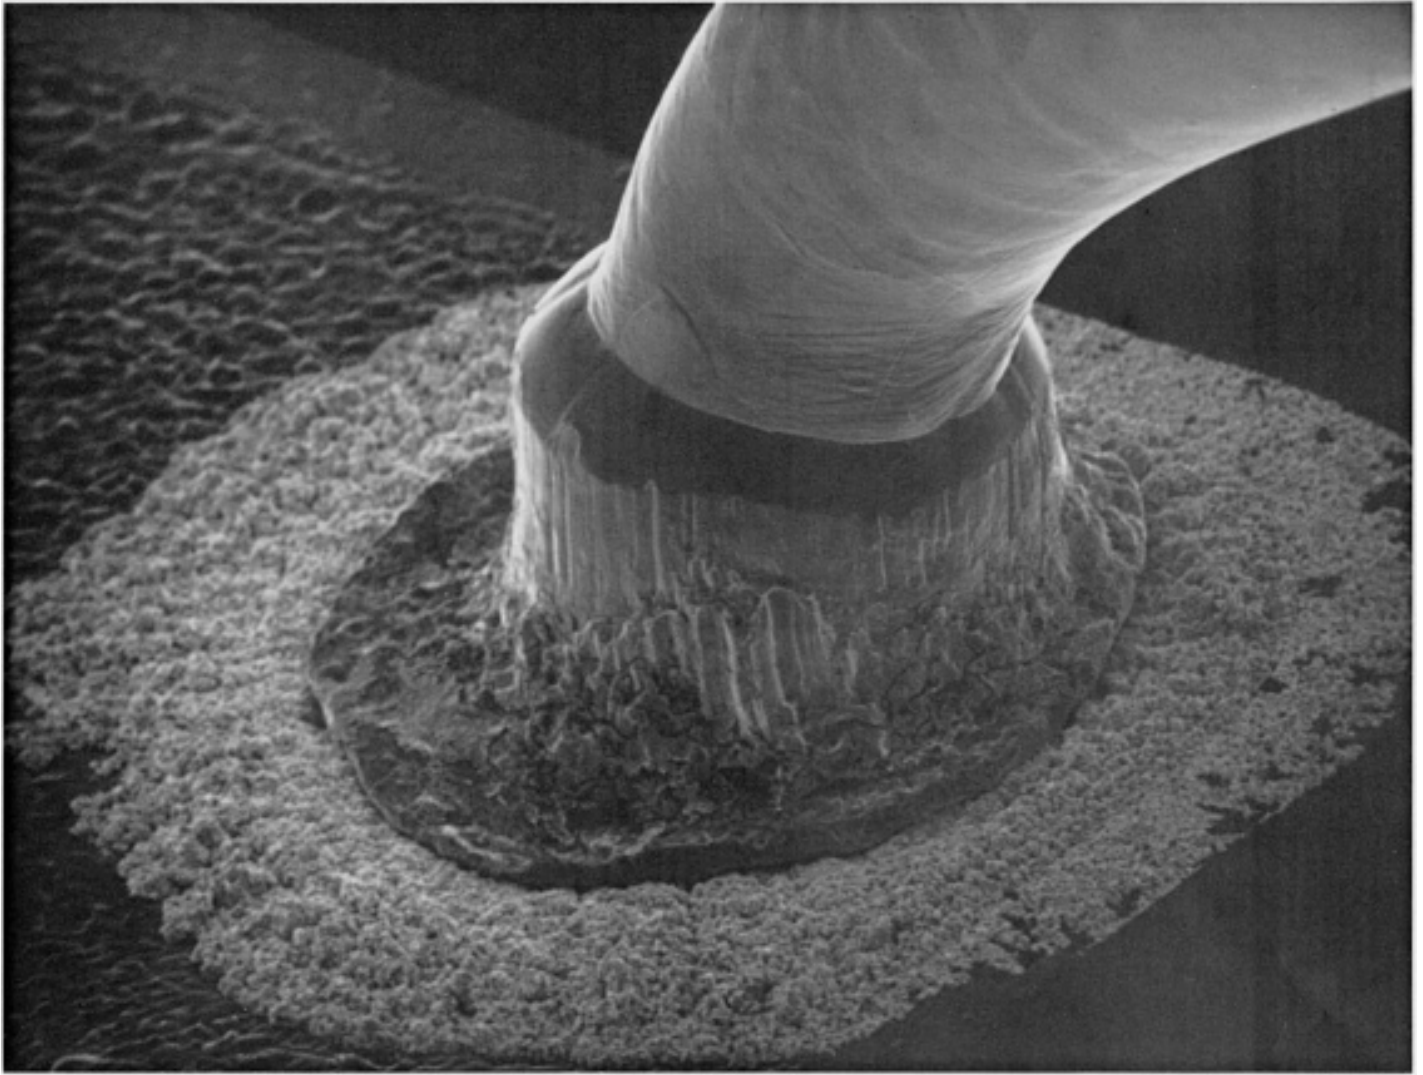
Fig. 1336 Thermocompression ball bond defect between a gold wire, 25 μm (1 mil) in diameter, and vacuum-deposited aluminum. Note the relatively thick intermetallic layer that formed during power cycling. SEM, 2750 \times (R.J. Schwinghamer, NASA Marshall Space Flight Center)

Fig. 1337 Same type of ball bond as in Fig. 1336. In this case, intermetallic formation weakened the bond, causing it to lift. SEM, 2700 \times (R.J. Schwinghamer, NASA Marshall Space Flight Center)
